**Cane River Creole National Historical Park**  
**Magnolia Plantation**  
**Overseer's House**  
**Historic Structure Report**

2004

2004  
Historic Structure Report  
Overseer's House  
Magnolia Plantation  
Cane River Creole National Historical Park  
Natchez, LA  
LCS#: 091558

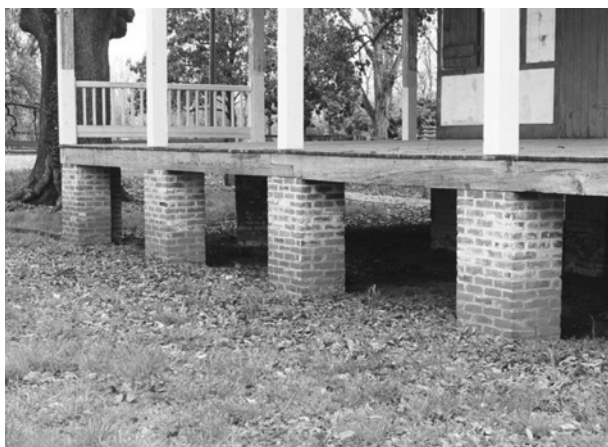
**FIGURE 2.** Foundation piers beneath southeast sill of southeast gallery.

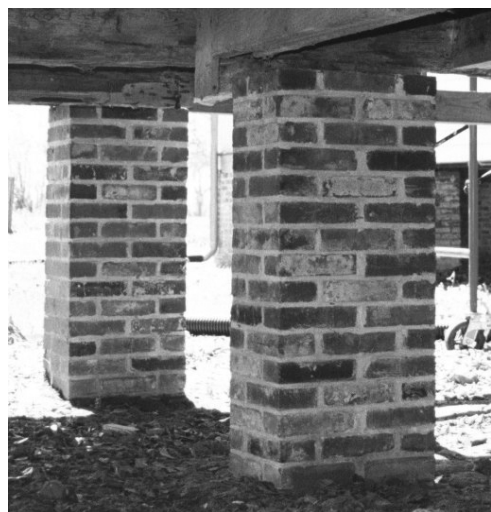
**FIGURE 3.** Foundation piers beneath Room 111 addition.

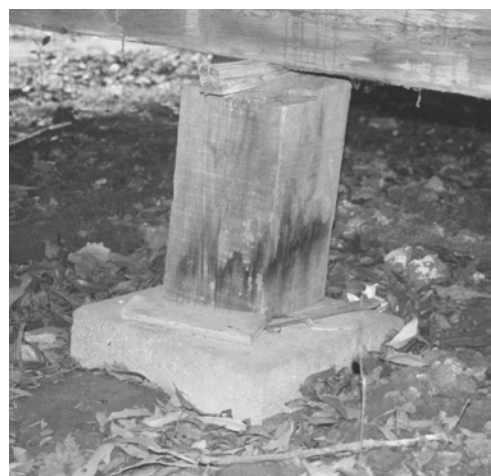
**FIGURE 4.** Odd pier beneath southwest sill of Room 110 addition.

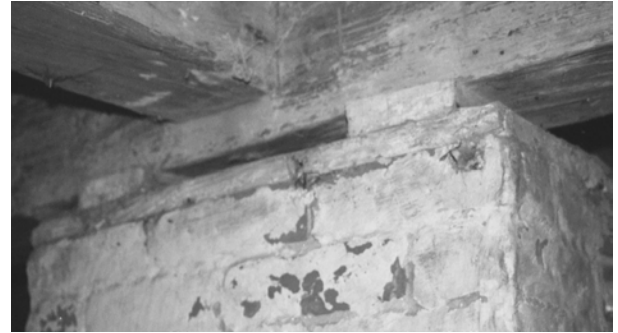
FIGURE 8. Detail of wood blocking between pier and floor framing.

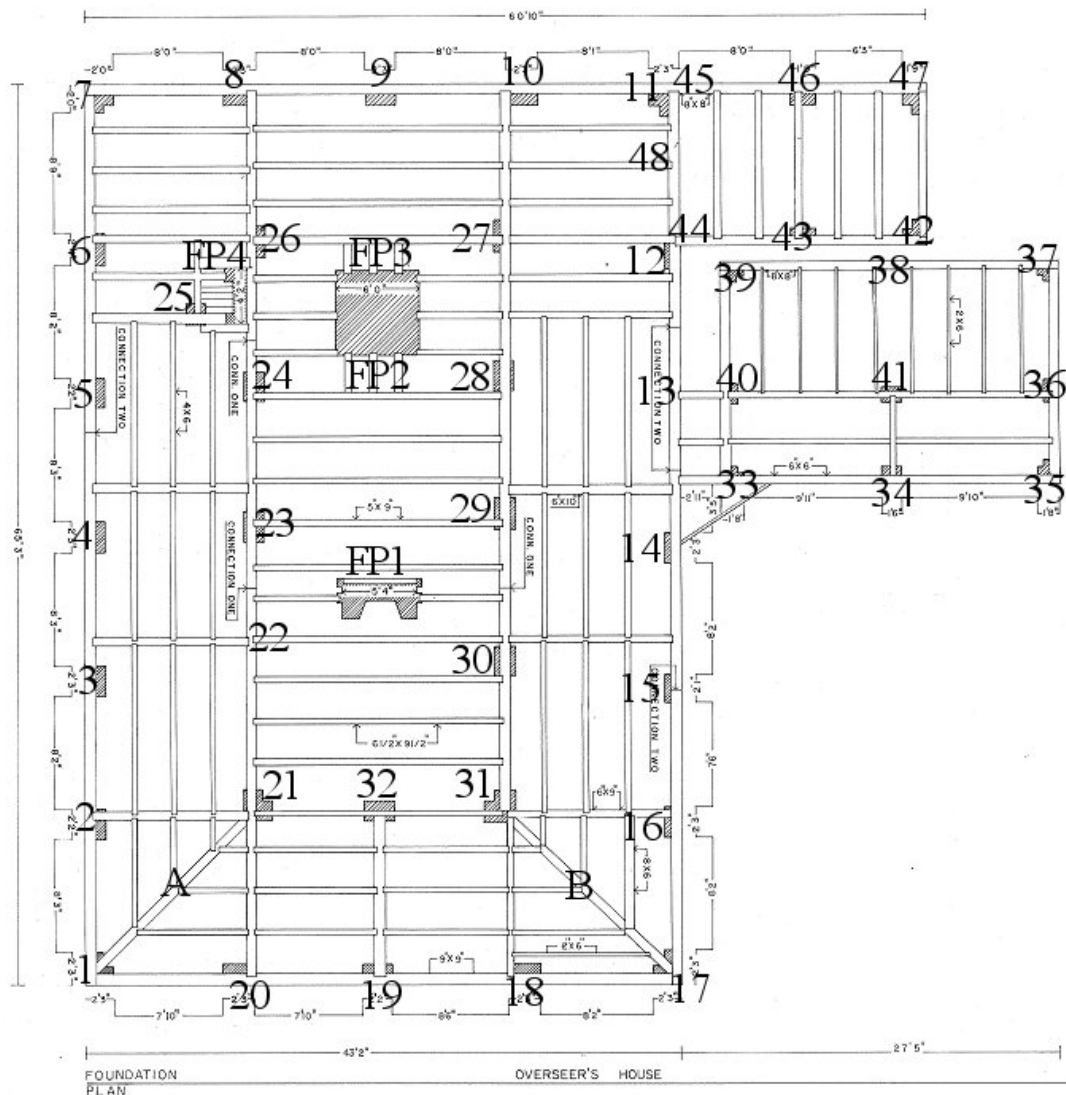
FIGURE 6. Summary description and condition of foundation piers.

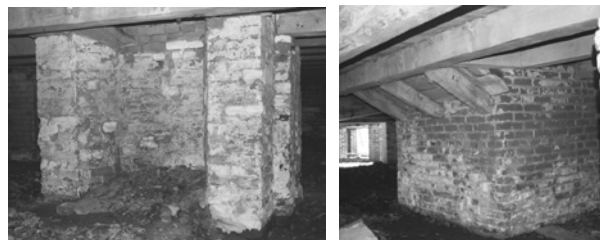
Fireplace 4 was created when Room 101 was extended to the southeast. The fireplace foundations appear sound.

**FIGURE 12.** Left, brick foundation of Fireplace 1, Room 104; right, brick foundation of Fireplace 2 (Room 103) and 3 (Room 102).

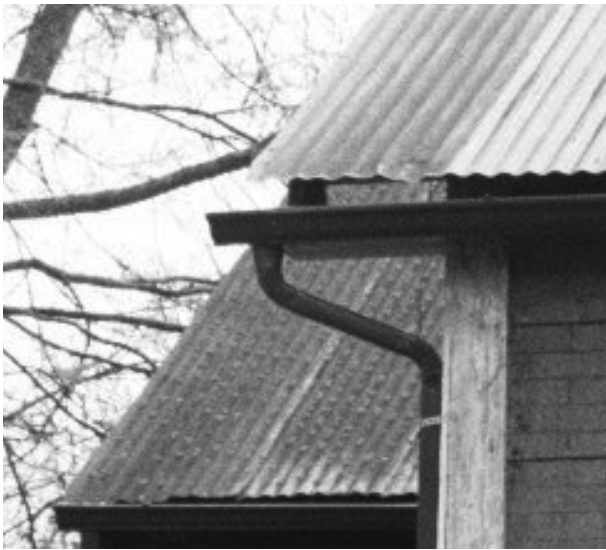
**FIGURE 34.** Corrugated roofing on additions (Rooms 110 and 111).

- Examine the existing roofing on the wing additions for any damage or moisture infiltration. Repair where necessary using materials that match the historic in dimension, detail, and finish.

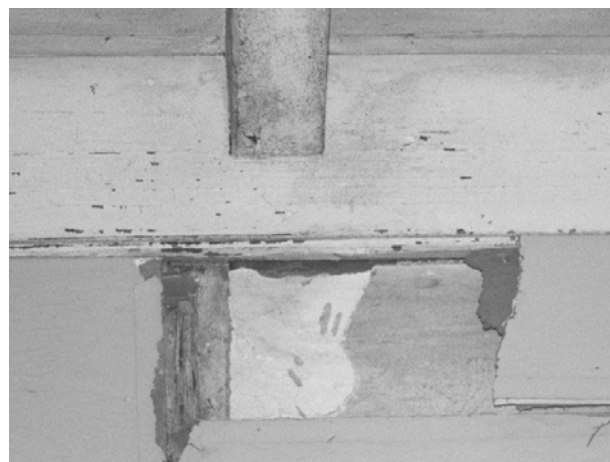
FIGURE 53. Room 104, ceiling joist (note bead), beam and exposed *bousillage* beneath gypsum wallboard.

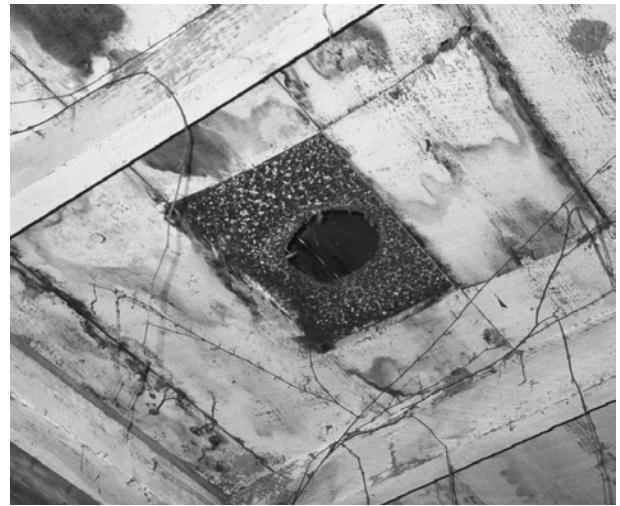
FIGURE 64. Ceiling, Room 110, showing stovepipe hole.
