## Alcatraz Barracks Building 64

Abbreviated Historic Structure Report

September 2003

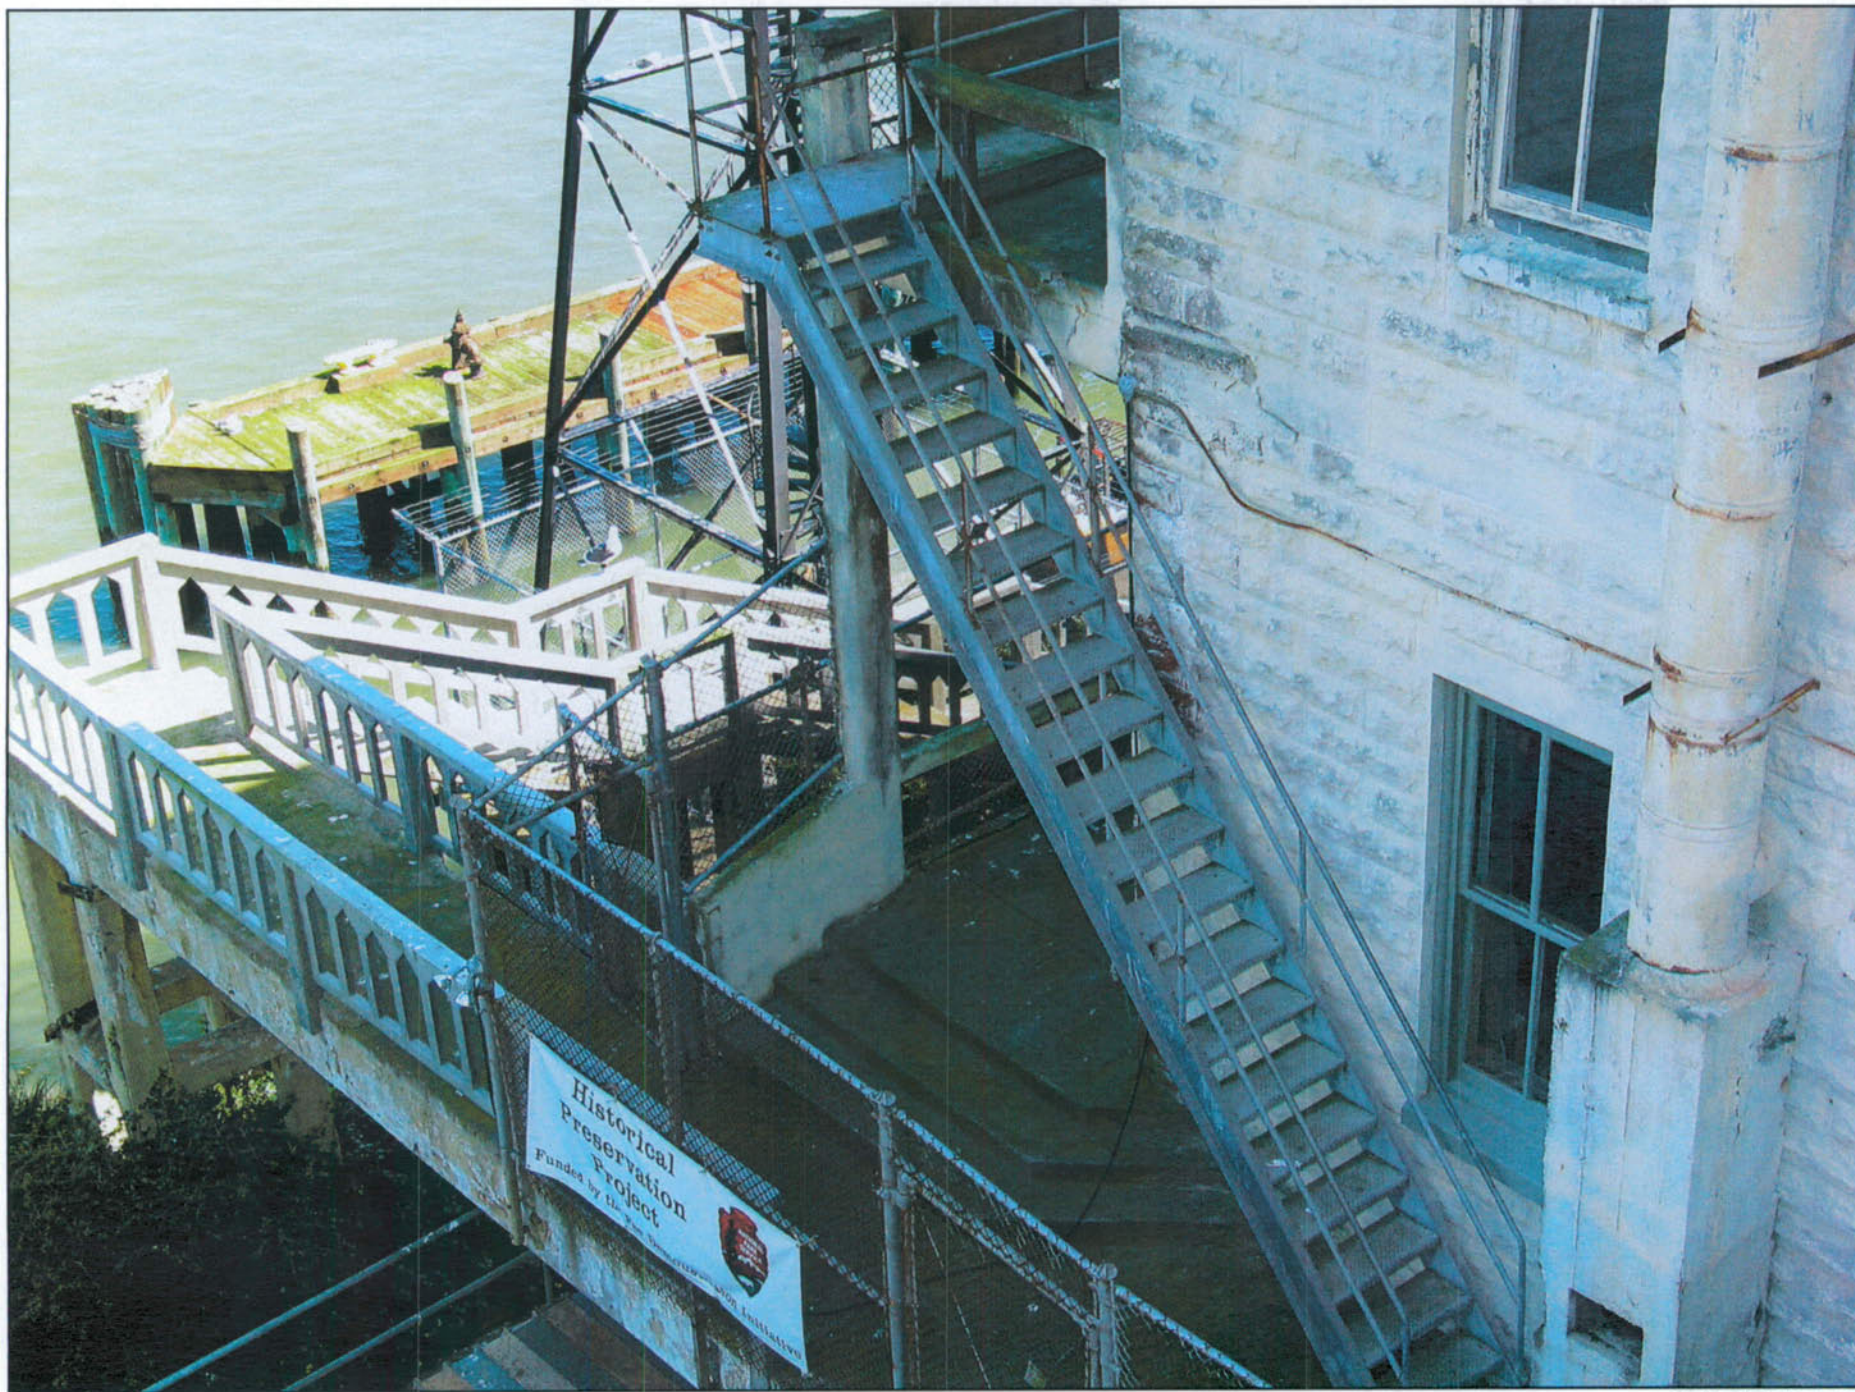
Opposite page: View of metal stair and concrete stair, north side, 2003. Photo Credit: John Martini.

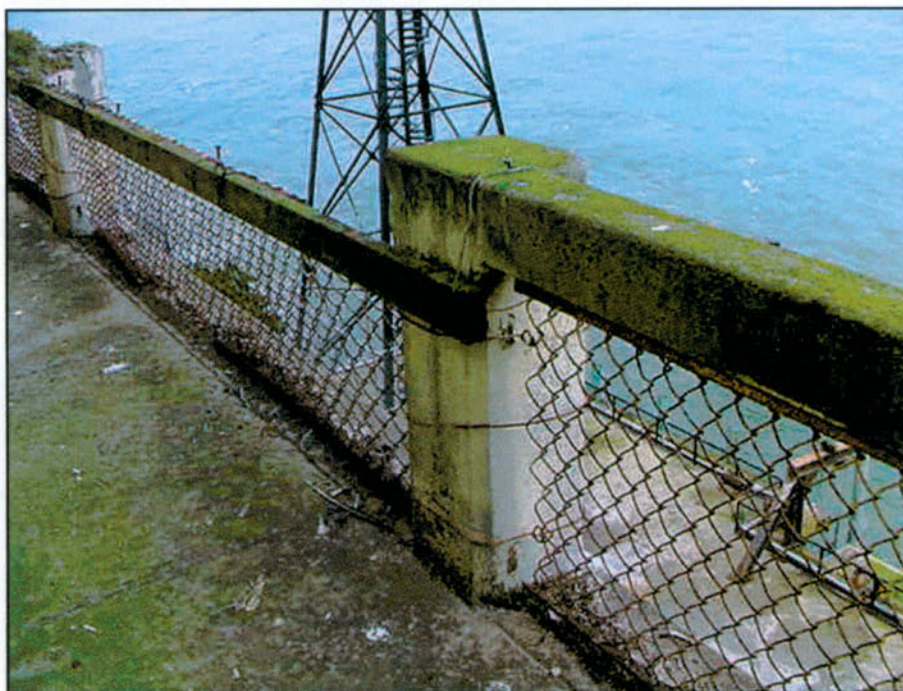
Bottom: Second floor balcony railing before repair, 2003. Photo Credit: Jane Lehman.
