# Presidio Gate, Broadway Gate and Vicinity

Cultural Landscape Report  
Presidio of San Francisco

Golden Gate National Recreation Area, California  
October 1996

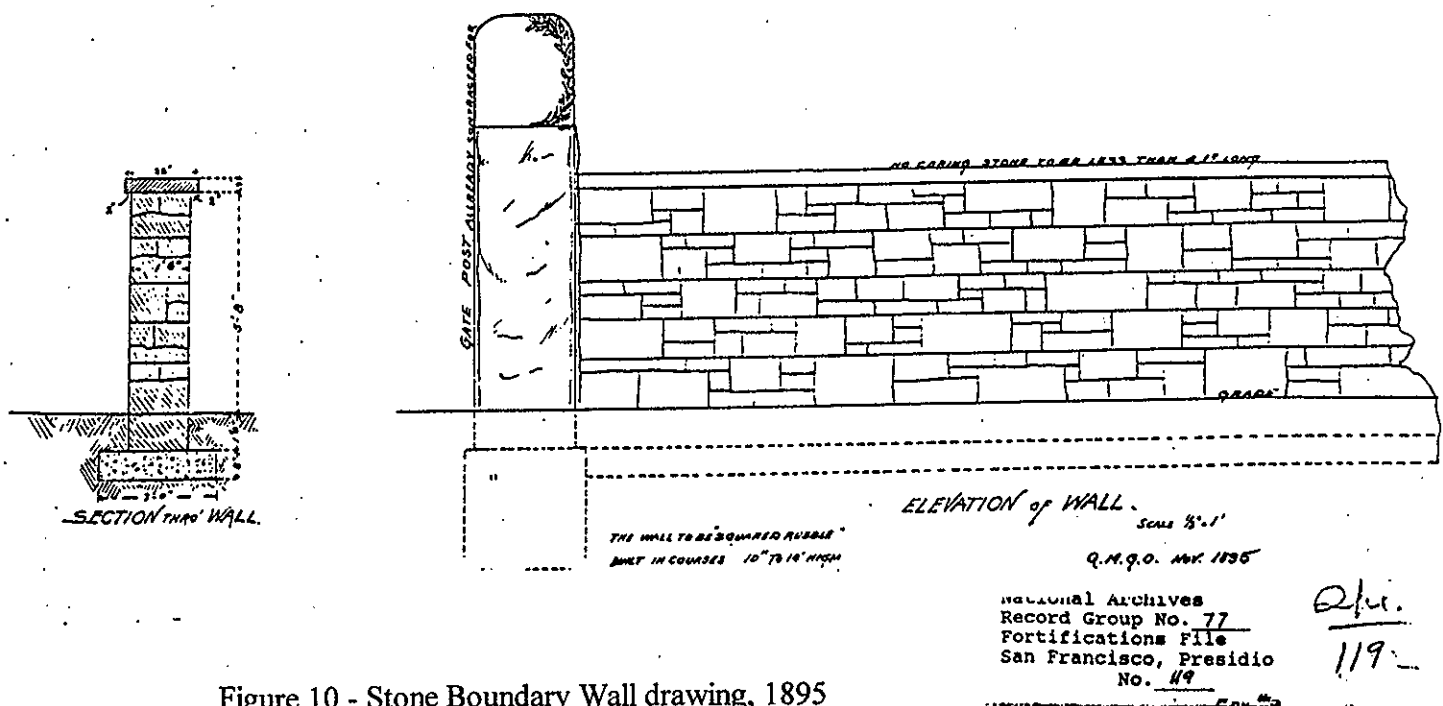
Figure 10 - Stone Boundary Wall drawing, 1895

The boundary wall is typically in good condition, an area on the east wall is missing, the coping and mortar joints need to be repaired in several areas.

The boundary wall is a key element to the historic landscape, for its definition of the Presidio, and for its quality of material and design. The stone boundary wall was constructed to "*prevent trespass by unauthorized persons and the unauthorized departure of soldiers of the post*" Major Wm. W. Harts, 1907. The walls should be repaired following the original design in form and materials.

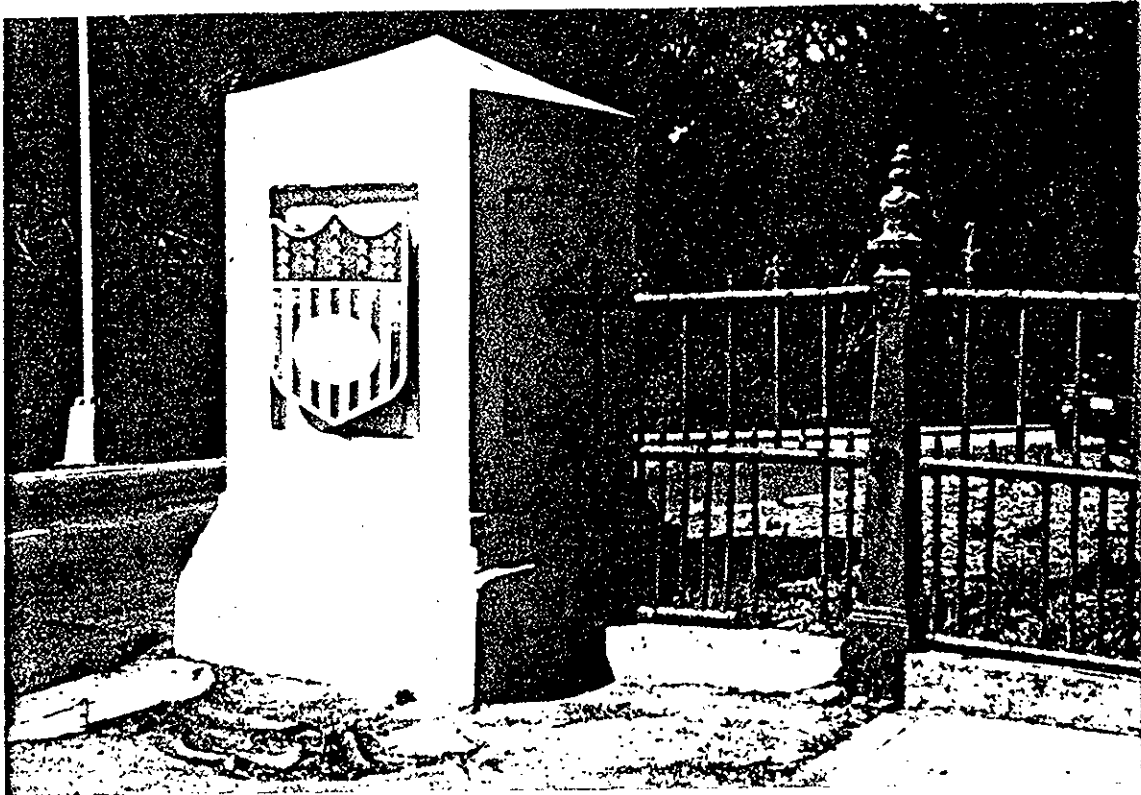
Figure 11 - Presidio Gate Masonry Pedestal

Today, the masonry pedestals have a thick stucco finish, buses are hitting the easternmost pedestal causing moderate damage to the base. The masonry pedestals are 19' apart at the base, extremely narrow for two buses to maneuver. The ornamental iron fence is moderately deteriorated, several pickets are missing, many of the finials are missing, decorative moldings from the iron posts are missing, many of the iron stringers are rusted away from the posts. The pedestrian gate is not the same gate as shown in the 1906 photograph, figure 3, it is unknown when this gate was replaced. The gate is moderately deteriorated, the connection to the masonry pedestal is missing. There is only one pedestrian gate, which is located on the west side of the entrance. Pedestrian and bicycle access from the east side is extremely dangerous, visitors must either cross Presidio boulevard or enter in the vehicular lanes. In either case view is obstructed by the masonry pedestals.

The road through the gate is 19' wide, minimum road width for buses to pass is 20'. The damage buses are causing to the pedestals is moderate at this time. As more vehicular traffic goes through the gate, the damage will become more severe. Design alternatives to reduce damage to the pedestals:

- A. Move the eastern pedestal to widen road to 22', the design standard for Presidio Boulevard. This solution would allow buses to pass and maintain the historic character of the gate. This solution would move the pedestal from its historic location.
- B. Keep the pedestals in existing locations, restore the cannon

bollards and iron vehicular gates, sign the gate as a narrow entrance. This solution would maintain the historic character and location of the gate. The width of the road would be less than 18', only one bus could pass through the gate. At this width, the gate becomes essentially a one lane gate.

C. Keep the pedestals in existing locations, add narrow curbs to both sides of the road, against the pedestals. This would add non-historic curb to the gate structure. The road width would be reduced to 18.5', extremely narrow for urban setting.

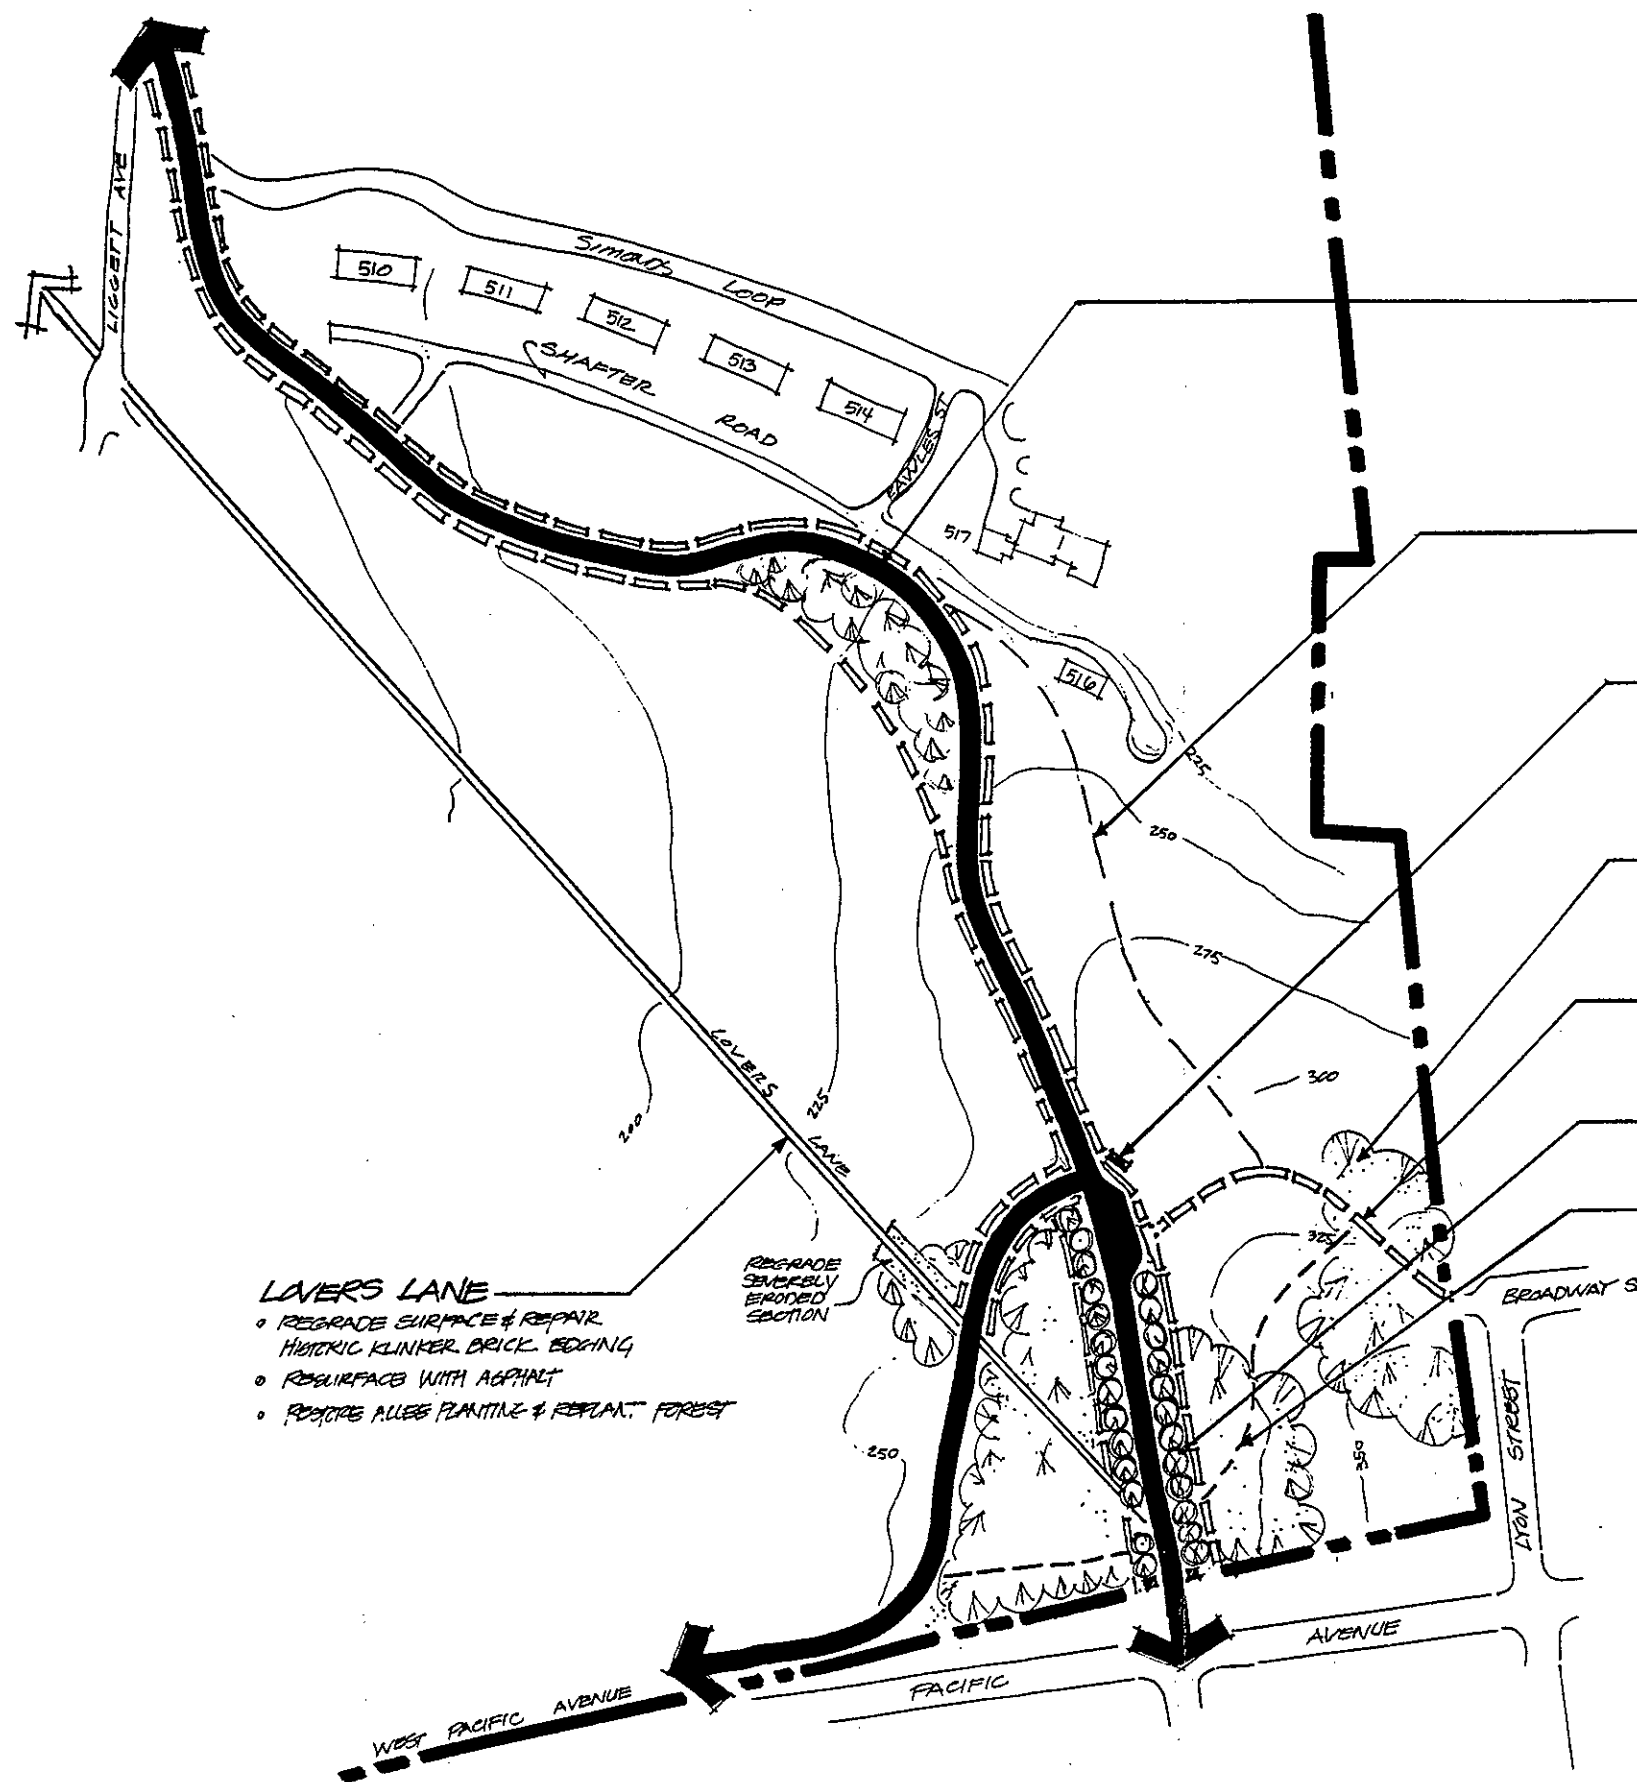
REGRADE SEVERELY ERODED SECTION

- LOVERS LANE**
- REGRADE SURFACE & REPAIR HISTORIC KLINKER BRICK EDGING
  - RESURFACE WITH ASPHALT
  - REGRADE ALLEE PLANTING & REPLANT FOREST

- REPLACE EXISTING GUARDRAIL WITH NPS WOOD GUARDRAIL
- REDUCE LANE WIDTH TO 11' LANES AND 4' BIKE LANES/SHOULDER
- REMOVE WOOD FENCE
- OPEN SPLIT WEST SIDE BIKE LANE AT CURVE
