Cape Hatteras National Seashore Bodie Island Coast Guard Station Historic Structure Report

2005

Joseph K. Oppermann - Architect, P.A.

2005 Historic Structure Report Bodie Island Coast Guard Station Cape Hatteras National Seashore Manteo, NC LCS#: 07238

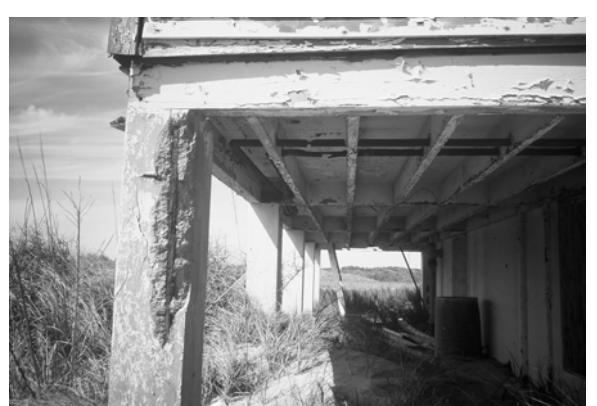
Figure C-4 Porch foundation and floor framing

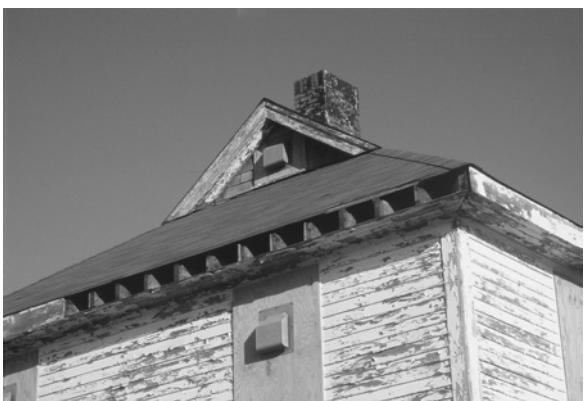
Roof & Rainwater Collection/Dispersal: The station has asphalt shingle roofing on all roof surfaces; it is in relatively good condition. No gutters or downspouts are in place, though early photographs show them installed on the porch roof and roof of the main block. Some fascia boards of the main block are currently missing, including an approximately 16 feet long section on the north elevation, and two sections totaling approximately 20 feet on the east elevation.

Figure C-5 Missing fascia board on the north elevation

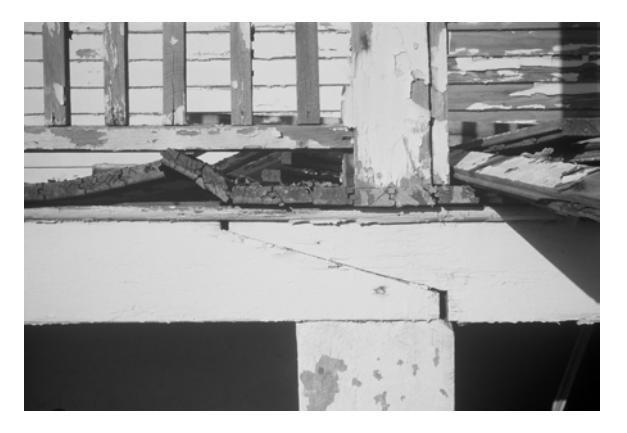
Porches: The first-floor wraparound porch on the south and west elevations is an original feature. The shallow pitch of the hip roof and concrete foundation piers of the porch remain unchanged. The south portion of the porch was enclosed at some time between 1956 and 1962. In 1962, stairs were built in their current location off the northernmost bay of the west section of the porch. Both the stairs and the exposed portion of the porch are in poor condition. Severely peeling paint has allowed access by water, causing the wood to swell and buckle, and rot has formed in numerous areas. The flooring in the south bay of the west section has collapsed.

Figure C-8 Buckling porch flooring and collapsed porch railings

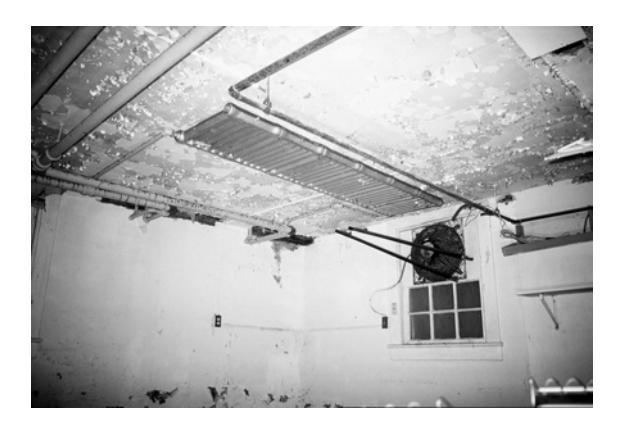
Figure C-12 Exhaust fan replaces top sash

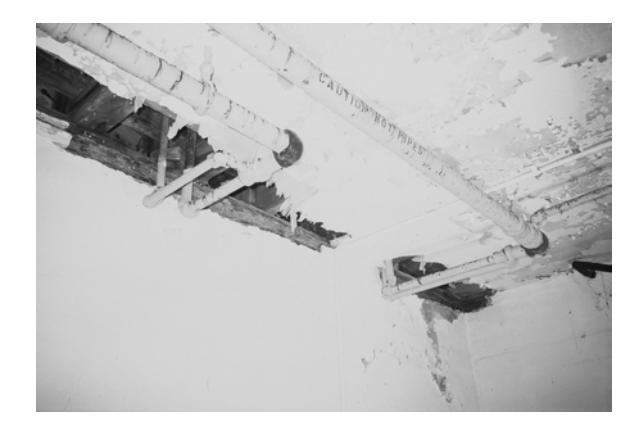
Figure C-13 Termite damage to ceiling joists and sill plate

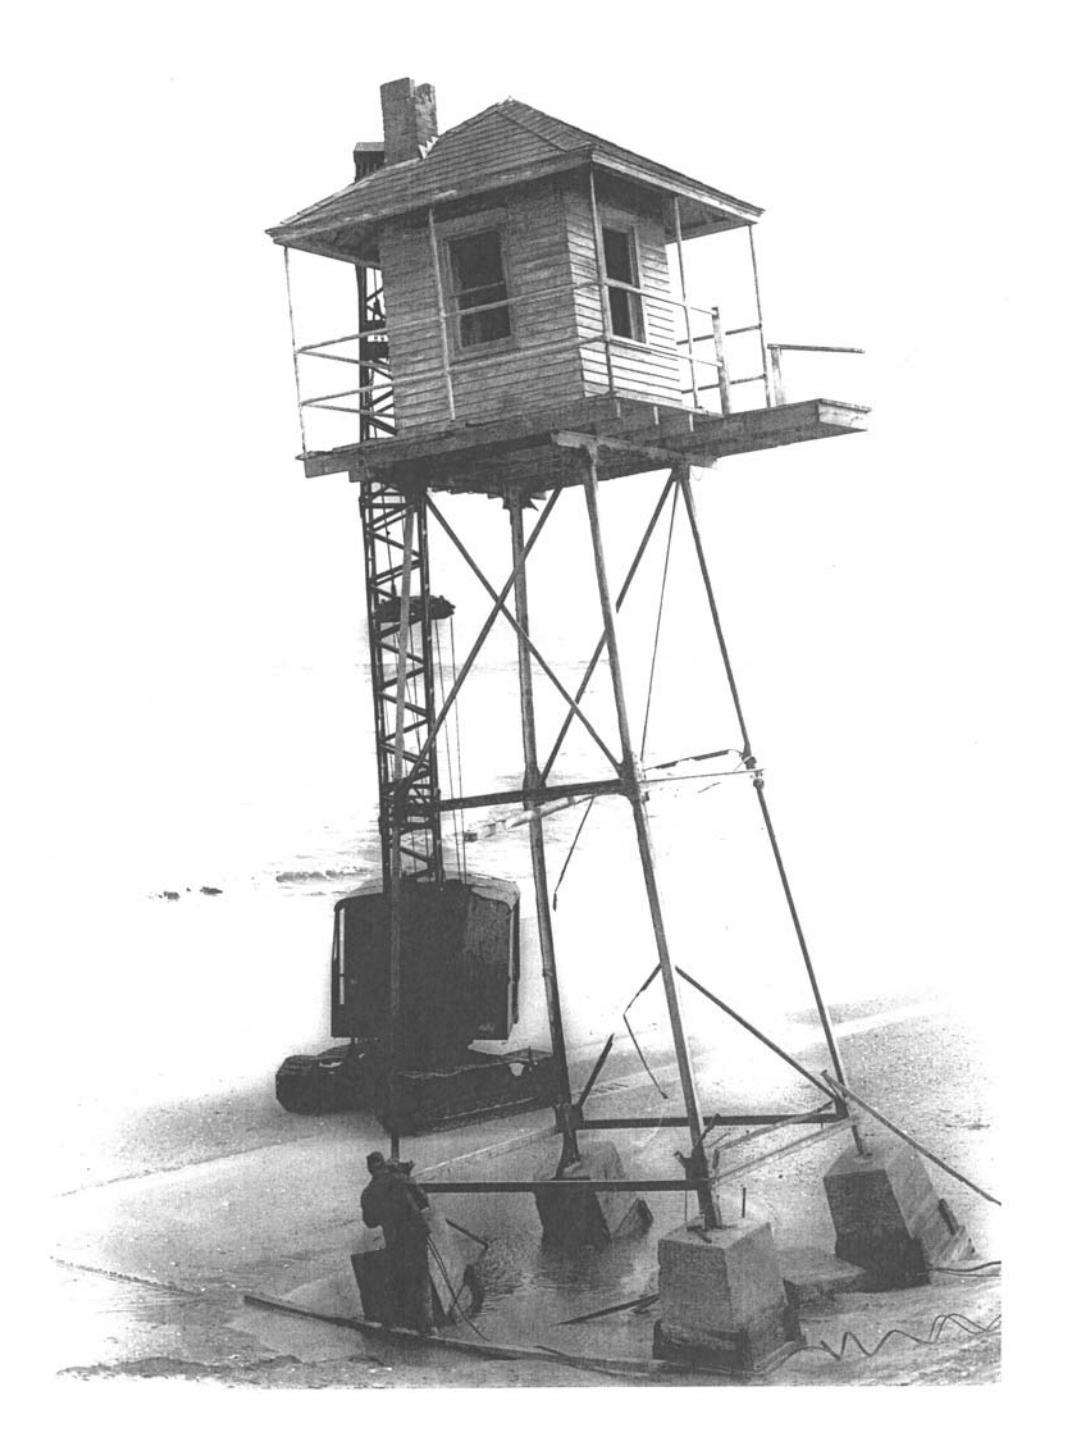
H.26 Crane in a failed attempt to save the 1925 Lookout Tower, Feb. 6, 1978.
