THE SECRETARY
OF THE INTERIOR'S
STANDARDS FOR
REHABILITATION &

GUIDELINES
ON **FLOOD**
ADAPTATION FOR
REHABILITATING
HISTORIC
BUILDINGS

U.S. Department of the Interior
National Park Service
Technical Preservation Services

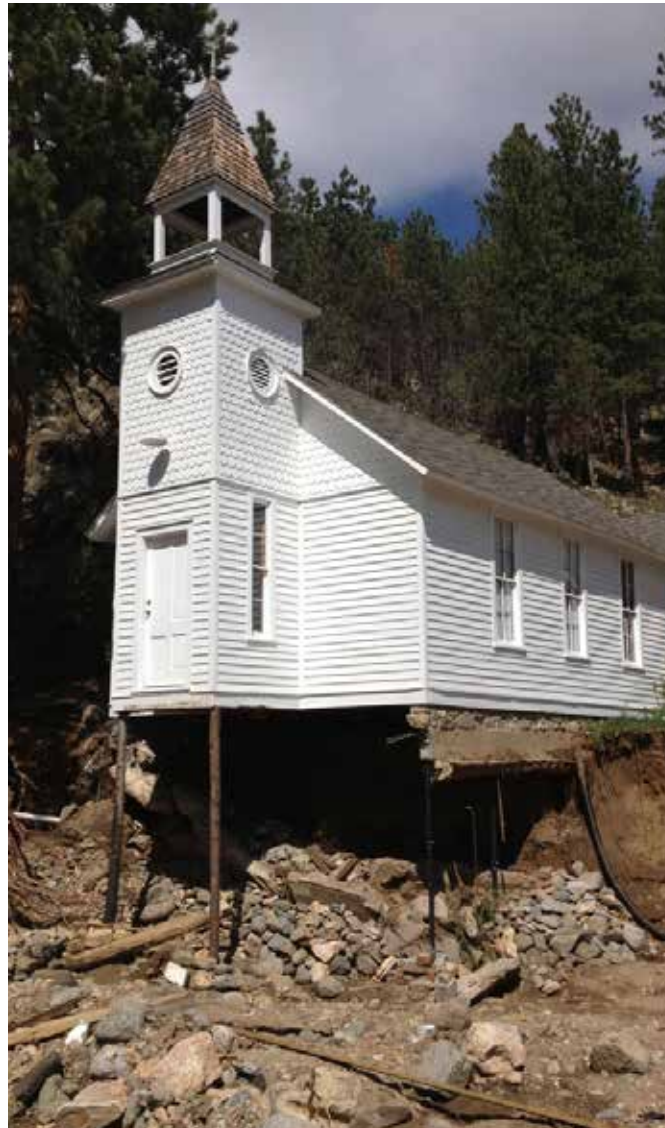
[9] Fast-moving flood waters can undermine a foundation or scour out land around a building. The Little Church of the Pines in Salina, CO, was left structurally compromised after heavy rains caused flooding in the Front Range of the Rocky Mountains in 2013. *Photo: Burton Construction burton-construction.com*

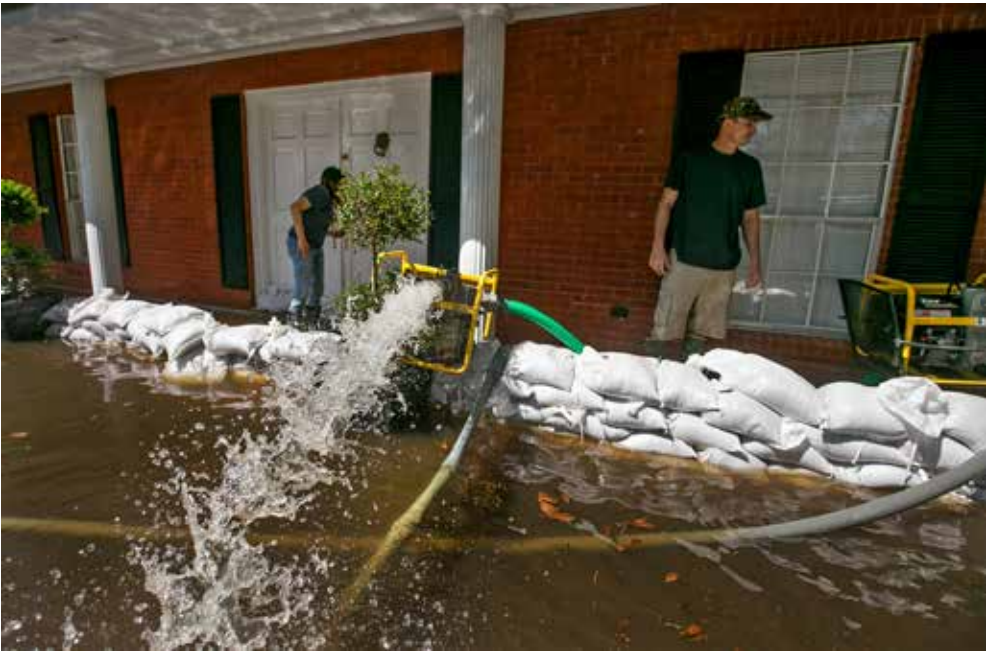
[26] Water can still seep through sandbag barriers. A property owner should have a pumping system with back-up generators to remove water from behind the barrier. Photo: Ted Jackson, NOLA.com | The Times-Picayune. The Advocate, 7/29/2019. The Times-Picayune/The Advocate

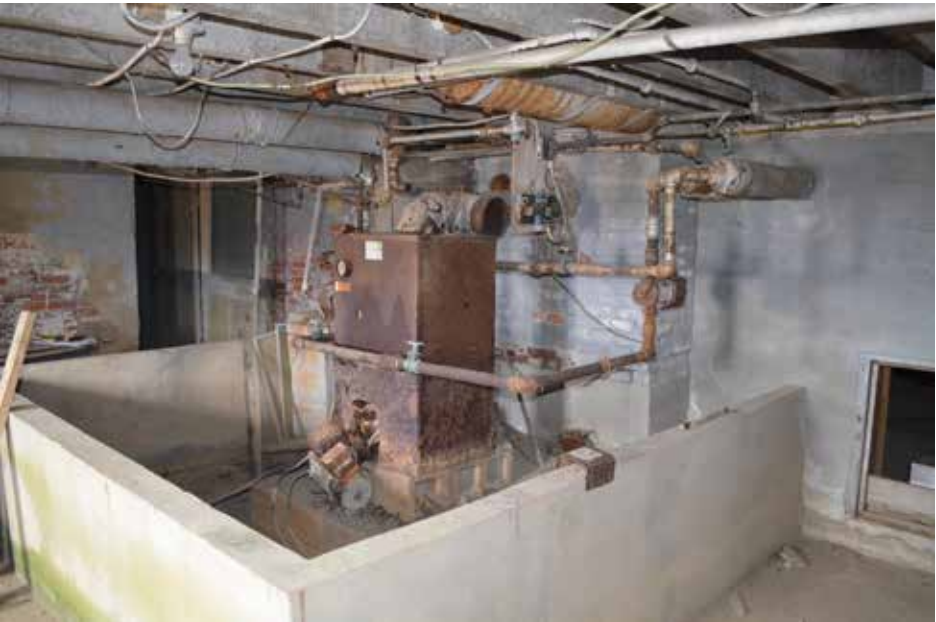
[42] Mechanical equipment that remains in a basement that is likely to flood should be enclosed behind waterproof walls. The walls may be partial height, as shown in this example, if flood waters are not expected to exceed that height. In other cases, waterproof enclosures must fully surround the equipment, which can be accessed by submarine-quality doors or hatches. *Photo: Quinn Evans*

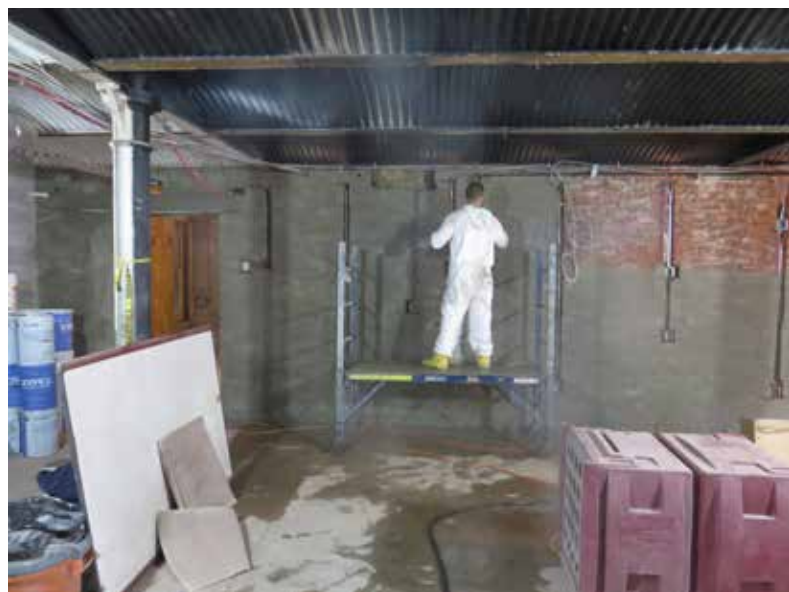
[48] A waterproof coating is applied to the interior surface of lower-level walls of the public library in Hoboken, NJ. Prior to applying such a coating, the product should be researched by building science professionals with knowledge of historic materials and methods to ensure that the coating will not cause damage to or accelerate deterioration of the structure. Photo: David V. Abramson for Hoboken Public Library

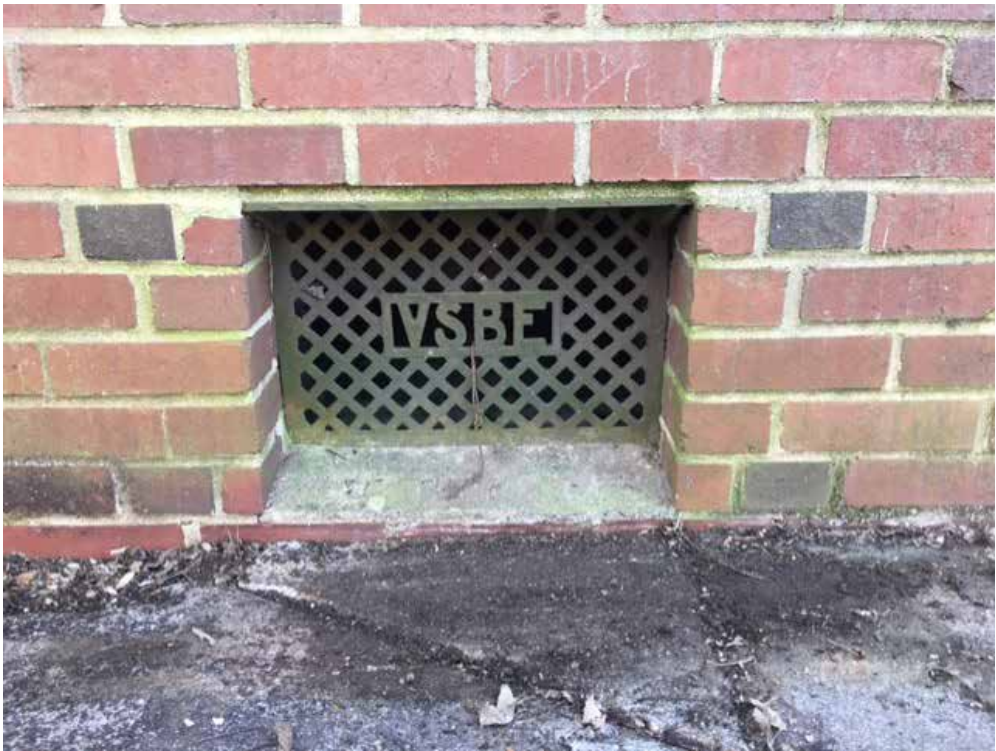
[56] To create a watertight seal around the building, any existing vents or openings below the established flood risk level must be sealed during a flood. Vents that cannot be sealed internally will require an exterior and/or interior cover to keep water from entering the building. *Photo: Chelius Carter*

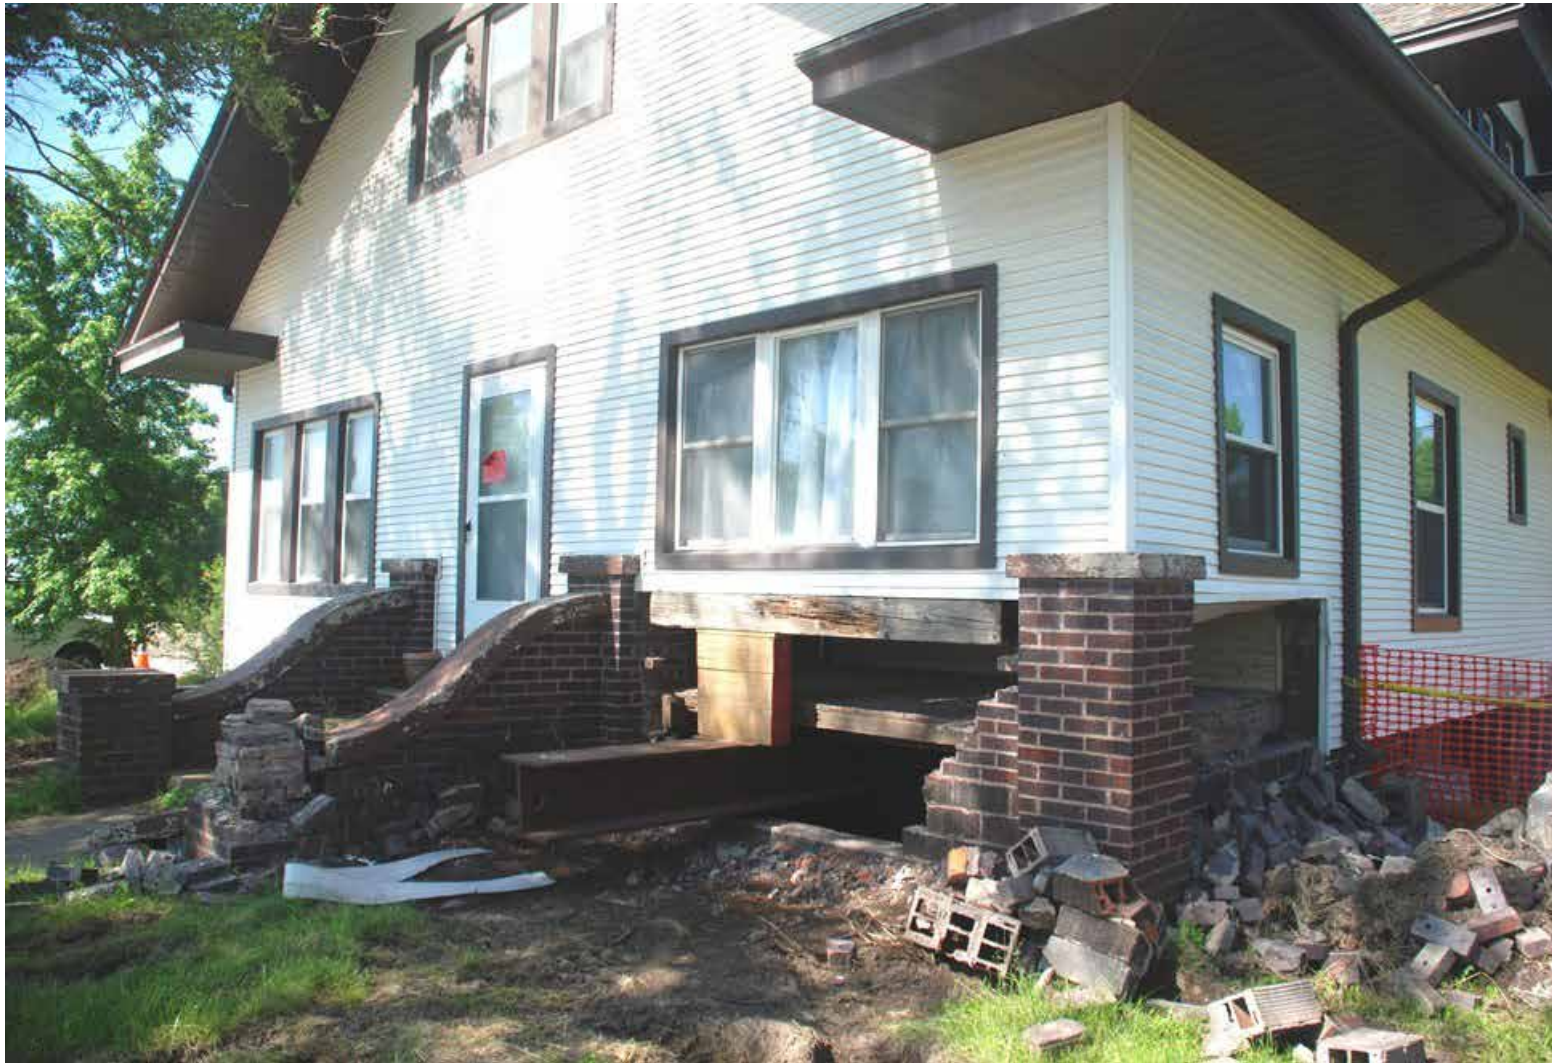
[72] Filling a basement requires access to bring the fill below grade and to maneuver compacting equipment in the space. In this example, a prior flood-damaged section of the foundation wall created an opening that allowed earthmoving equipment access to the basement. The exterior will be repaired once work is complete below grade. Photo: Mitch Paine

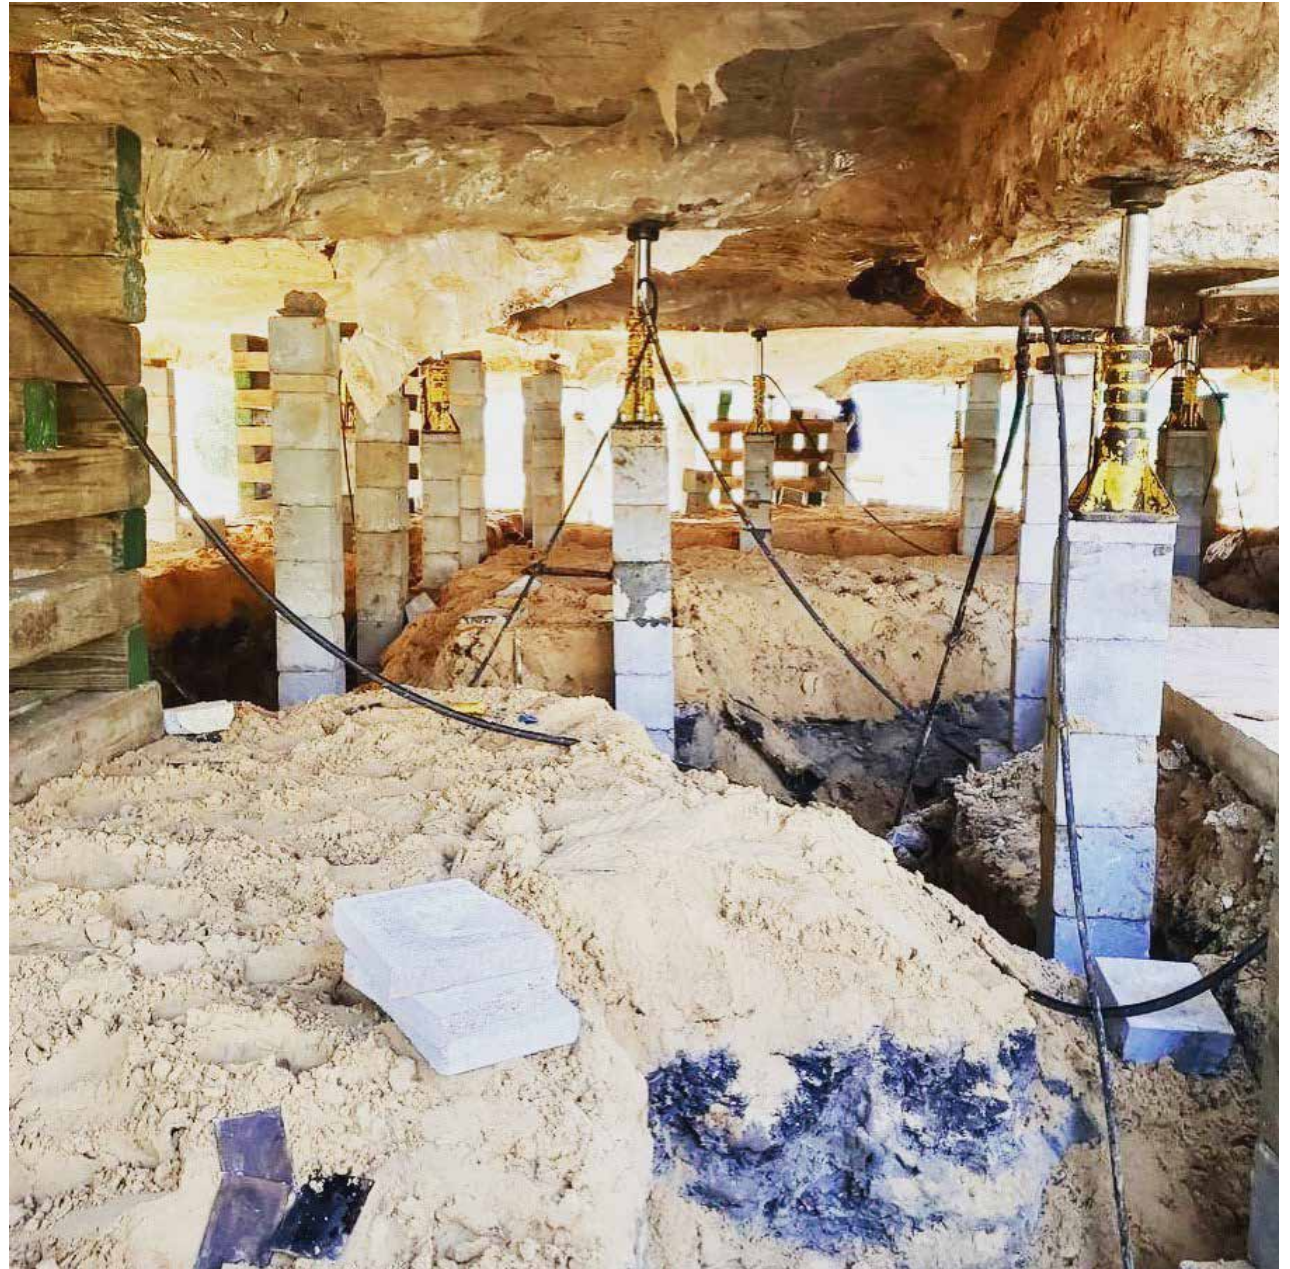
[79] Buildings on a concrete slab can be more challenging to lift. In some cases, as shown in this example, the existing slab can be lifted and still remain the floor for the interior spaces. In other instances, the slab may need to remain at grade, with a new elevated floor structure constructed above. *Photo: p3elevation.com*

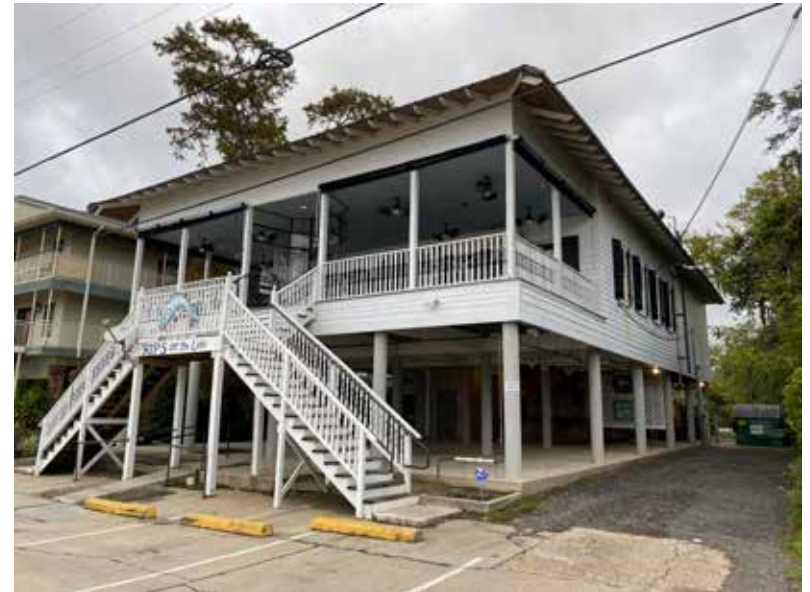
[89] This building in Louisiana has been raised on piers, but the foundation piers are set back from the face of the building, do not line up with the porch posts, and are visually undersized. New foundation piers, posts, and columns should have a visual appearance that more closely matches traditional foundation placement, size, and materials, even if that requires wrapping more modern, slender steel members with a masonry veneer. Photo: Roderick Scott

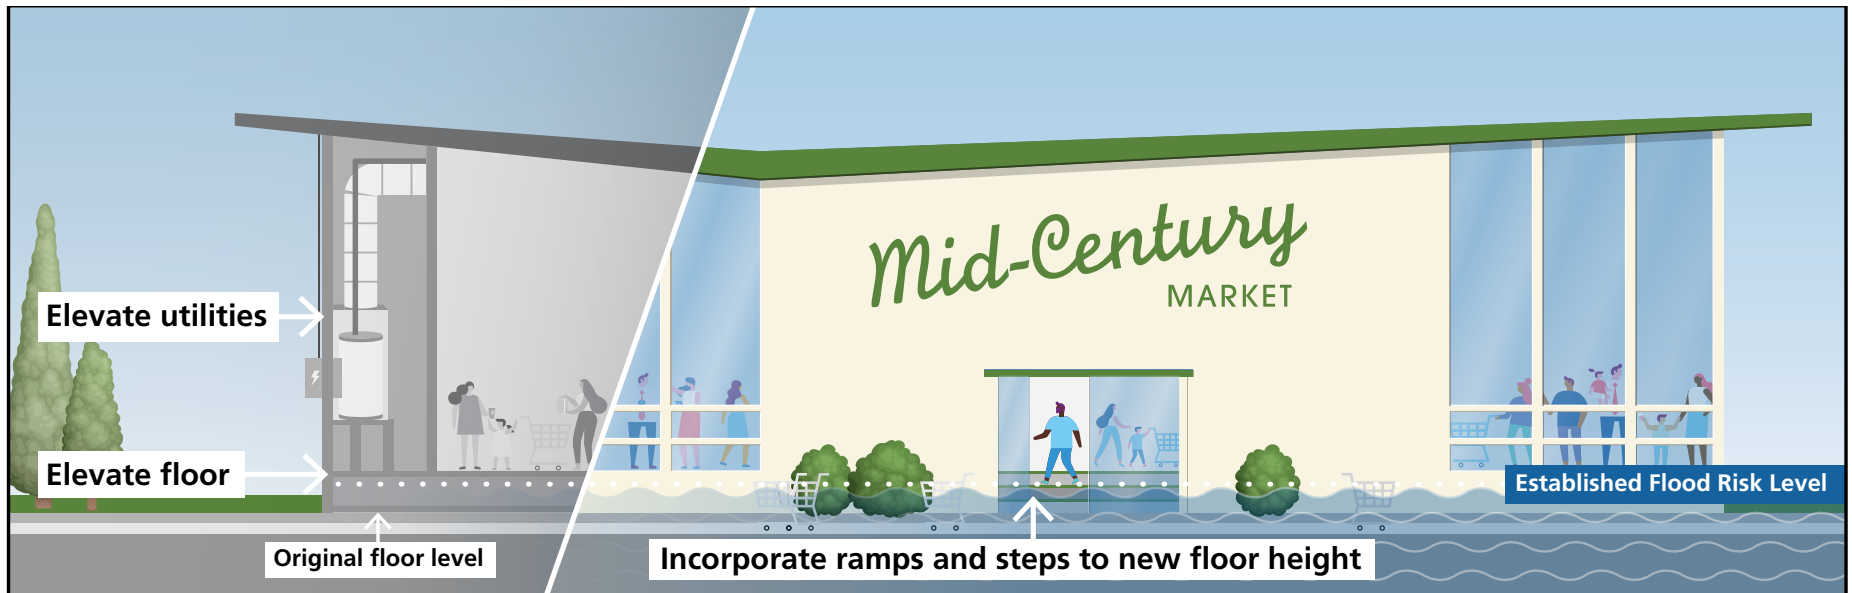
[100] Elevating the interior floor level above the established flood risk requires several building alterations, including constructing a new floor, elevating any utilities, and creating access to the new floor level. The original floor to ceiling height must be substantial enough to allow space for the new elevated first floor. *Graphic: Blank Space LLC for NPS*

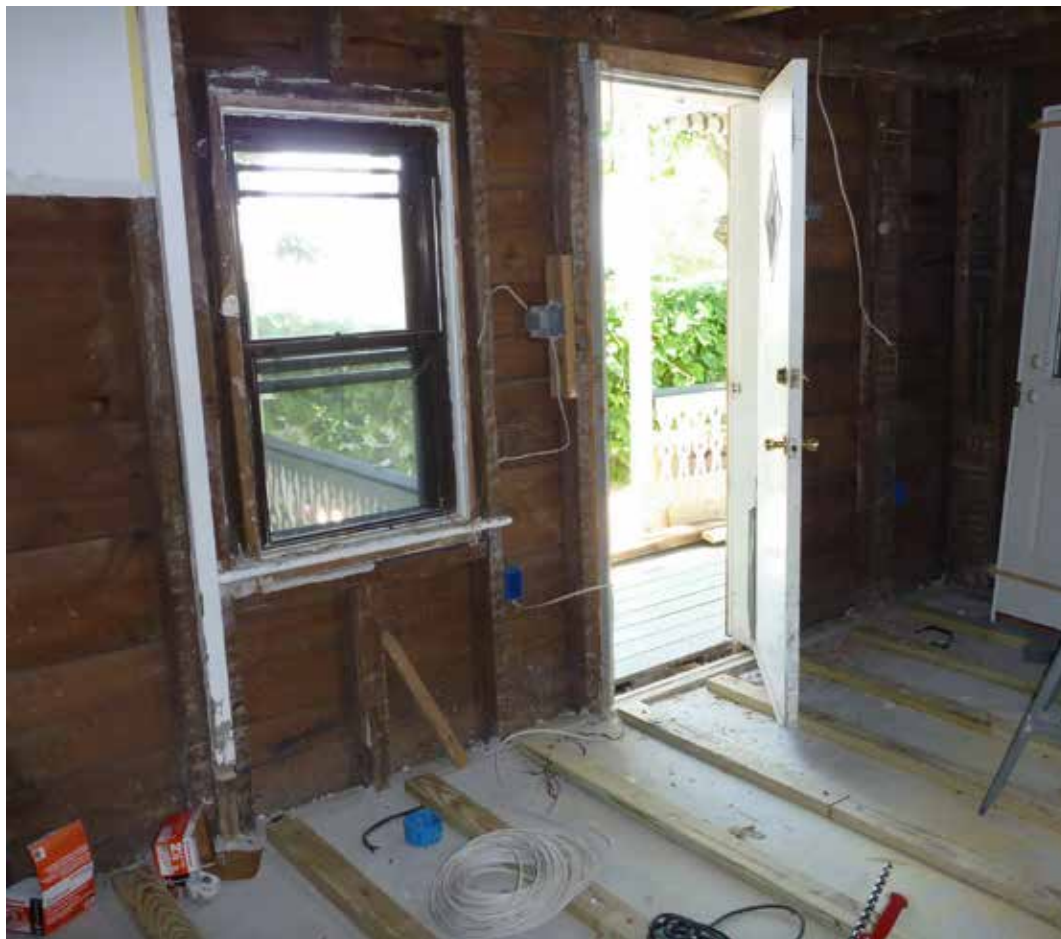
Figure 2: In-progress repairs after Hurricane Sandy. Walls are open to the interior for initial drying. A new concrete structural slab has been topped with treated wood sleepers in preparation for a new flood-damage resistant mahogany floor. Photo: Mary Delaney Krugman, JD, MSHP

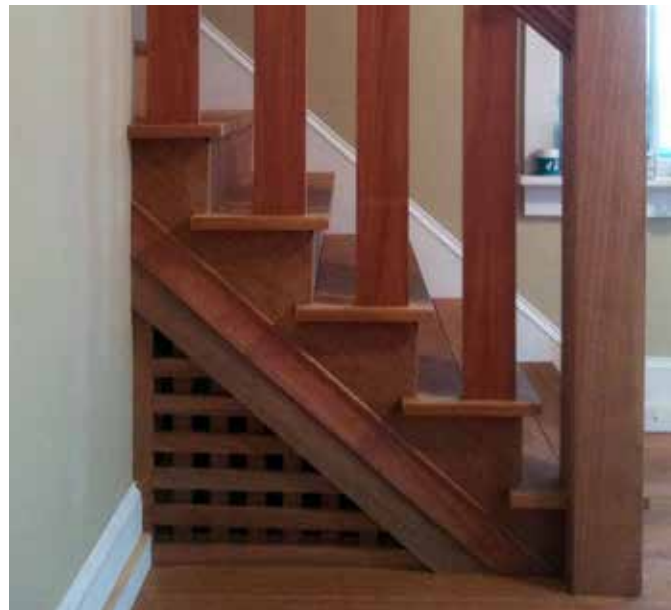
Figure 3: Instead of solid wall material, an open lattice was installed under the stair to vent an otherwise inaccessible space. Photo: Mary Delaney Krugman, JD, MSHP

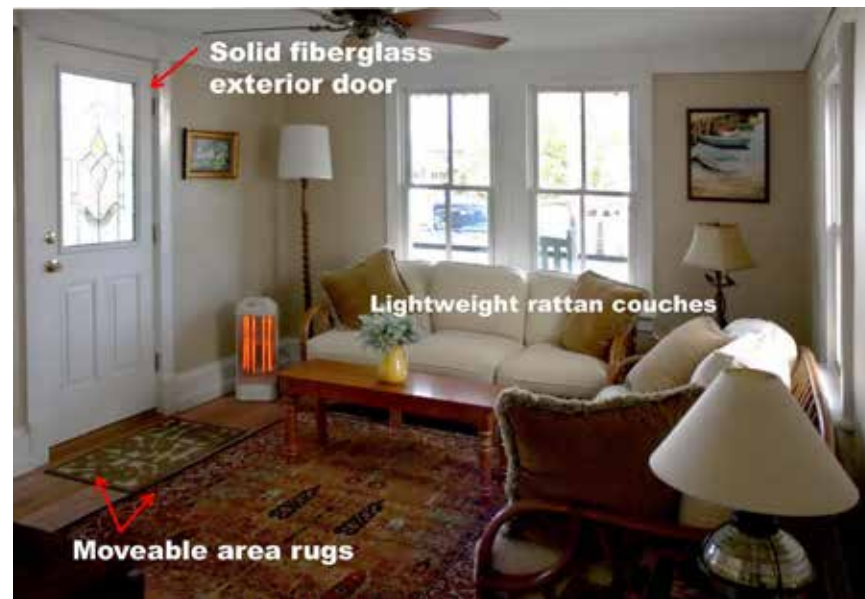
Figure 7: After repairs and wet floodproofing measures have been implemented, the new floor and wall surfaces are flood-damage resistant. The front door and windows were also replaced with more compatible designs using flood-damage resistant materials Photo: Mary Delaney Krugman, JD, MSHP

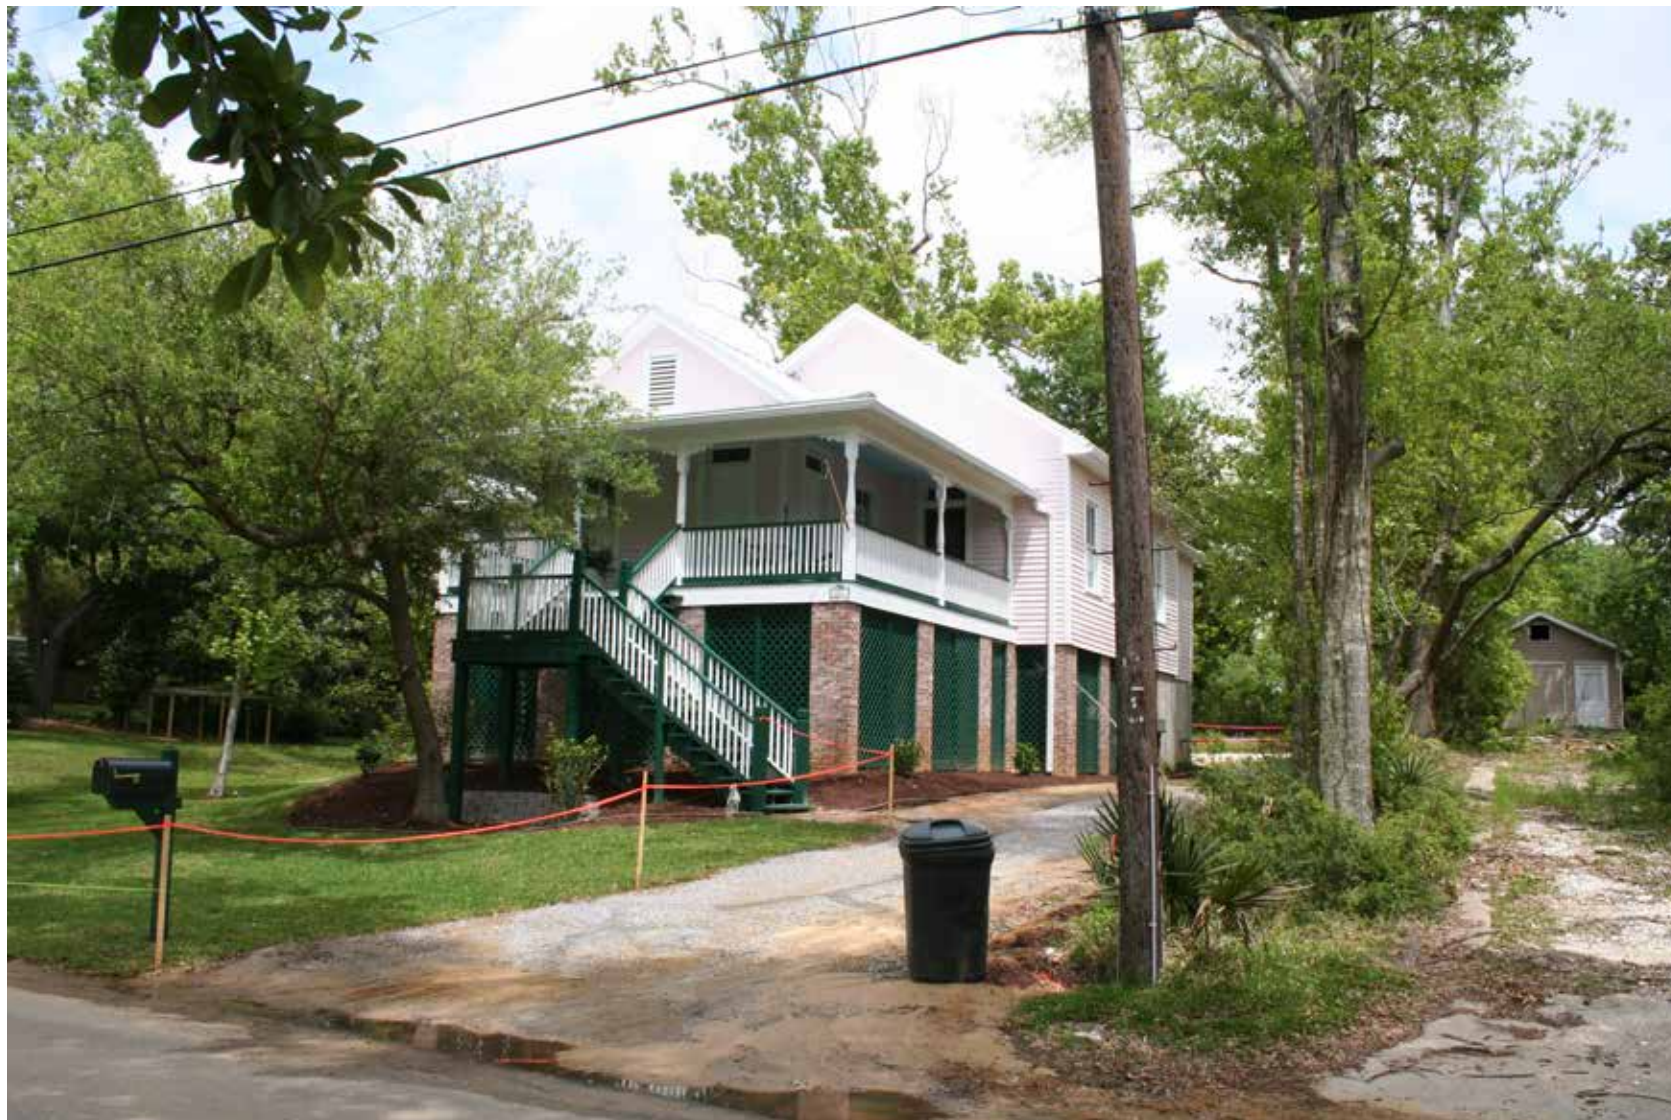
Figure 5: A taller foundation was constructed to elevate the house above the established flood risk level. While the house is higher than it was historically, the change is still in keeping with the historic character of the house, which had been on a tall foundation historically. The change is also consistent with historic regional traditions of adapting buildings to flood events. Additionally, the details of the foundation, with the brick piers and painted lattice, matches features of the historic design. The stairs access the porch in the historic location, but the extended run required by the taller foundation is turned 90 degrees below the landing to allow a surviving tree to remain in front of the house. A small retaining wall behind the tree holds fill that was added around the house to mask some of the change in height. Photo: Mississippi Department of Archives and History, Mississippi Historic Resources Inventory (HRI) Database. <http://www.apps.mdah.ms.gov/Public>

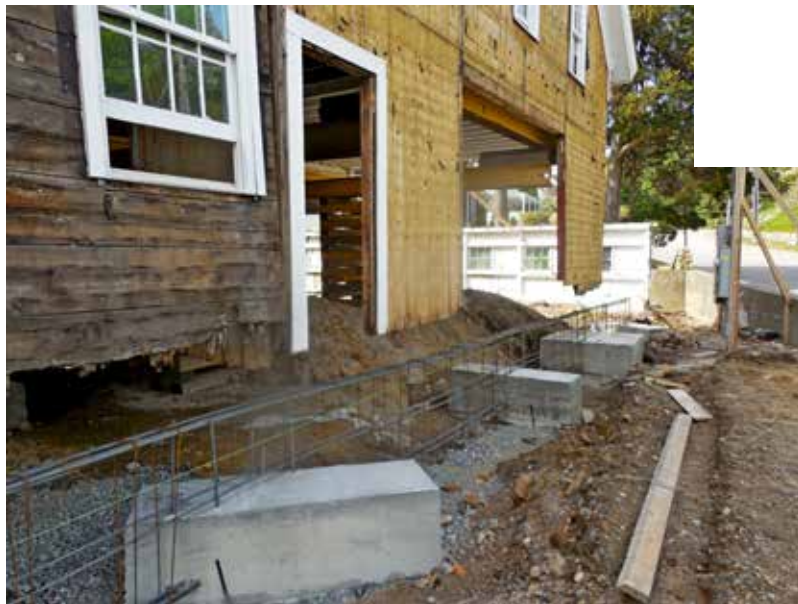
Figure 3: The structure was lifted in sections several feet in the air to provide space and access for foundation work. Photo: GNCB Consulting Engineers

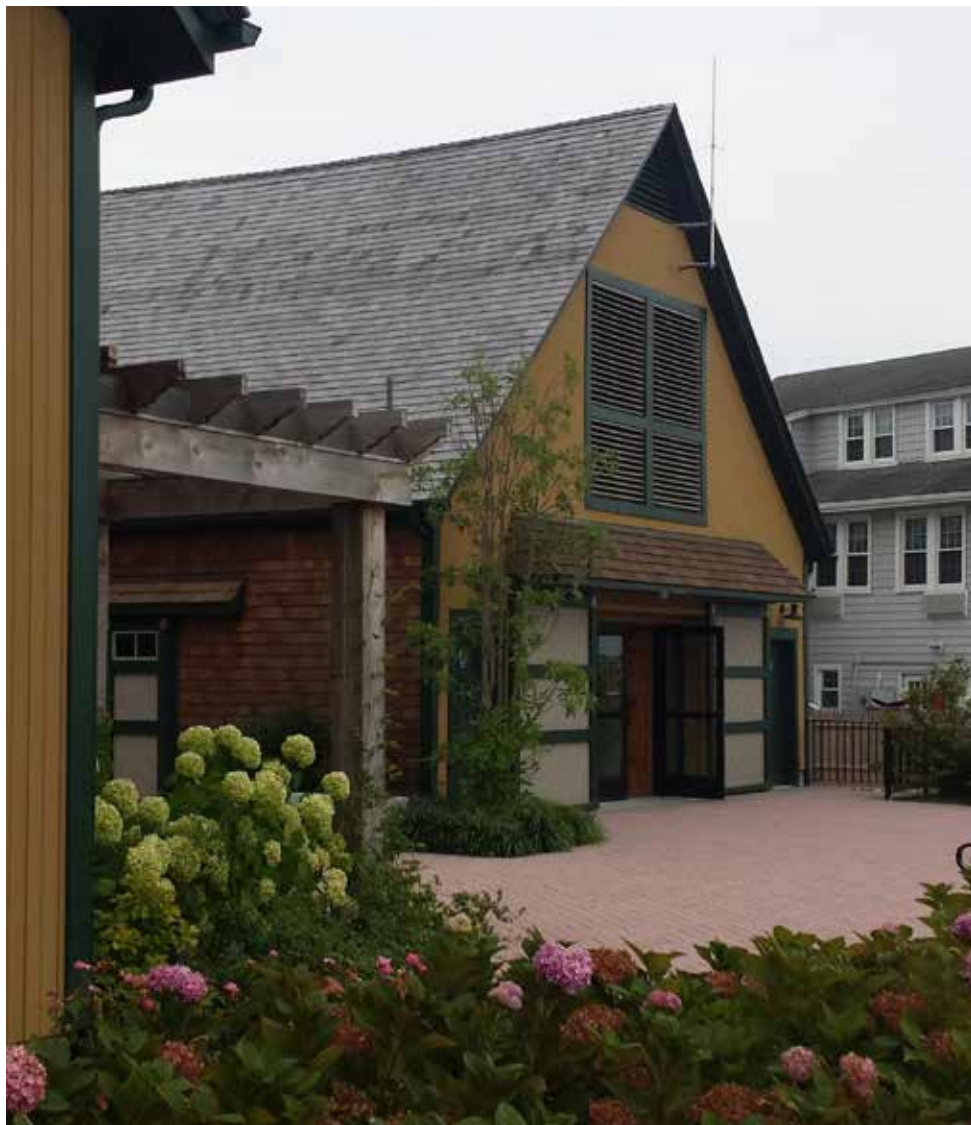
Figure 6: The mechanical room was relocated to the upper floor at the back of the building, discernible in this photo by the louvered vents. Photo: Jennifer Wellock/NPS
