# 4 PRESERVATION BRIEFS

## Roofing for Historic Buildings

U.S. Department of the Interior  
National Park Service  
Cultural Resources  
Heritage Preservation Services

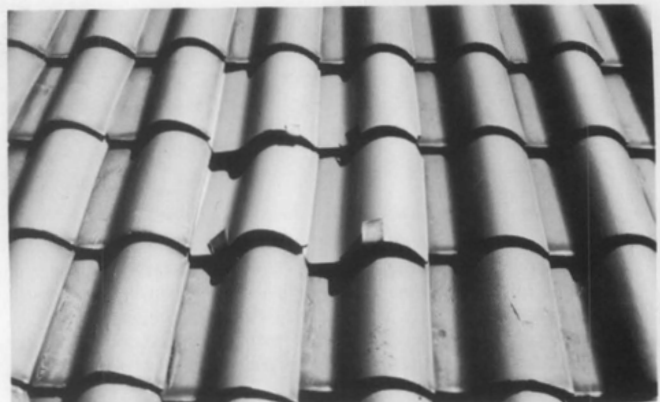
*Repairs on this pantile roof were made with new tiles held in place with metal hangers. (Main Building, Ellis Island, New York)*

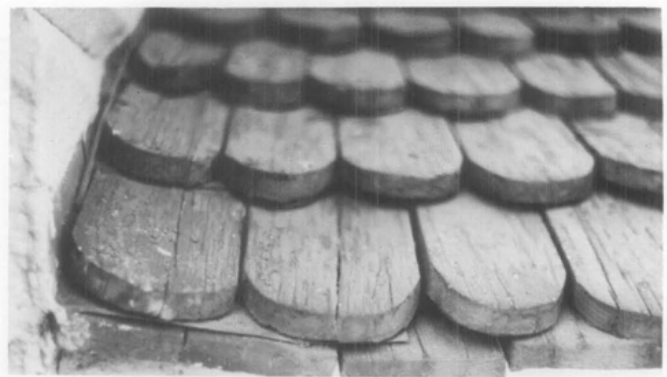
*Replacement of particular historic details is important to the individual historic character of a roof, such as the treatment at the eaves of this rounded butt wood shingle roof. Also note that the surface of the roof was carefully sloped to drain water away from the side of the dormer. In the restoration, this function was augmented with the addition of carefully concealed modern metal flashing. (Mount Vernon, Virginia)*

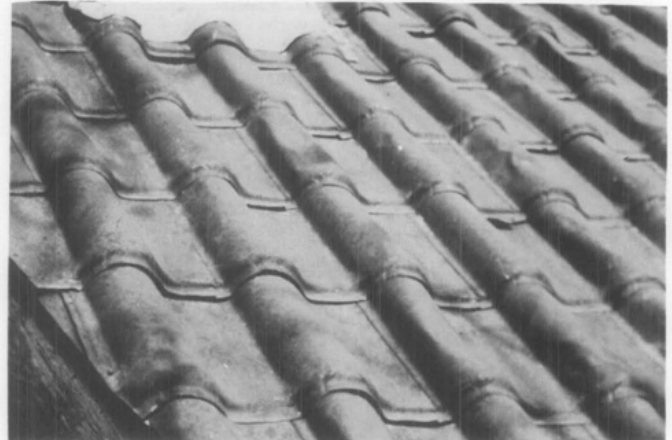
*Galvanized sheet-metal shingles imitating the appearance of pantiles remained popular from the second half of the 19th century into the 20th century. (Episcopal Church, now the Jerome Historical Society Building, Jerome, Arizona, 1927)*

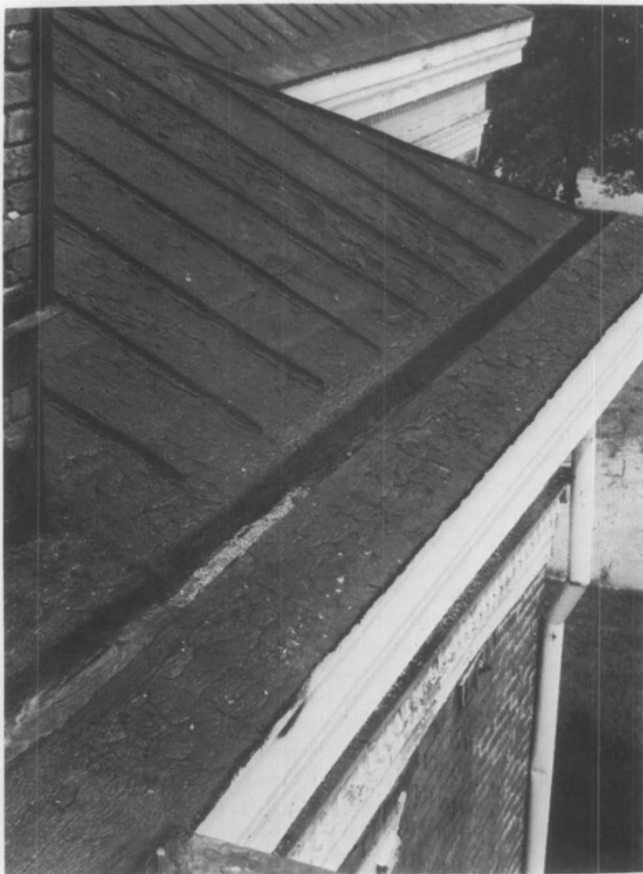
Repeated repair with asphalt, which cracks as it hardens, has created a blistered surface on this sheet-metal roof and built-in gutter, which will retain water. Repairs could be made by carefully heating and scraping the surface clean, repairing the holes in the metal with a flexible mastic compound or a metal patch, and coating the surface with a fibre paint. (Roane County Courthouse, Kingston, Tennessee, photo courtesy of Building Conservation Technology, Inc.)

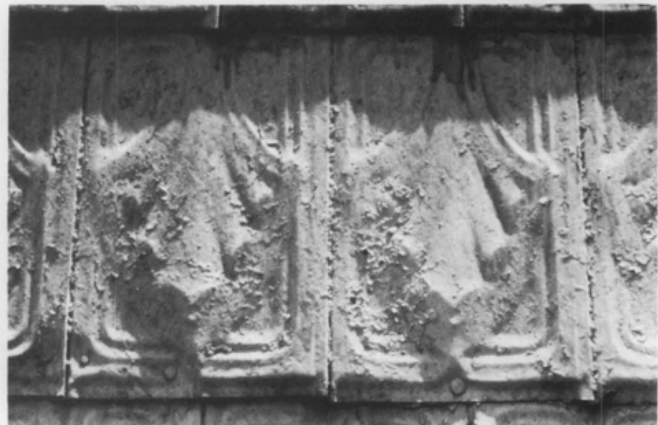
Tin shingles, commonly embossed to imitate wood or tile, or with a decorative design, were popular as an inexpensive, textured roofing material. These shingles  $8\frac{3}{8}$  inch by  $12\frac{1}{2}$  inch on the exposed surface were designed with interlocking edges, but they have been repaired by surface nailing, which may cause future leakage. (Ballard House, Yorktown, Virginia, photo by Gordie Whittington, National Park Service)

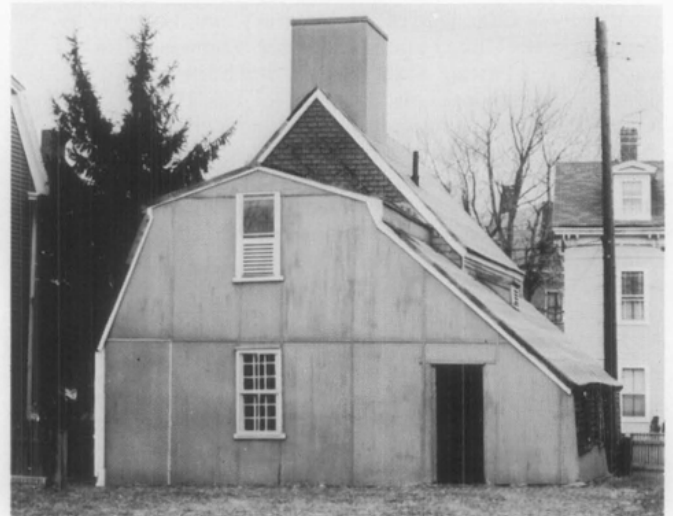
*Temporary stabilization or "mothballing" with materials such as plywood and building paper can protect the roof of a project until it can be properly repaired or replaced. (Narbonne House, Salem, Massachusetts)*

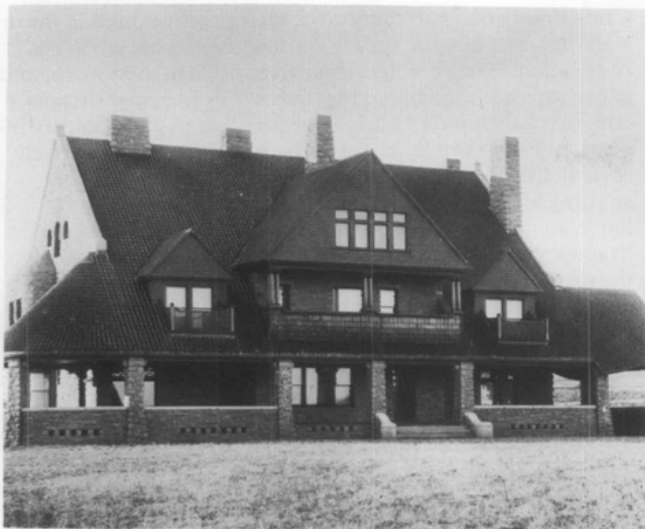
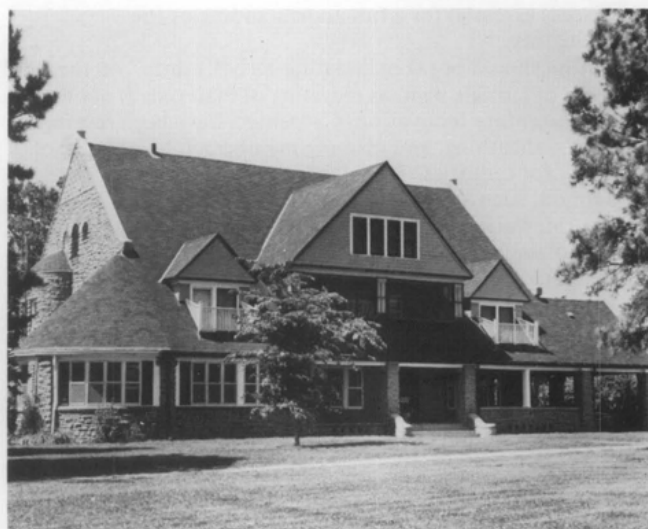
*These two views of the same house demonstrate how the use of a substitute material can drastically affect the overall character of a structure. The textural interest of the original tile roof was lost with the use of asphalt shingles. Recent preservation efforts are replacing the tile roof. (Frank House, Kearney, Nebraska, photo courtesy of the Nebraska State Historical Society, Lincoln, Nebraska)*

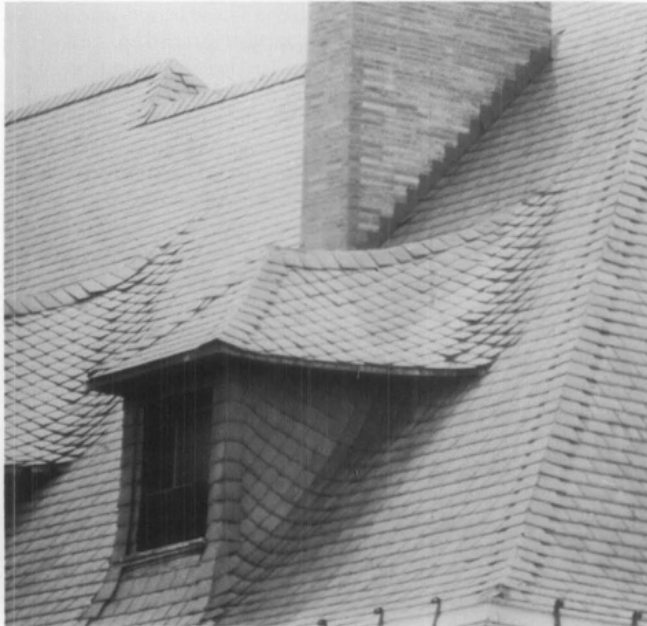
*Because of the roof's visibility, the slate detailing around the dormers is important to the character of this structure. Note how the slates swirl from a horizontal pattern on the main roof to a diamond pattern on the dormer roofs and side walls. (18th and Que Streets, NW, Washington, D.C.)*

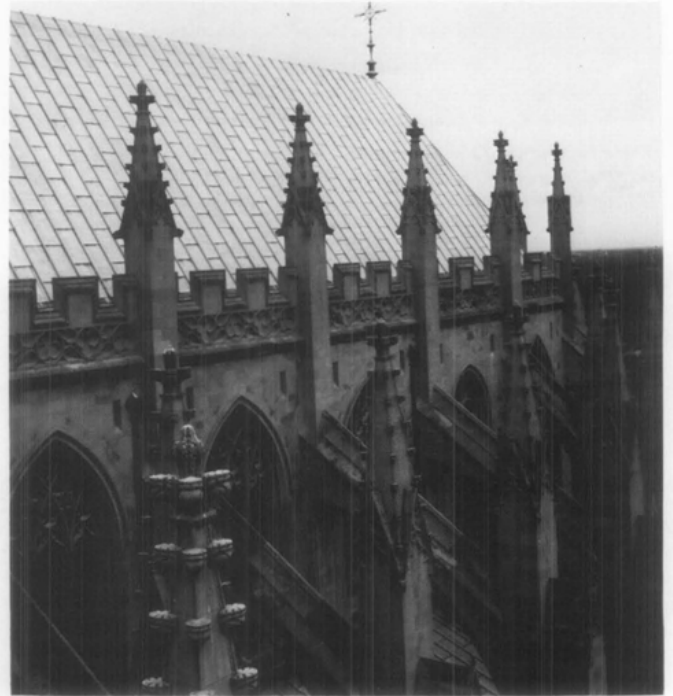
*Good design and quality materials for the roof surface, fastenings, and flashing minimize roofing failures. This is essential on roofs such as on the National Cathedral where a thorough maintenance inspection and minor repairs cannot be done easily without special scaffolding. However, the success of the roof on any structure depends on frequent cleaning and repair of the gutter system. (Washington, D.C., photo courtesy of John Burns, A.I.A.)*

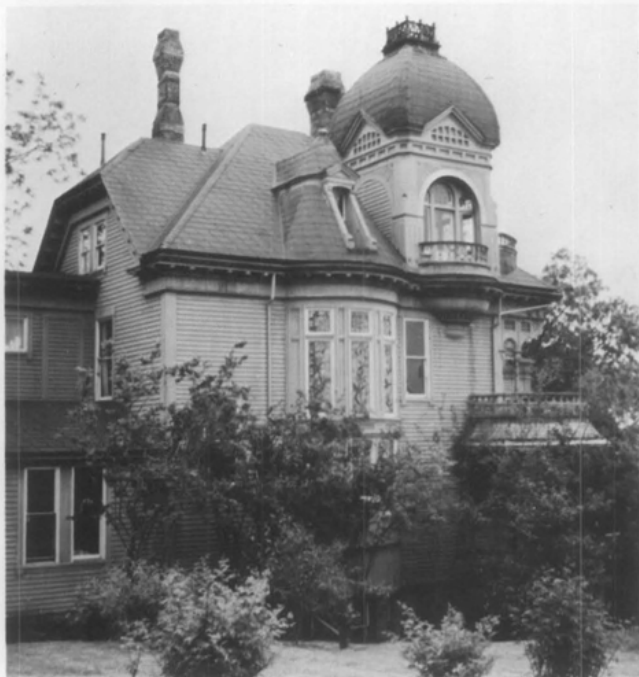
*Special problems inherent in the design of an elaborate historic roof can be controlled through the use of good materials and regular maintenance. The shape and detailing are essential elements of the building's historic character, and should not be modified, despite the use of alternative surface materials. (Gamwell House, Bellingham, Washington)*

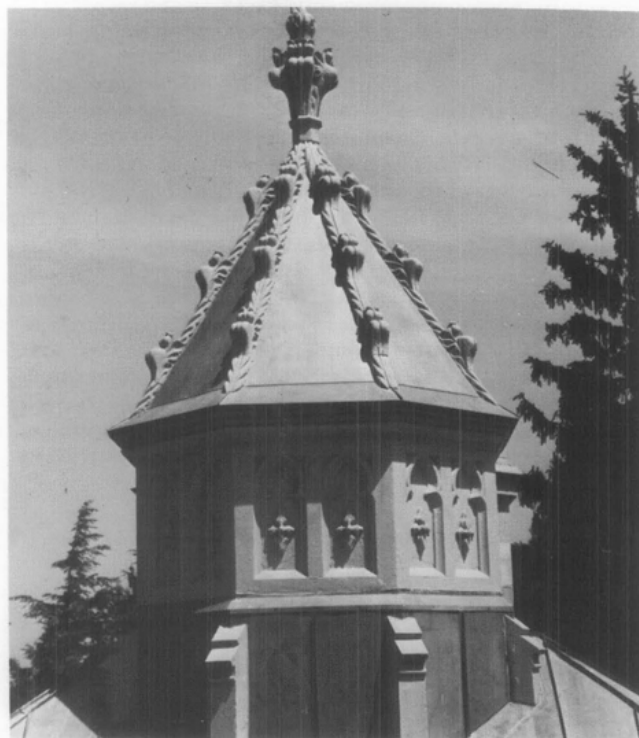
Decorative features such as cupolas require extra maintenance. The flashing is carefully detailed to promote run-off, and the wooden ribbing must be kept well-painted. This roof surface, which was originally tin plate, has been replaced with lead-coated copper for maintenance purposes. (Lyndhurst, Tarrytown, New York, photo courtesy of the National Trust for Historic Preservation)
