15 PRESERVATION BRIEFS

Preservation of Historic Concrete

Paul Gaudette and Deborah Slaton

National Park Service
U.S. Department of the Interior
Heritage Preservation Services

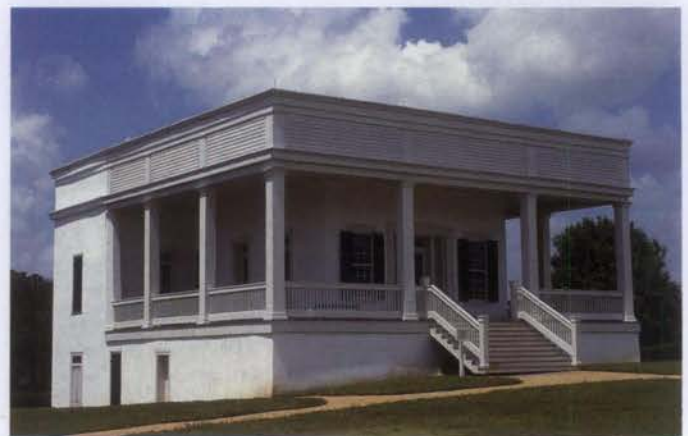
Figure 1. The Sebastopol House in Seguin, Texas, is an 1856 Greek Revival-style house constructed of lime concrete. Lime concrete or “limecrete” was a popular construction material, as it could be made inexpensively from local materials. By 1900, the town had approximately ninety limecrete structures, twenty of which remain. Photo: Texas Parks and Wildlife Department.

publicized in the second edition of Orson S. Fowler's *A Home for All* (1853) which described the advantages of "gravel wall" construction to a wide audience. The town of Seguin, Texas, thirty-five miles east of San Antonio, already had a number of concrete buildings by the 1850s and came to be called "The Mother of Concrete Cities," with approximately ninety concrete buildings made from local "lime water" and gravel (Fig. 1).

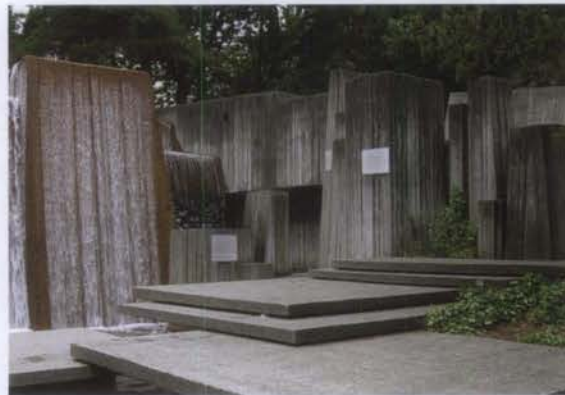
Figure 9. The Ira C. Keller Fountain in Portland, Oregon, was designed by Lawrence Halprin and constructed in 1969. The fountain is constructed primarily of concrete pillars with formboard textures and surrounding elements, patterned with geometric lines, which facilitate the path of water. Photo: Anita Washko, Wiss, Janney, Elstner Associates, Inc.

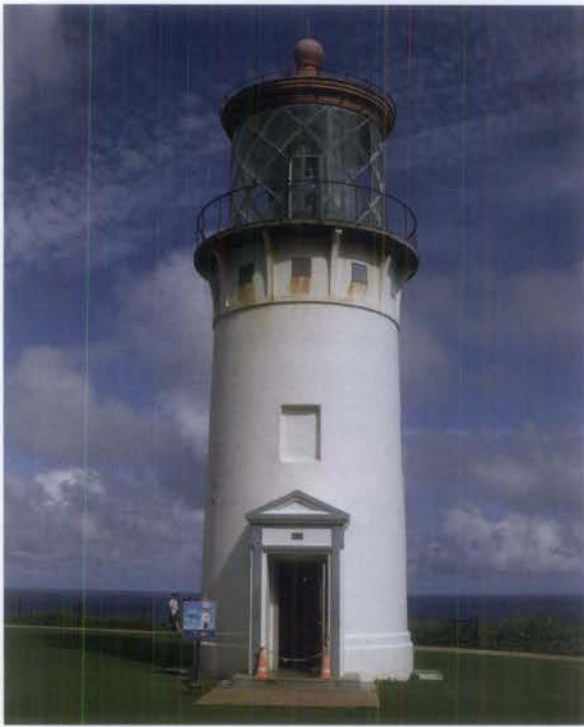
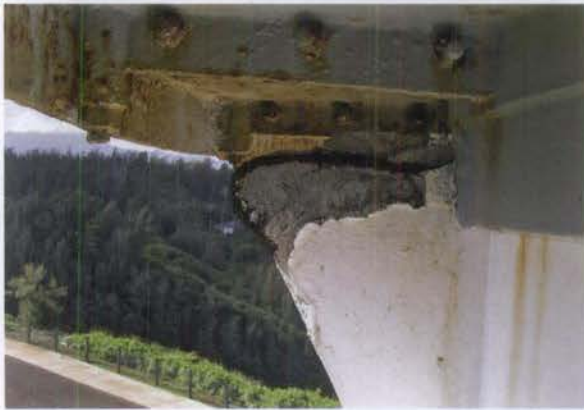
Figure 12. The concrete lighthouse at the Kilauea Point Light Station, Kilauea, Kauai, Hawaii, was constructed circa 1913. The concrete, which was a good quality, high strength mix for its day, is in good condition after almost one hundred years in service. Deterioration in the form of spalling related to corrosion of embedded reinforcing steel has occurred primarily in areas of higher ornamentation such as projecting bands and brackets (see close-up photo).

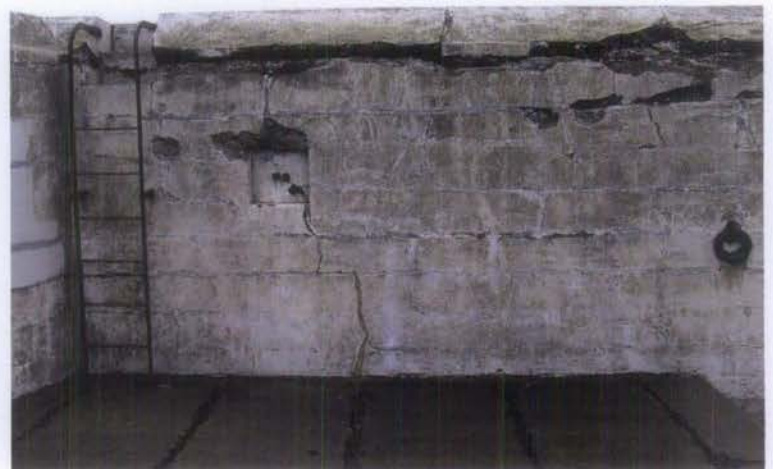
Figure 13. Fort Casey on Admiralty Head, Fort Casey, Washington, was constructed in 1898. The lift lines from placement of concrete are clearly visible on the exterior walls and characterize the finished appearance.

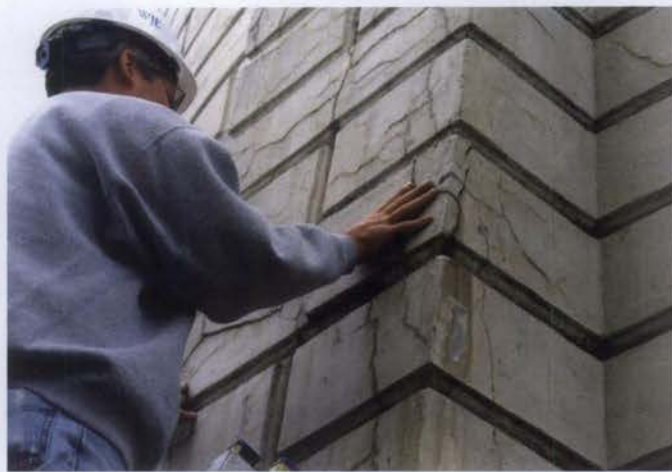
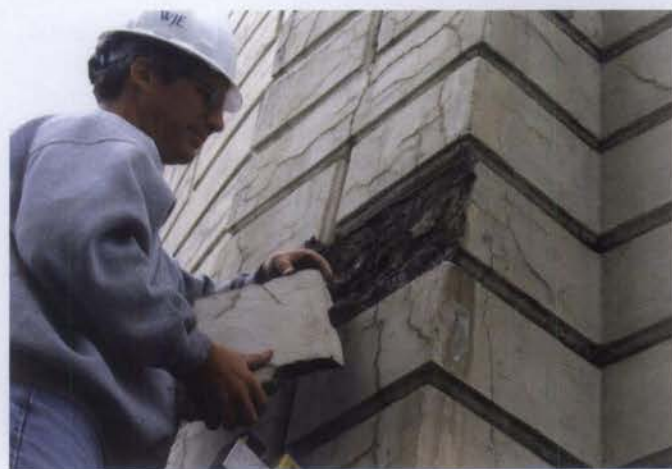
Figures 14. Layers of architectural concrete that have debonded (spalled) from the surface were removed from a historic water tank during the investigation performed to assess existing conditions. Photos: Anita Washko, Wiss, Janney, Elstner Associates, Inc.

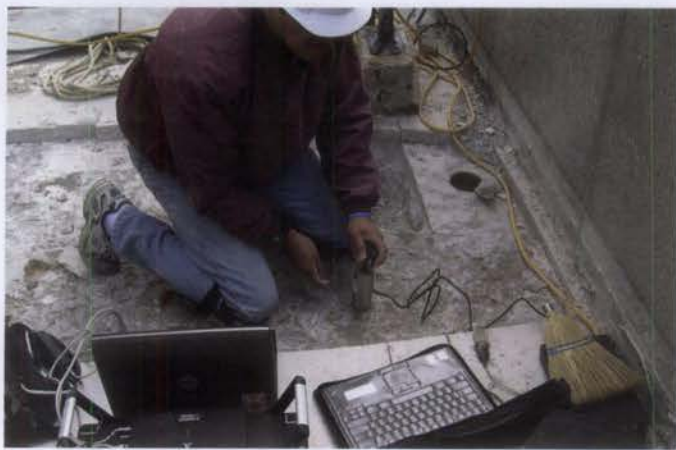
Figure 16. Impact echo testing is performed on a concrete structural slab to help determine depth of deterioration. In this method, a short pulse of energy is introduced into the structure and a transducer mounted on the impacted surface of the structure receives the reflected input waves or echoes. These waves are analyzed to help identify flaws and deterioration within the concrete.

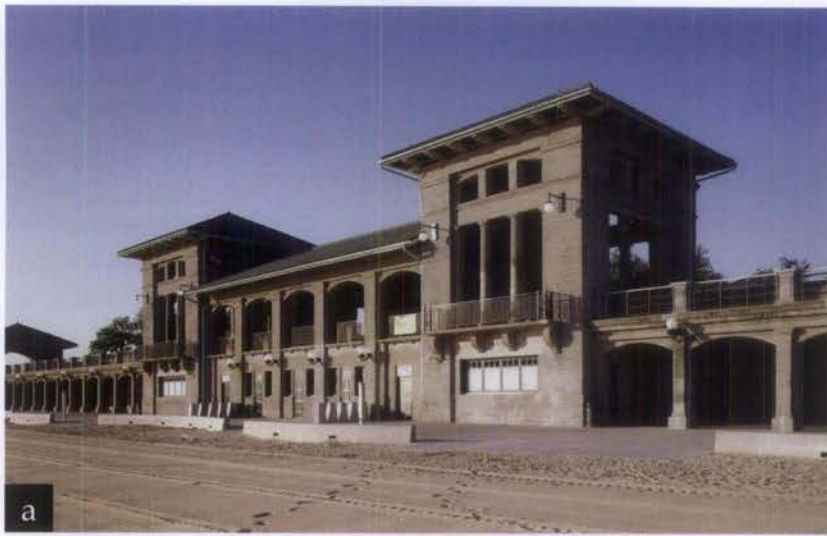
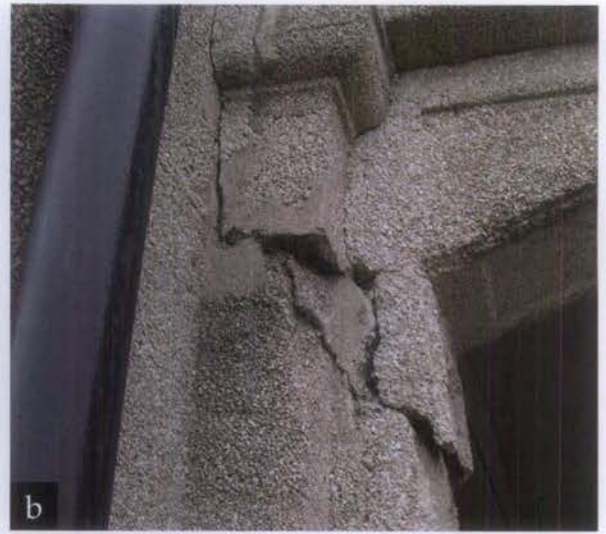
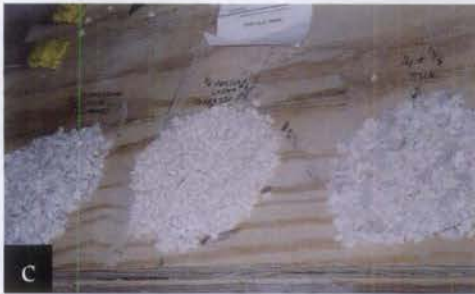
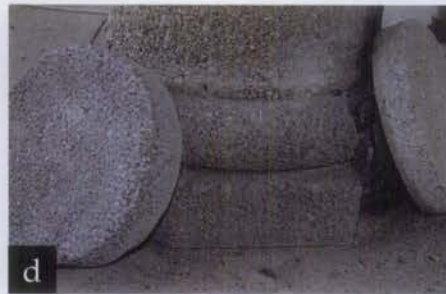
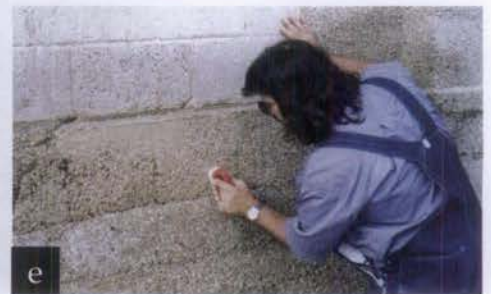
Figure 17. (a) The 63rd Street Beach House was constructed on the shoreline of Chicago in 1919. The highly exposed aggregate concrete of the exterior walls of the beach house was used for many buildings in the Chicago parks as an alternative to more expensive stone construction. Photo: Leslie Schwartz Photography. (b) Concrete deterioration included cracking, spalling, and delamination caused by corrosion of embedded reinforcing steel and concrete damage due to cyclic freezing and thawing. (c) Various sizes and types of aggregates were reviewed for matching to the original concrete materials. (d) Mock-ups of the concrete repair mix were prepared for comparison to the original concrete. Considerations included aggregate type and size, cement color, proportions, aggregate exposure, and surface finish. (e) The craftsman finished the surface to replicate the original appearance in a mock-up on the structure. Here, he used a nylon bristle brush to remove loose paste and expose the aggregate, creating a variable surface to match the adjacent original concrete.

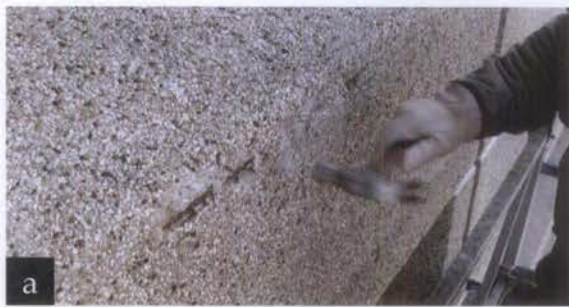
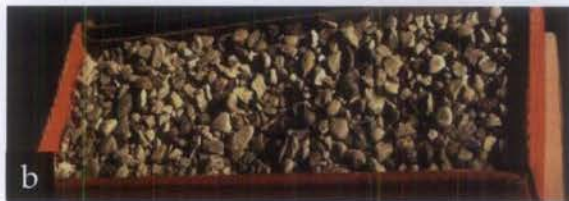
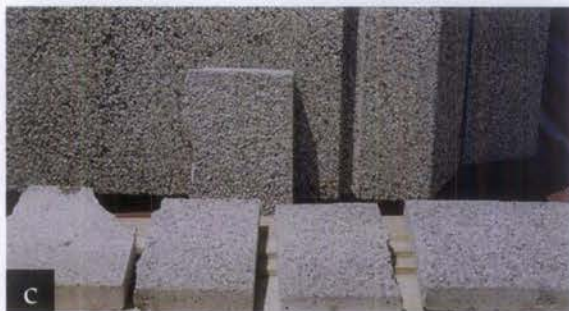
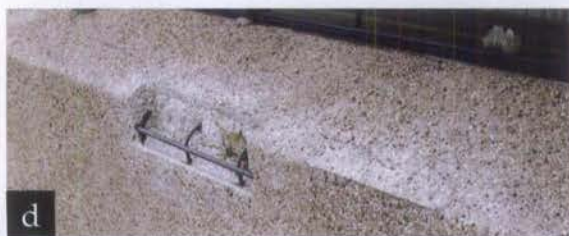
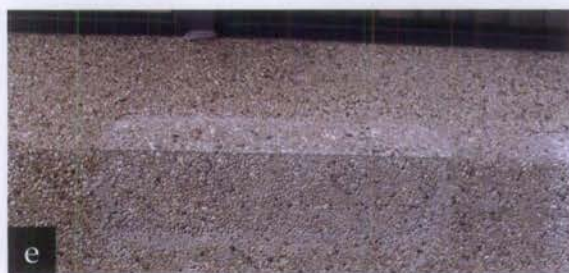
Figure 18. (a) Exposed aggregate precast concrete is sounded with a hammer to detect areas of deterioration. Corrosion of the exposed reinforcing steel bar has led to spalling of the adjacent concrete. (b) Samples of aggregate considered for use in repair concrete are compared to the original concrete materials in terms of size, color, texture, and reflectance. (c) Various sample panels are made using the selected concrete repair mix design for comparison to the original concrete on the building, and the mix design is adjusted based on review of the samples. (d) After removal of the spall, the concrete surface is prepared for installation of a formed patch. (e) Prior to placement of the concrete, a retarding agent is brush-applied to the inside face of the formwork to slow curing at the surface. After the concrete is partially cured, the forms are removed and the surface of the concrete is rubbed to remove some of the paste and expose the aggregate to match the original concrete.

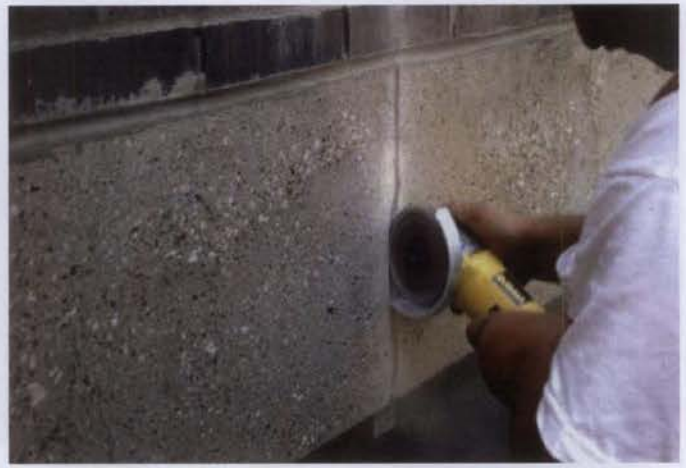
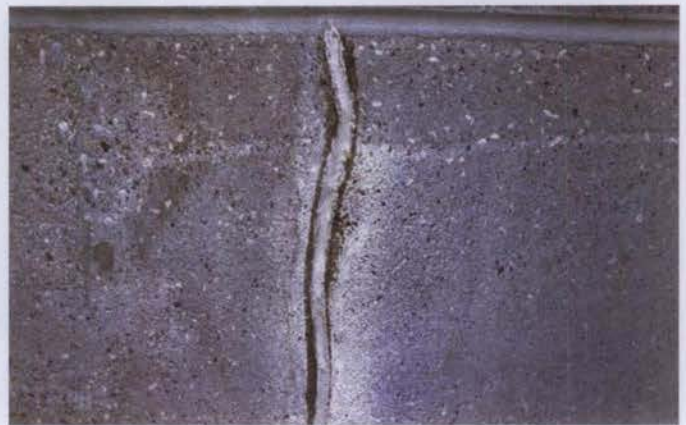
Figure 19. A high-speed grinder is used to widen a crack in preparation for installation of a sealant. This process is called "routing." After the crack is prepared, the sealant is installed to prevent moisture infiltration through the crack. Although sealant repairs can provide a durable, watertight repair for moving cracks, they tend to be very visible.

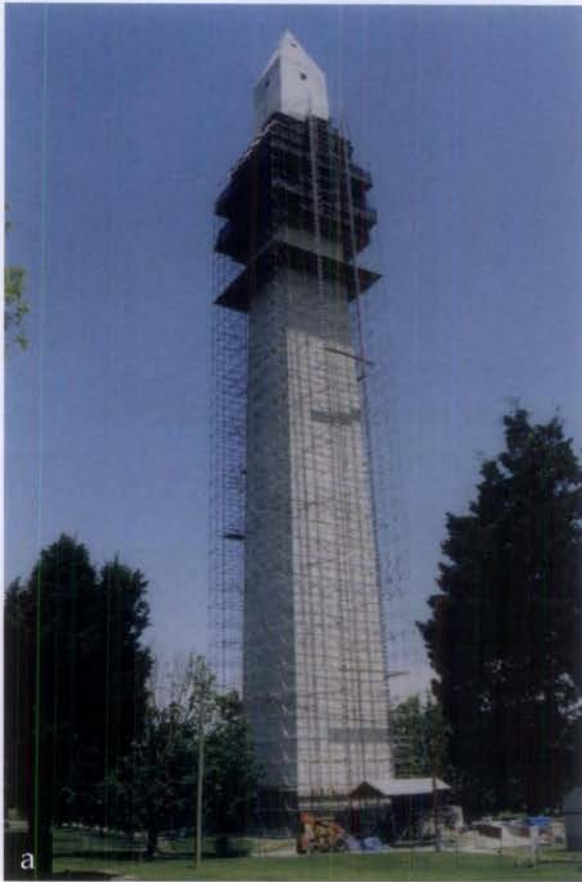
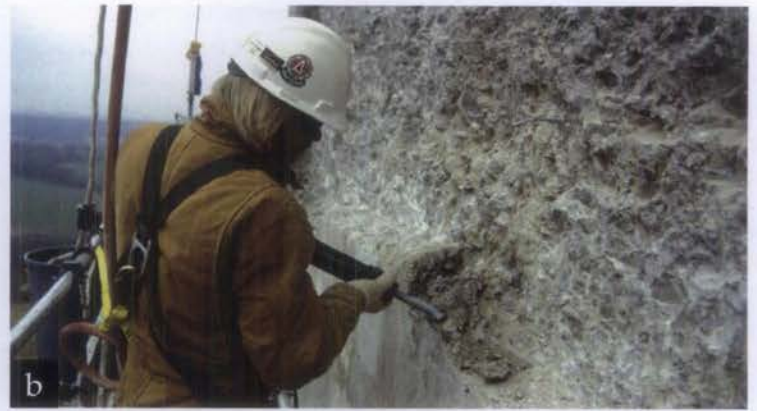
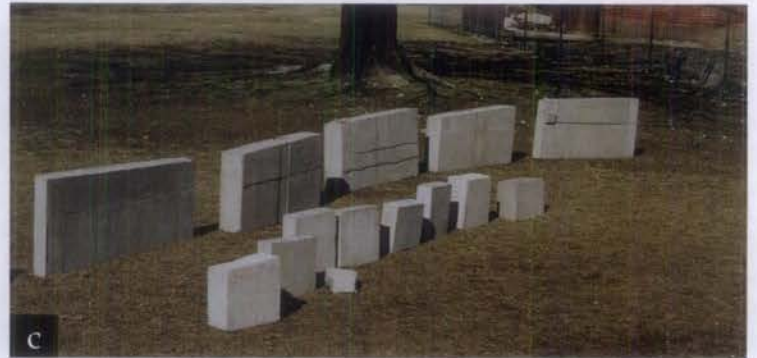
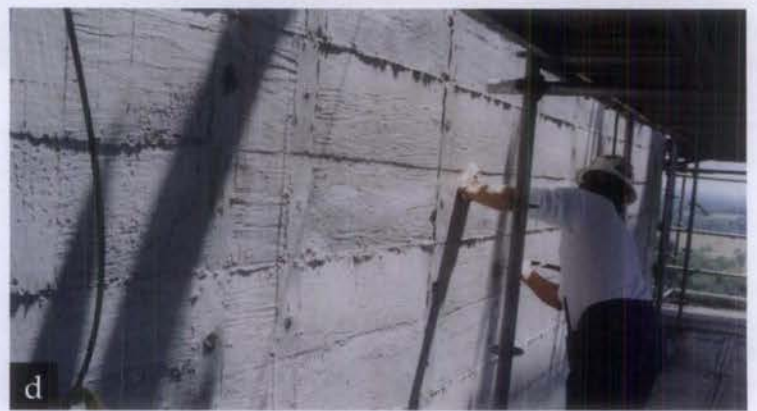
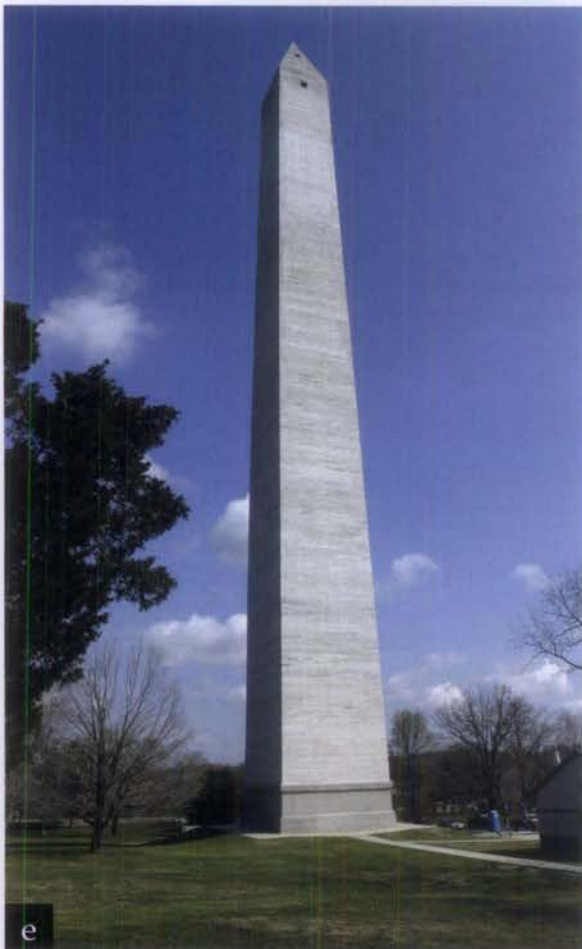
Figure 20. (a) The Jefferson Davis Memorial in Fairview, Kentucky, constructed from 1917–1924, is 351 feet tall and constructed of unreinforced concrete. The walls of the memorial are 8 feet thick at the base and 2 feet thick at the top of the wall. Access to the monument for investigation was provided by rappelling techniques, while ground supported and suspended scaffolding was used to access the exterior during repairs. (b) The concrete was severely deteriorated at isolated locations, with spalling and damage from cyclic freezing and thawing of entrapped water. In addition, previous repairs were at the end of their service life and removal of deteriorated concrete and failed previous repairs was required. Light duty chipping hammers were used to avoid damage to adjacent material when removing deteriorated concrete to the level of sound concrete. (c) Field samples were performed to match the color, finish, and texture of the original concrete. A challenge in matching of historic concrete is achieving variability of appearance. (d) The completed surface after repairs exhibits intentional variability of the concrete surface to match the appearance of the original concrete. Some formwork imperfections that would normally be removed by finishing were intentionally left in place, to replicate the highly variable finish of the original concrete. (e) The Jefferson Davis Memorial after completion of repairs in 2004. Photo e: Joseph Lenzi, Senler, Campbell & Associates, Inc.

due to original construction techniques, architectural design, or differential exposure to weather. Trial repairs and mock-ups are used to evaluate the proposed replacement concrete work and to refine construction techniques (Fig 20).
