# 29 PRESERVATION BRIEFS

## The Repair, Replacement, and Maintenance of Historic Slate Roofs

Jeffrey S. Levine

U.S. Department of the Interior  
National Park Service  
Cultural Resources  
Heritage Preservation Services

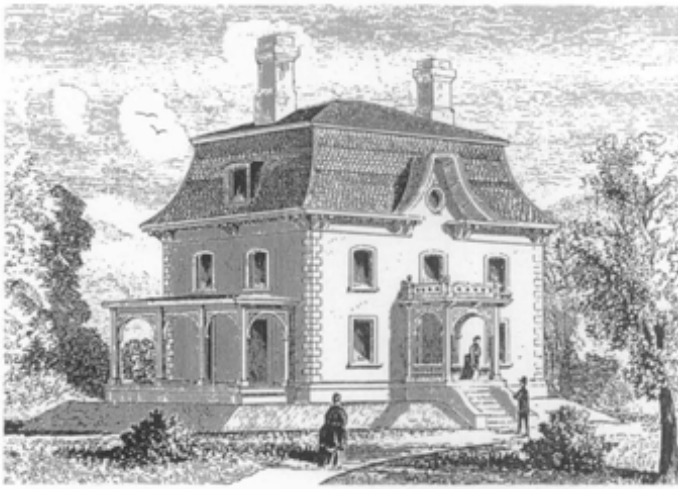
Figure 1. Architectural pattern books of the mid-nineteenth century awakened Americans to the availability and quality of slate for roofing purposes by incorporating slate roofs in their designs. Design XX, "A French Roof House," in A. J. Downing's *Victorian Cottage Residences* is shown.

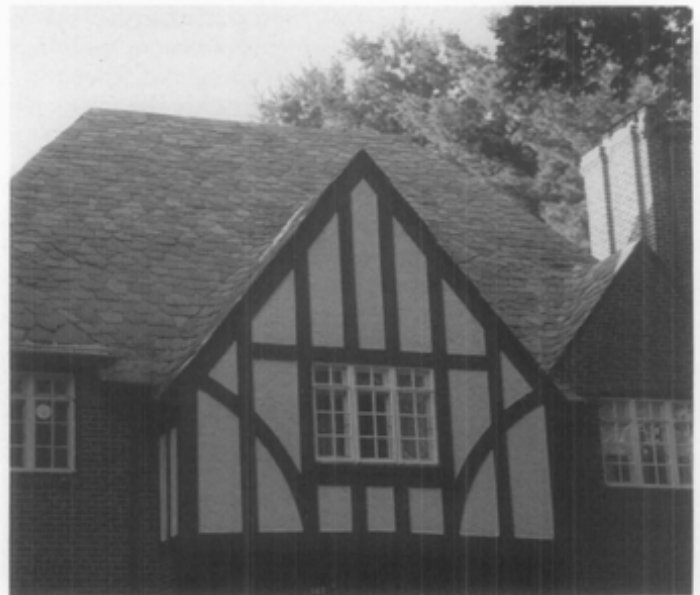
Figure 2. The quaint character of this Tudor style residence is derived, in part, from its textural roof.

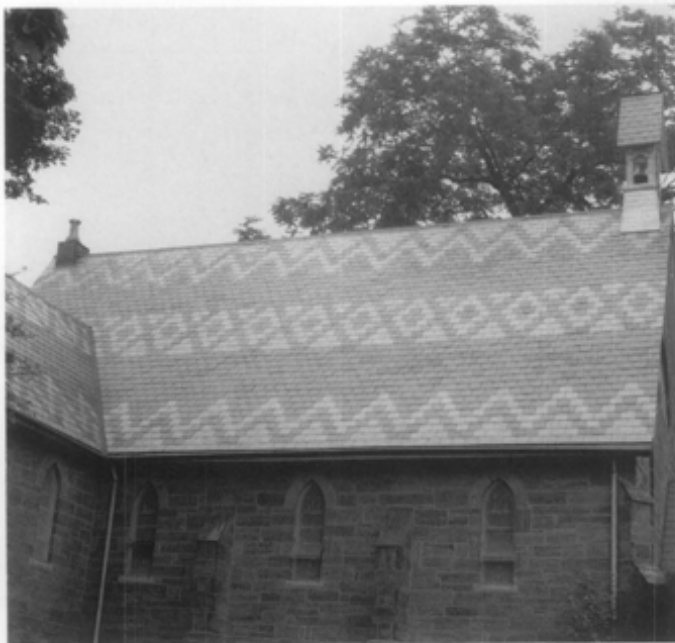
Figure 3. A sawtooth geometric design composed of red, green, and black slates makes this roof the most visually important feature of the building.

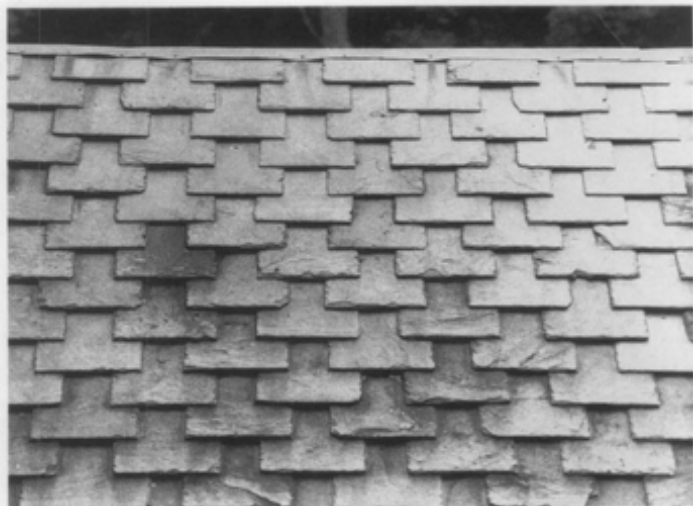
Figure 4. Widely spaced open slating was often used on utilitarian structures where ventilation was desirable. It provided an interesting texture and visual pattern to often plain structures.

Historically, three types of slate roofing—standard, textural, and graduated—were available according to the architectural effect desired. Standard grade slate roofs were most common. These are characterized by their uniform appearance, being composed of slates approximately 3/16" (0.5cm) thick, of consistent length and width, and having a smooth cleavage surface. Thirty different standard sizes were available, ranging from 10" (25cm) × 6" to 24" × 14" (15cm × 61cm × 35cm). The slates were laid to break joints and typically had square ends and uniform color and exposure. Patterned and polychromatic roofs were created by laying standard slates of different colors and shapes on the roof in such a way as to create sunbursts, flowers, sawtooth and geometric designs, and even initials and dates (Figure 3). On utilitarian structures, such as barns and sheds, large gaps were sometimes left between each slate within a given course to reduce material and installation costs and provide added ventilation for the interior (Figure 4).

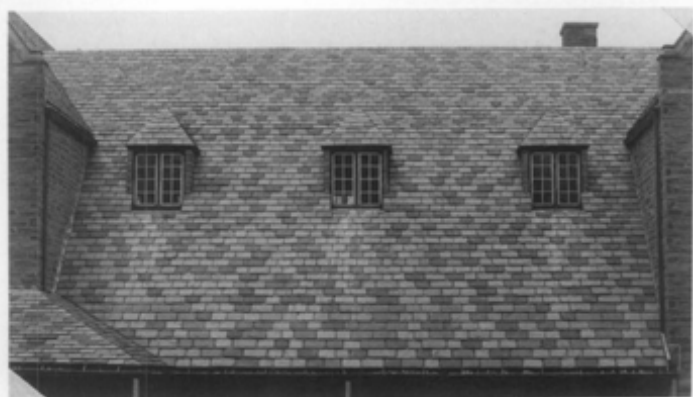
Figure 5. This graduated slate roof is composed of large, thick slates at the eave which are reduced in size and thickness as the slating progresses to the ridge.

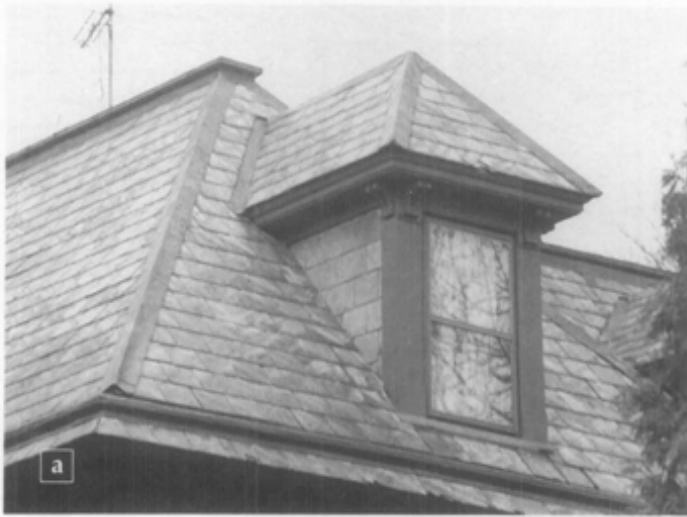
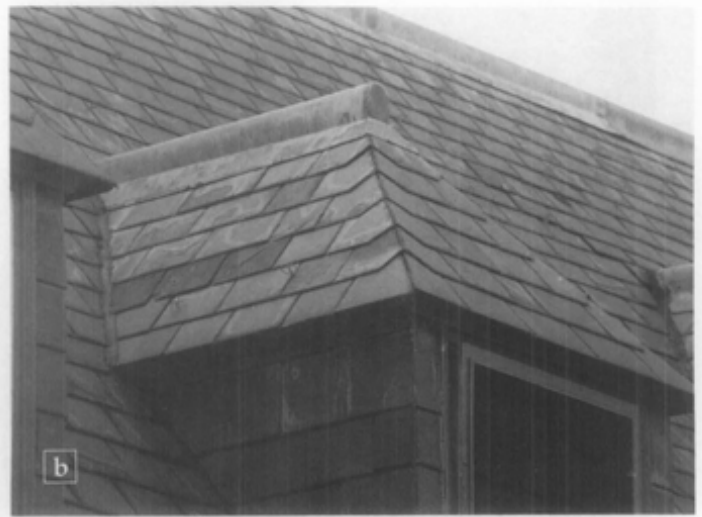
Figure 6. Hips are formed at the external angle of two roofing slopes. In (a), the hips at both the roof and the dormer are covered with metal. Note also the open valley and the built-in gutter. In (b), the dormer hip slates have been laid in a fantail pattern to help shed water. Note also the metal ridge cap.

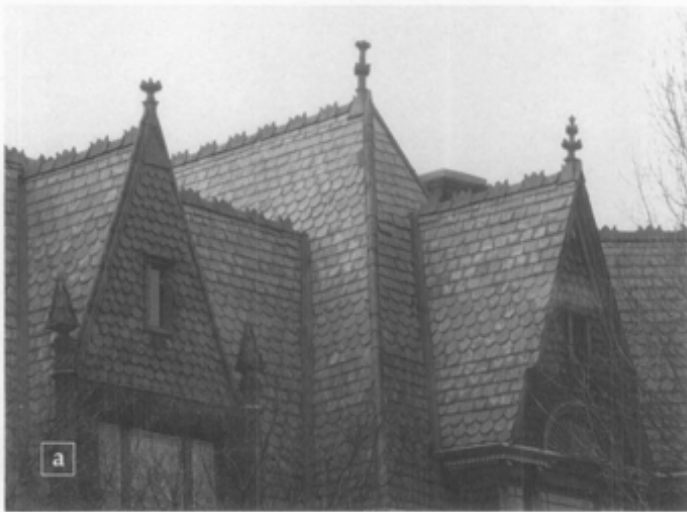
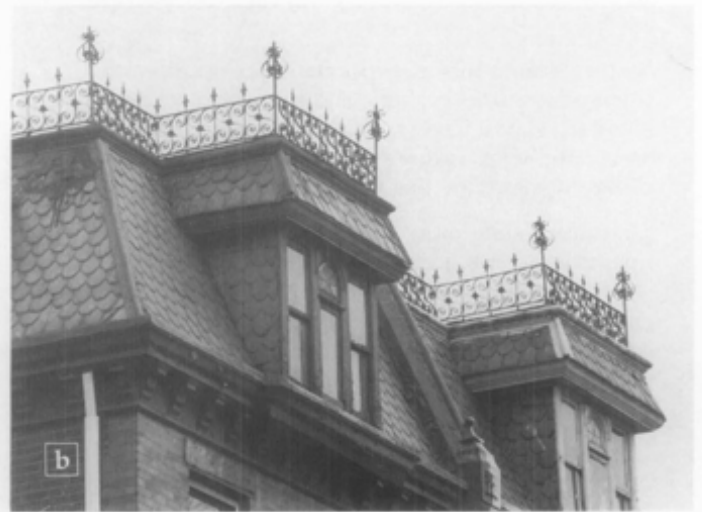
Figure 7. Ridge caps and cresting can be elaborate. Ridges are formed at the long horizontal juncture of two roofing slopes and capping protects this joint from moisture. In (a), a terra cotta capping with a decorative profile complements the finial over the various roof peaks. In (b), the mansard roof has a decorative iron cresting at the break between the lower and the upper roof slopes.

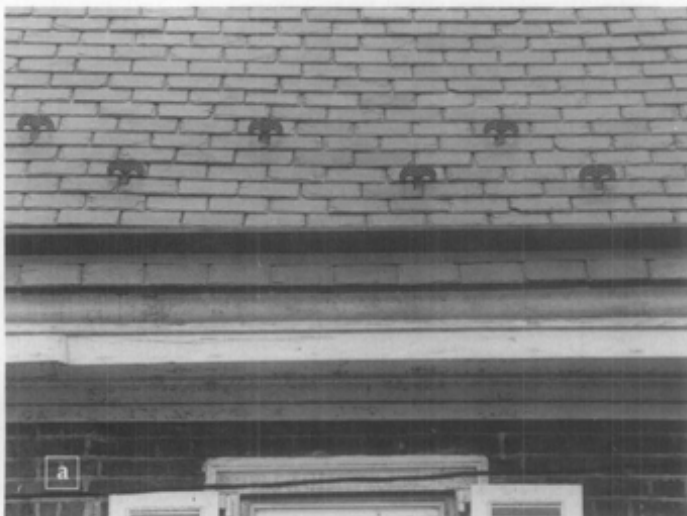
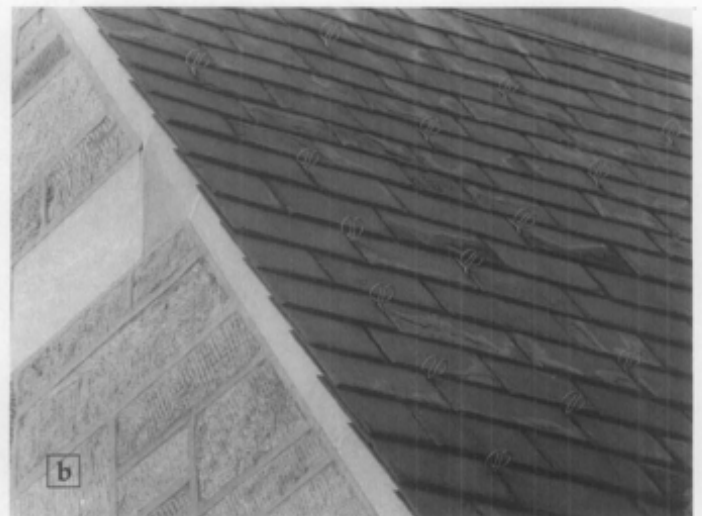
Figure 8. Eave details include snow guards, snow boards, gutter treatments. Snow guards are generally used in areas where ice and snow accumulate to avoid dangerous slides from the roof. In (a) the snow guards are set in two staggered rows above a pole gutter. In (b), the copper wire snow guards are set more frequently up a very steep gable.

Detailing at the hips, ridges and valleys provided added opportunity to ornament a slate roof. Hips and ridges can be fashioned out of slate according to various traditional schemes whereby the slates are cut and overlapped to produce a watertight joint of the desired artistic effect. Traditional slate ridge details are the saddle ridge, strip saddle ridge, and comb ridge, and for hips, the saddle hip, mitered hip, Boston hip, and fantail hip (Figure 6). A more linear effect was achieved by covering the ridges and hips with flashing called "cresting" or "ridge roll" formed out of sheet metal, terra cotta, or even slate (Figure 7). Snow guards, snow boards, and various types of gutter and rake treatments also contributed to the character of historic slate roofs (Figure 8).

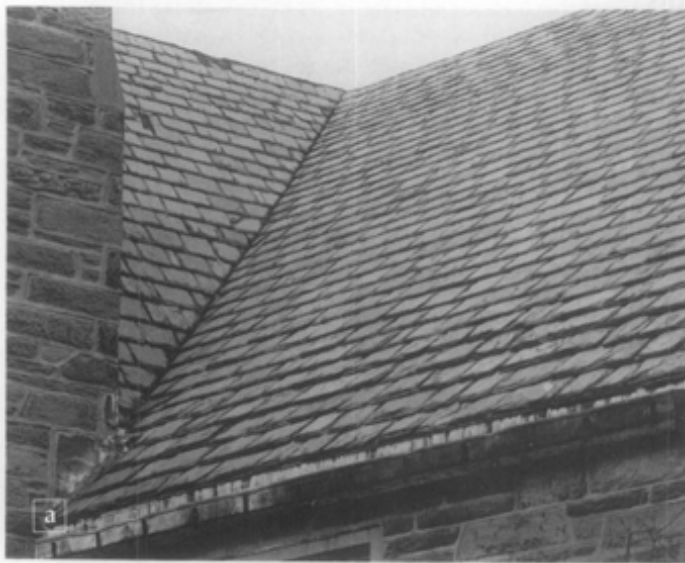
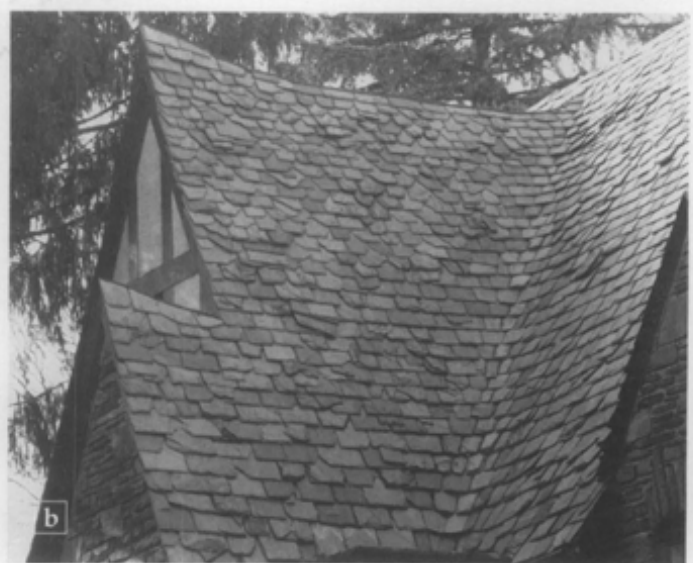
Figure 9. Valleys are formed at the internal angle of two roofing slopes. Flashing is often placed under the slate to increase moisture protect at this vulnerable joint. Shown in (a) is a closed valley where the slates are held tight to the valley line. (b) illustrates of a round valley where the transition between the two slopes is a continuous curve. It requires careful workmanship and an experienced roofer.

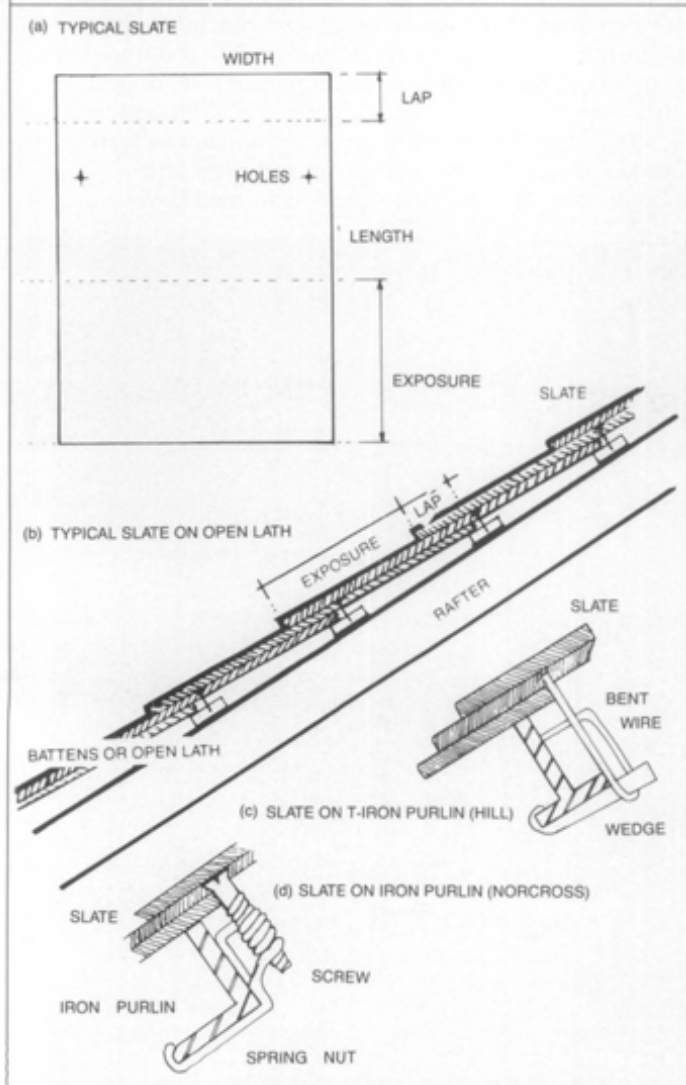
Figure 10. (a) shows a typical slate; exposure may be calculated by subtracting the headlap from the total length of the slate and dividing by two. Slates were typically nailed either to closed wooden decking or to open laths (b). In the late 19th century, with the concern for fireproof construction, special fasteners were developed to secure slate to steel purlins (c) 1881 patent to James G. Hill; (d) 1889 patent to Orlando W. Norcross).

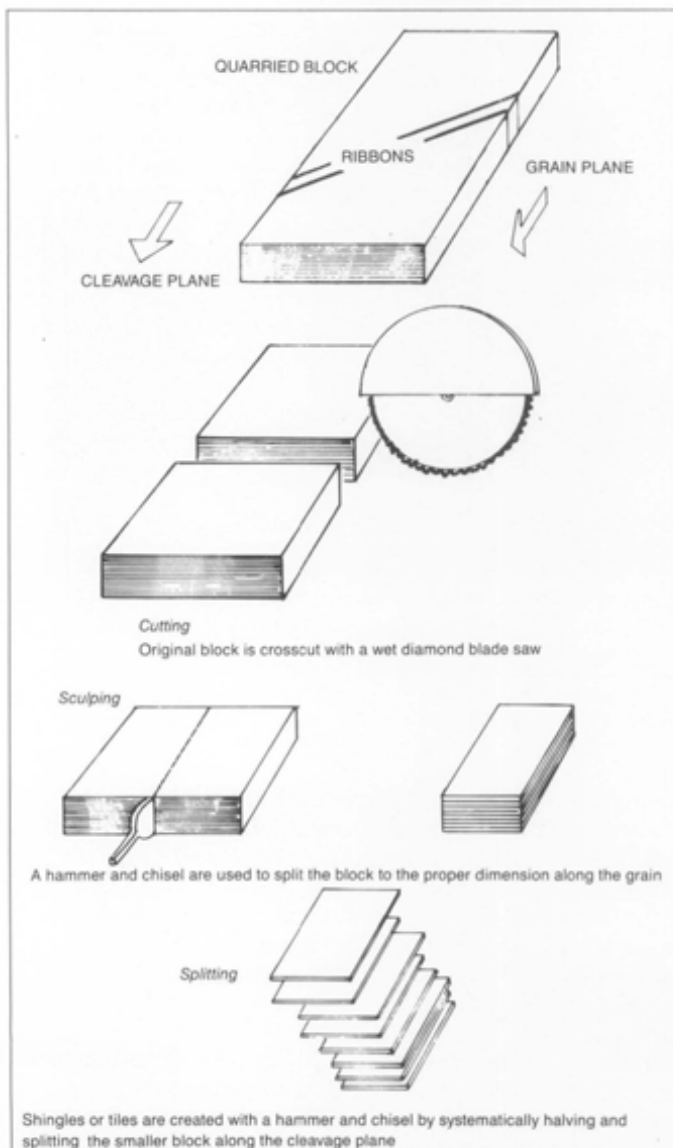
Figure 11. Slate roofing tiles or shingles are still manufactured using traditional methods brought to this country by Welsh immigrants in the nineteenth century. Shown above are the first 3 steps of cutting, sculping and splitting. Once the rough slate tile is made it is trimmed and punched for holes.

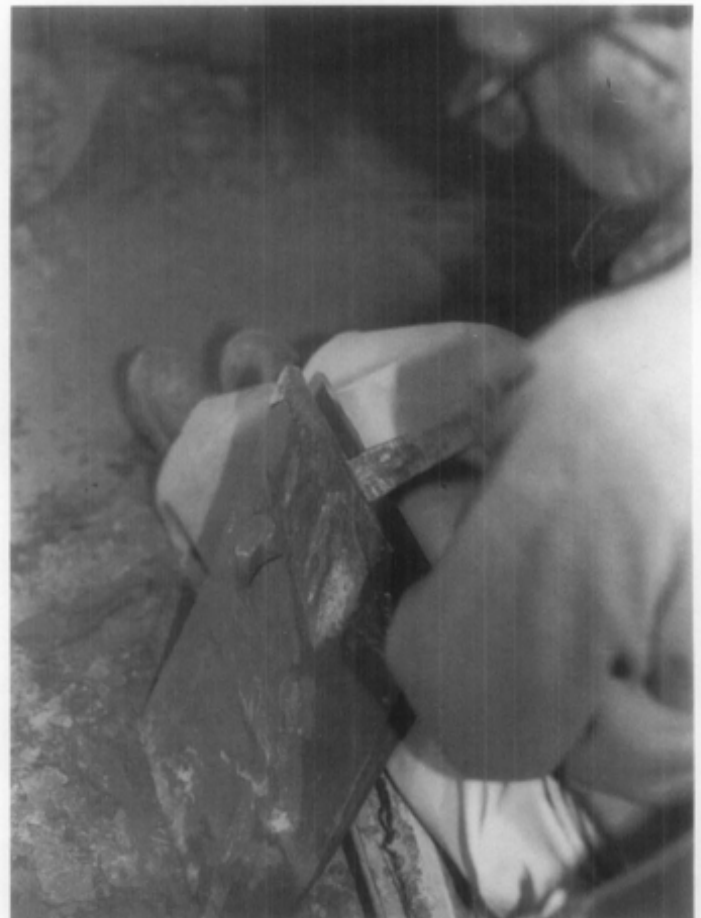
Figure 12. In the splitting area, the slightly oversized blocks are split along their cleavage planes. The splitter's tools consist of a wooden mallet and splitting chisels. The process of halving the split portions is repeated until a tile or shingle of appropriate thinness is obtained.

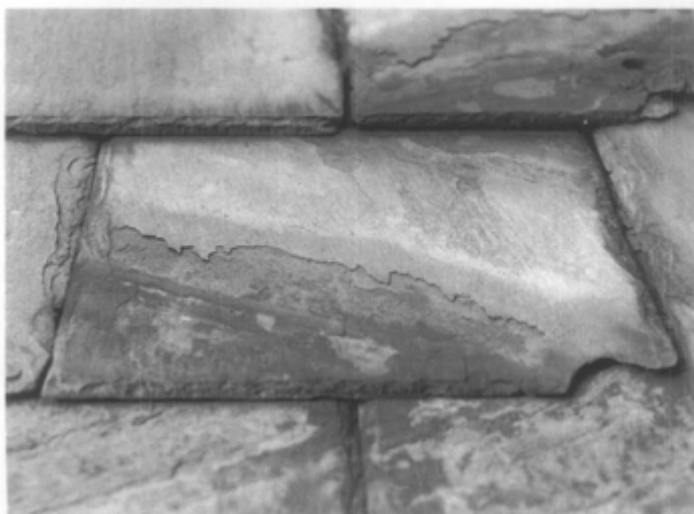
Figure 13. Paper thin lamination can be seen flaking off of this weathered, 120 year piece of Pennsylvania Hard-Vein slate.

The natural weathering of roofing slate manifests itself as a slow process of chipping and scaling along the cleavage planes (Figure 13). Paper thin laminations flake off the surface of the slate and the slate becomes soft and spongy as the inner layers begin to come apart, or delaminate. The nature of the sound given off by a slate when tapped with one's knuckles or slating hammer is a fair indication of its condition. High-grade slate, when poised upon the fingertips and struck, will emit a clear, solid sound. Severely weathered slates are much less sonorous, and give off a dull thud when tapped.

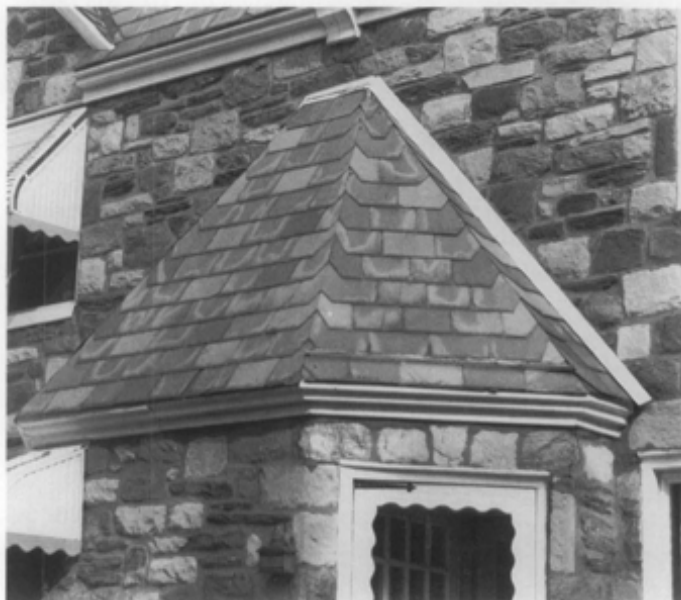
Figure 14. The white blotches on these Pennsylvania Soft-Vein slates indicate areas where gypsum is leaching out onto the surface of the slates.

The weathering of slate is chiefly due to mineral impurities (primarily calcite and iron sulfides) in the slate which, in concert with alternating wet/dry and hot/cold cycles, react to form gypsum (Figure 14). Because gypsum

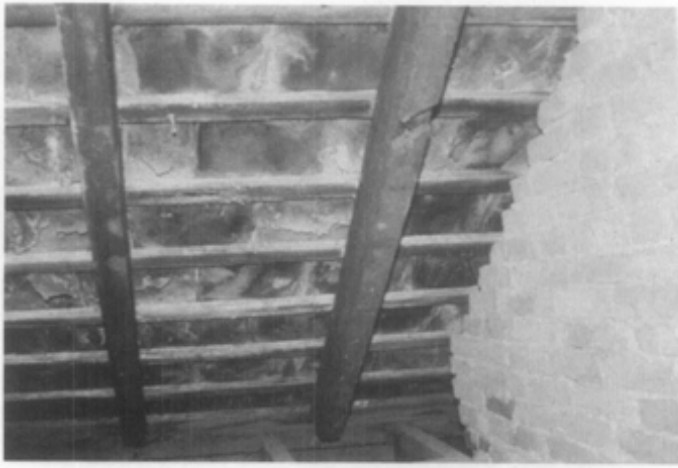
Figure 15. View of the underside of slates laid on open sheathing shows that delamination and flaking is just as bad or worse on the underside of slates as on the exposed surface. This is why most slates cannot be flipped over for reuse.

molecules take up about twice as much volume as calcite molecules, internal stresses result from the reaction, causing the slate to delaminate. This type of deterioration is as prominent on the underside of the roof as on the exposed surface due to the leaching and subsequent concentration of gypsum in this area (Figure 15). Consequently, deteriorated roofing slates typically cannot be flipped over and re-used.

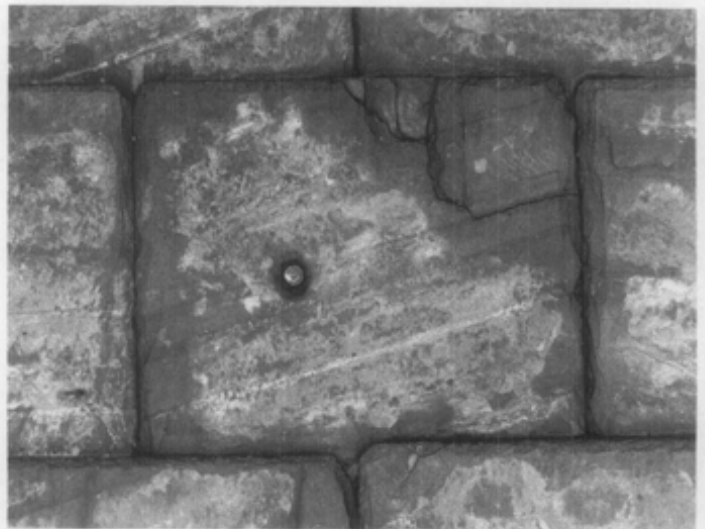
Figure 16. Detail view of a slate which has been punctured by the head of a nail used to secure the slate in the course below. Likely, the nail was not hammered in far enough when originally installed.

Installation problems often involve the improper nailing and lapping of slates. The nailing of slates differs from that of other roofing materials. Slate nails should not be driven tight as is the case with asphalt and wood shingles. Rather, they should be set such that the slate is permitted to hang freely on the nail shank. Nails driven too far will crack the slate and those left projecting will puncture the overlying slate (Figure 16). Nail heads left exposed accelerate roof deterioration by providing a point for water entry. Non-ferrous slater's nails, such as solid copper or stainless steel, should always be used since plain steel and galvanized nails will usually rust out long before the slate itself begins to deteriorate. The rusting of nineteenth century cut nails is a common cause of slate loss on historic roofs.

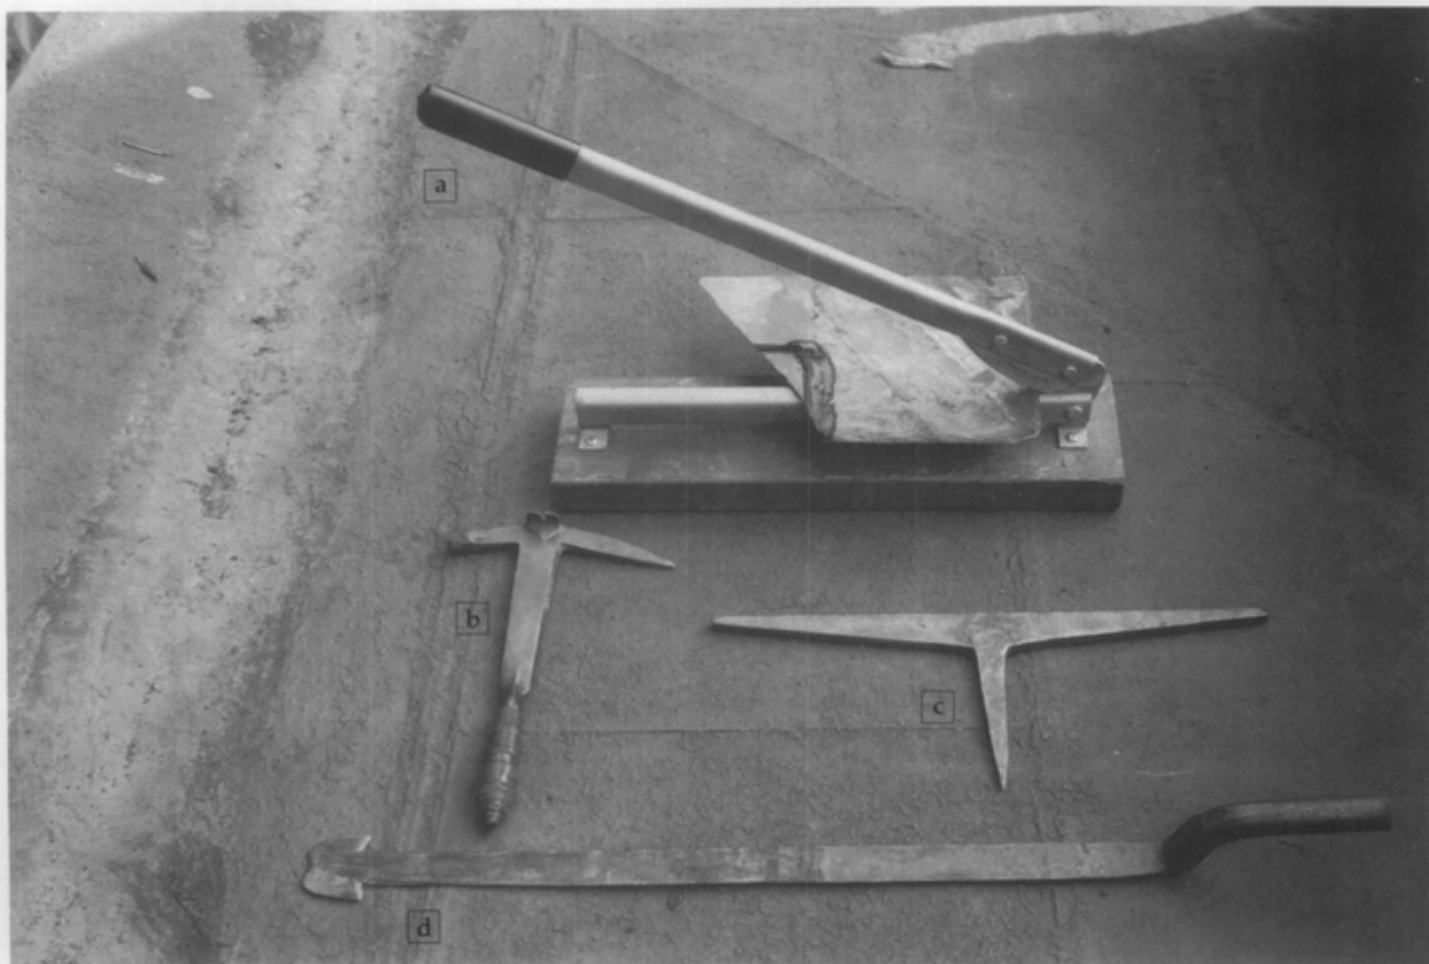
Figure 17. Slater's Tools. The cutter (a) is used to trim slate edges; the slate hammer (b) is used for hammering nails, trimming, cutting and punching holes in slates, and pulling roofing nails; the steak (c) is a T-shaped piece of iron upon which the slater places the edge of a slate to be trimmed; and the ripper (d) is slid under the slates to pull out the nails.

The ability to lay slate properly so as to produce a water-tight and aesthetically pleasing roof requires training, much practice, and the right tools (Figure 17). The

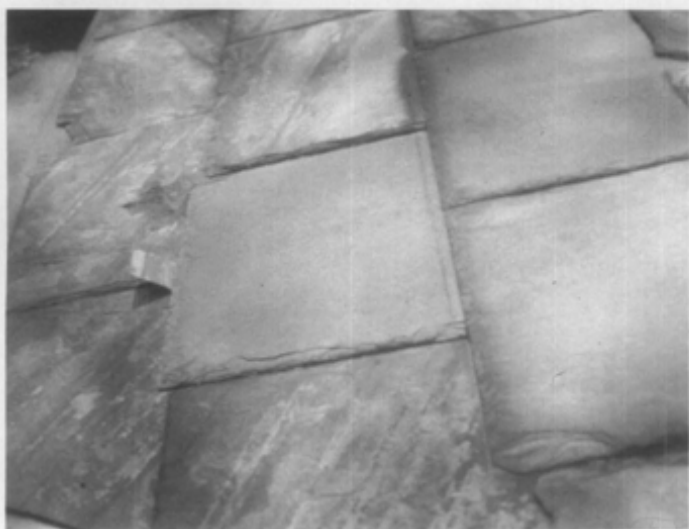
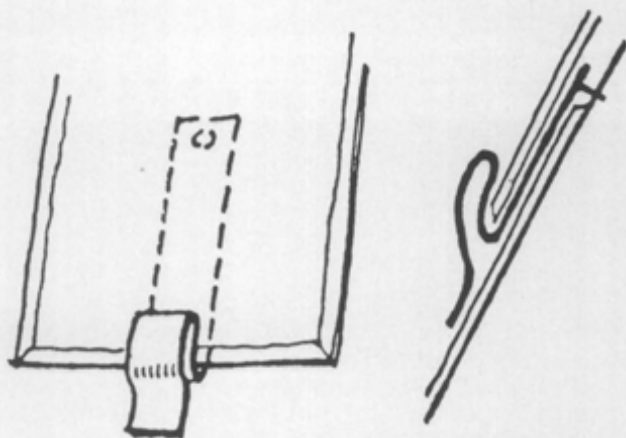
Figure 18. A method of securing replacement slates is shown. The copper strip is nailed to the roof sheathing just above the head of the slate in the course below. The replacement slate is then inserted and the copper tab folded over its tail. This type of repair is not recommended for northern climates where snow and ice can cause the copper tab to fold over, allowing the replacement slate to slide out of position as occurred here on the left.

Broken, cracked, and missing slates should be repaired promptly by an experienced slater in order to prevent water damage to interior finishes, accelerated deterioration of the roof and roof sheathing, and possible structural degradation to framing members (Figures 18 and 19).

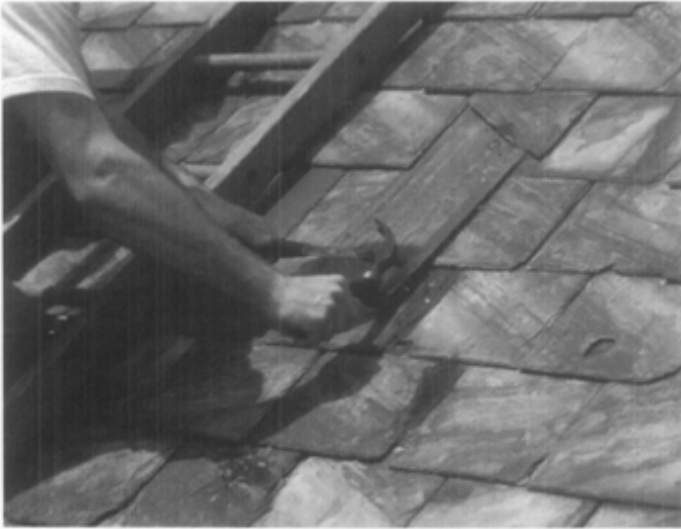
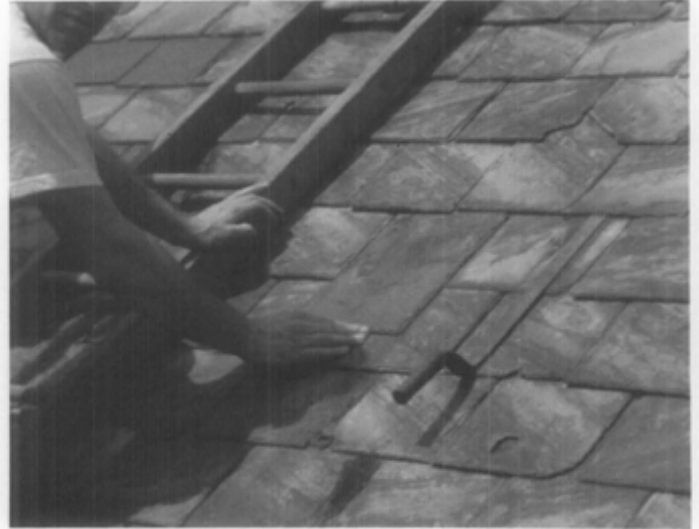
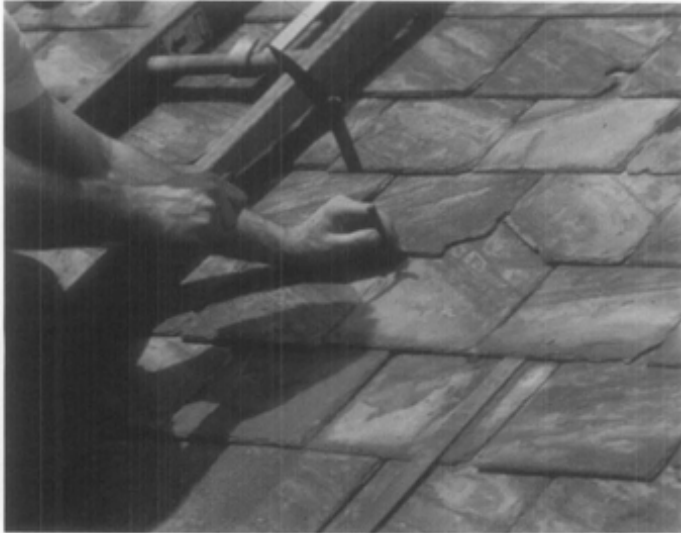
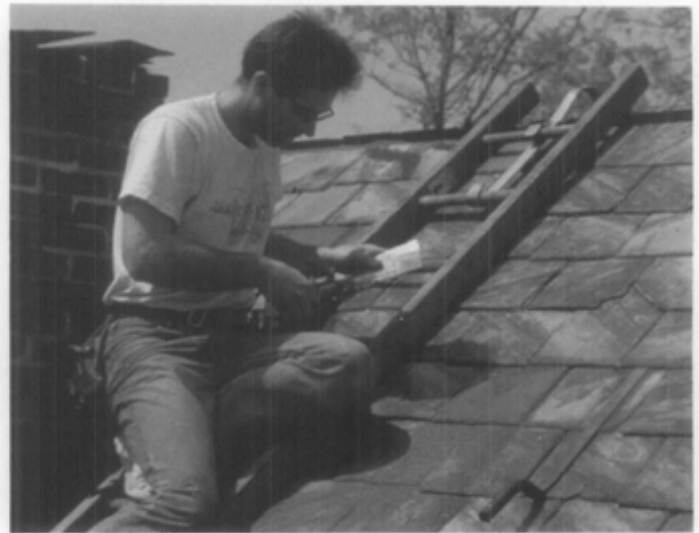
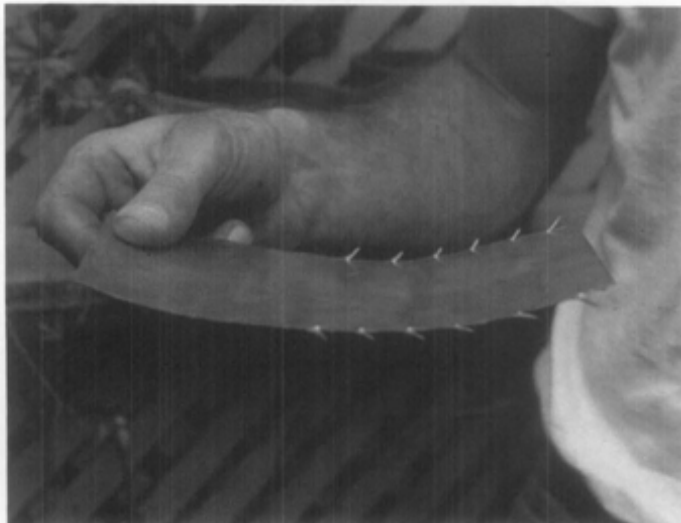
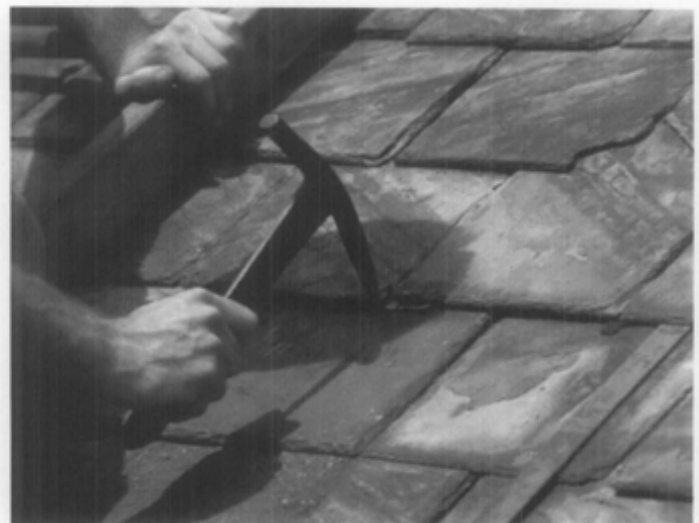
(a) A ripper is used to remove the nails from the deteriorated slate.

(b) A replacement slate is slid into place.

(c) A new slate is secured in place with a copper nail.

(d) A copper bib is formed to protect the newly created nail hole.

(e) The bib is cut along its edges and bent into a concave shape to create a friction fit.

(f) The slate hammer is used to push the bib in place over the nail head.

Figure 19. Above is a repair sequence for replacing a damaged slate.

The damaged slate is first removed by cutting or pulling out its nails with a ripper. If steel cut nails, rather than copper nails, were used in laying the roof, adjacent slates may be inadvertently damaged or displaced in the ripping process, and these, too, will have to be repaired. If the slate does not slide out by itself, the pointed end of the slate hammer can be punched into the slate and the slate dragged out. A new slate, or salvaged slate, which should match the size, shape, texture, and weathered color of the old slate, is then slid into place and held in position by one nail inserted through the vertical joint between the slates in the course above and approximately one inch below the tail of the slate two courses above. To prevent water penetration through the newly created nail hole, a piece of copper with a friction fit, measuring roughly 3" (7.5 cm) in width and 8" (20 cm) in length, is slid lengthwise under the joint between the two slates located directly above the new slate and over the nail. Alternate methods for securing the replacement slate include the use of metal hooks, clips, and straps that are bent over the tail end of the slate. The application of roofing mastic or sealants to damaged slates should *not* be considered a viable repair alternative because these materials, though effective at first, will eventually harden and crack, thereby allowing water to enter (Figure 20). Mastic also makes future repairs more difficult to execute, is unsightly, and, when applied to metal flashings, accelerates their corrosion.

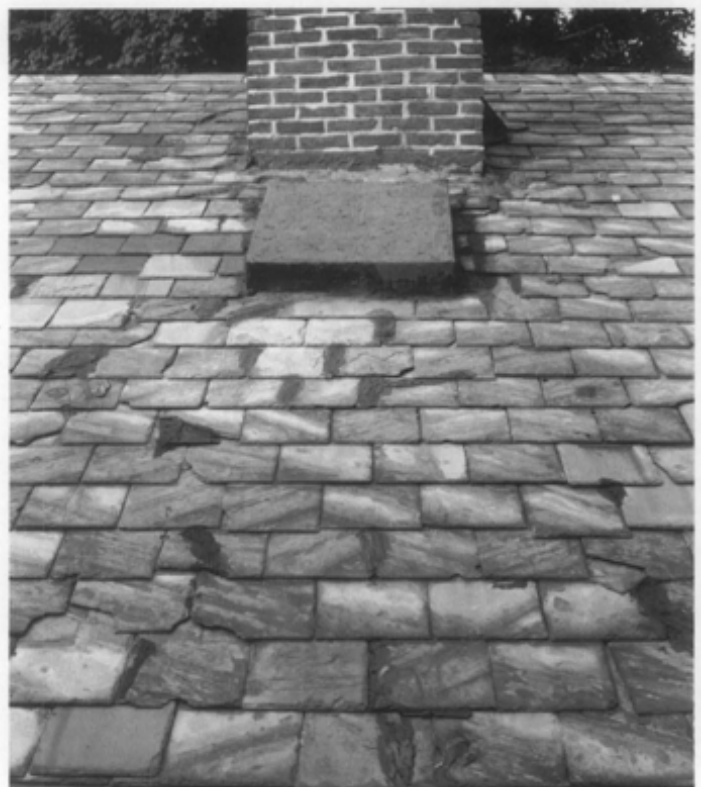
Figure 20. This roof has been poorly repaired numerous times in the past. The installation of mastic to seal out moisture has only exacerbated the problem. A timely repair and good maintenance could have extended the life of this roof.

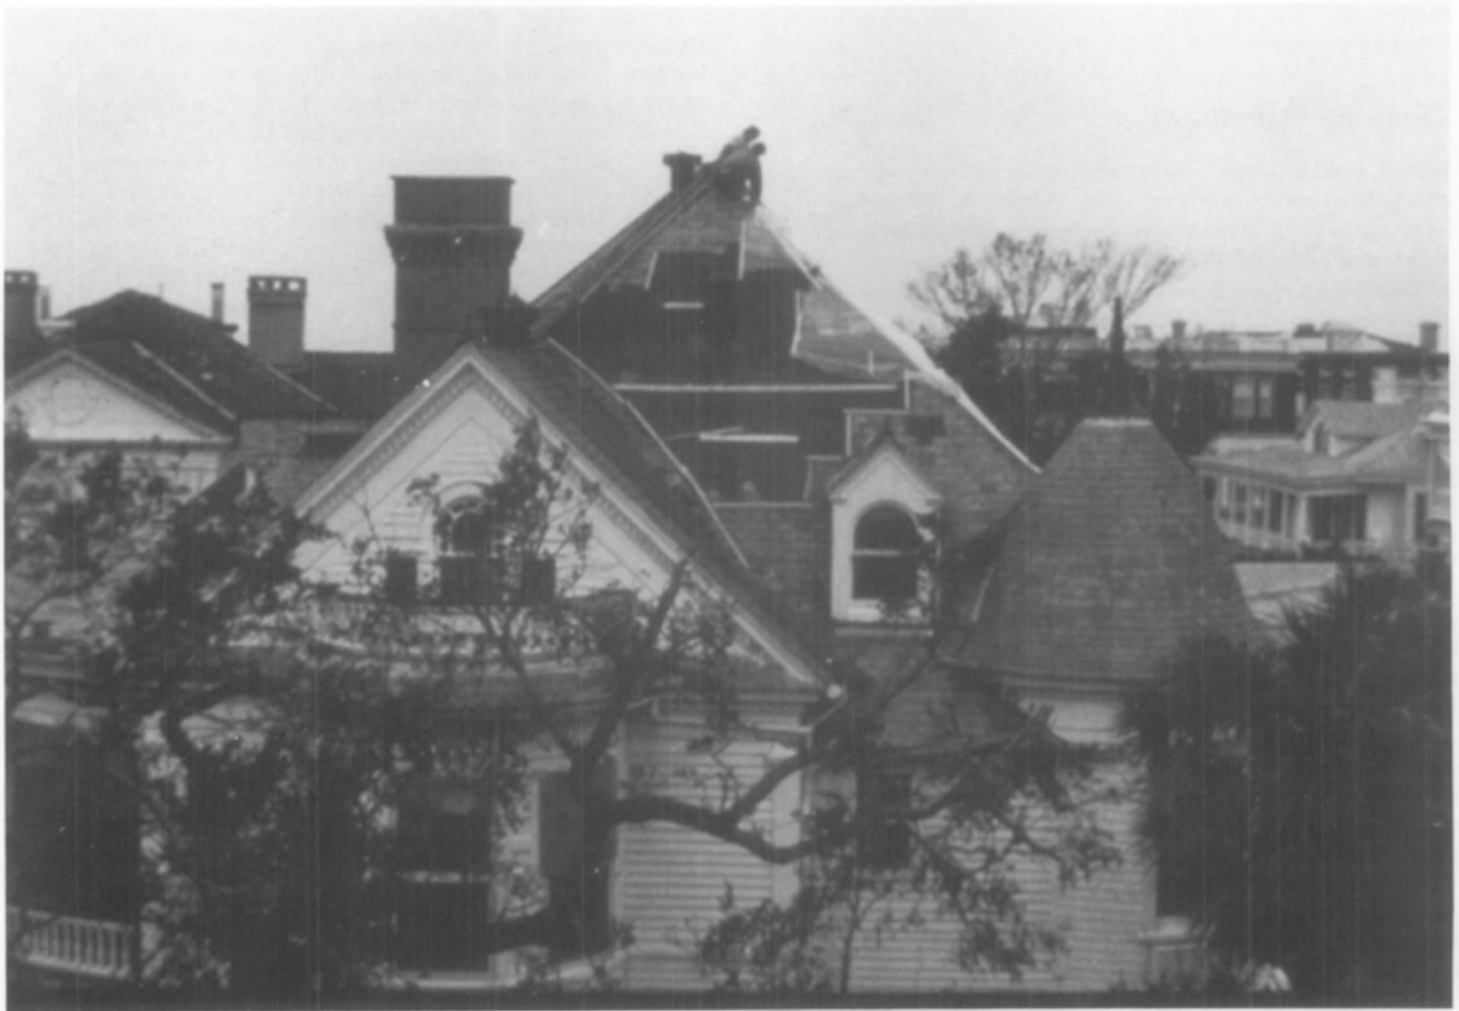
*Figure 21. As a result of hurricanes and other disasters, it may be necessary to temporarily stabilize a roof until materials can be obtained and a qualified roofing contractor hired. Heavy roofing felt was stitched into this slate roof to stop moisture penetration until matching slate was obtained for repair. Significant slate roofs should not be stripped off and replaced with asphalt shingles. Photograph courtesy of the National Park Service.*

In emergency situations, such as when severe hurricanes or tornadoes blow numerous slates off the roof, a temporary roof covering should be installed immediately after the storm to prevent further water damage to the interior of the building and to permit the drying out process to begin. Heavy gauge plastic and vinyl tarpaulins are often used for this purpose, though they are difficult to secure in place and can be blown off in high winds. Roll roofing, carefully stitched in to areas of the remaining roof, is a somewhat more functional solution that will allow sufficient time to document the existing roof conditions, plan repairs, and order materials (Figure 21).

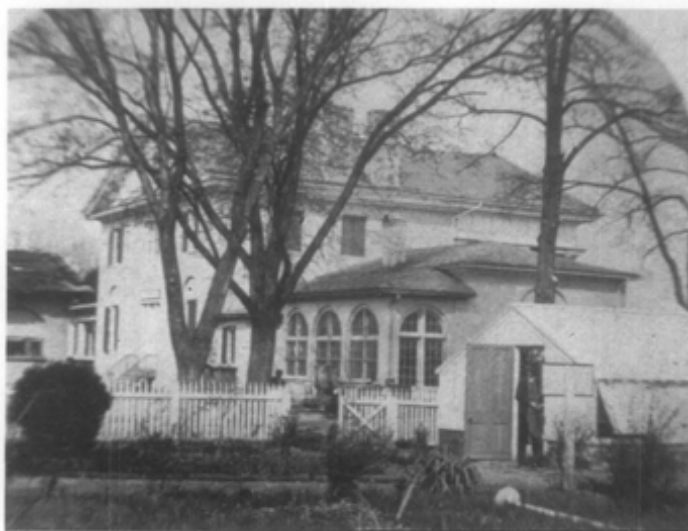
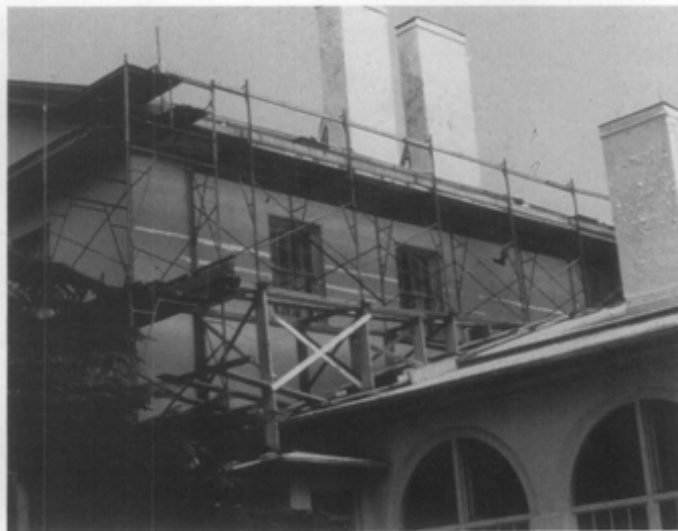
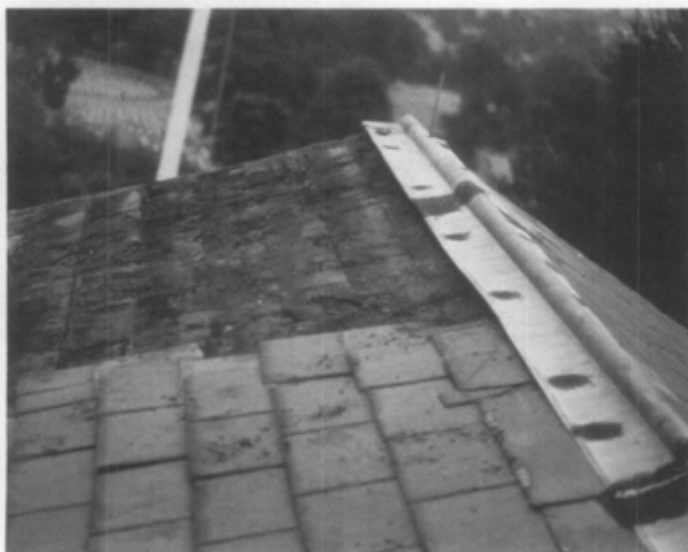
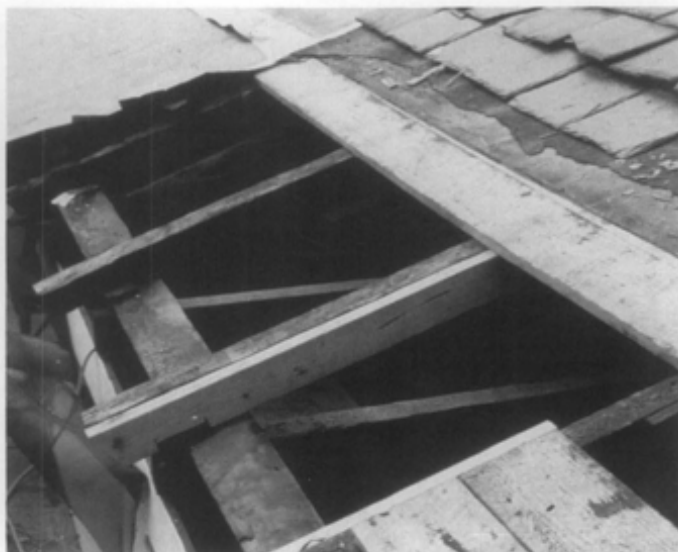
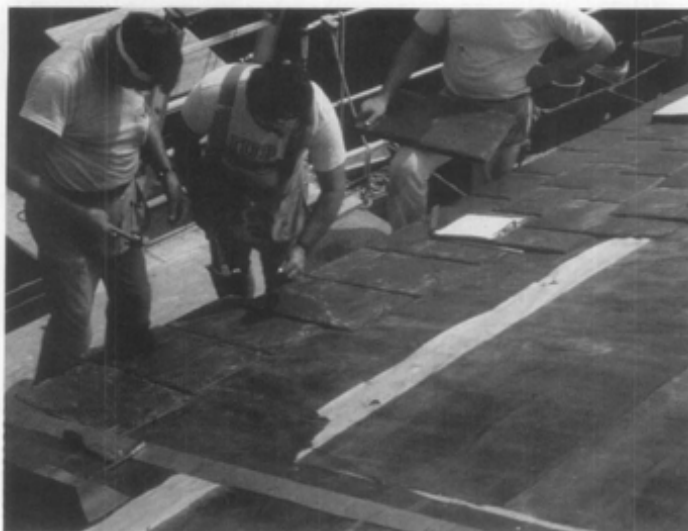
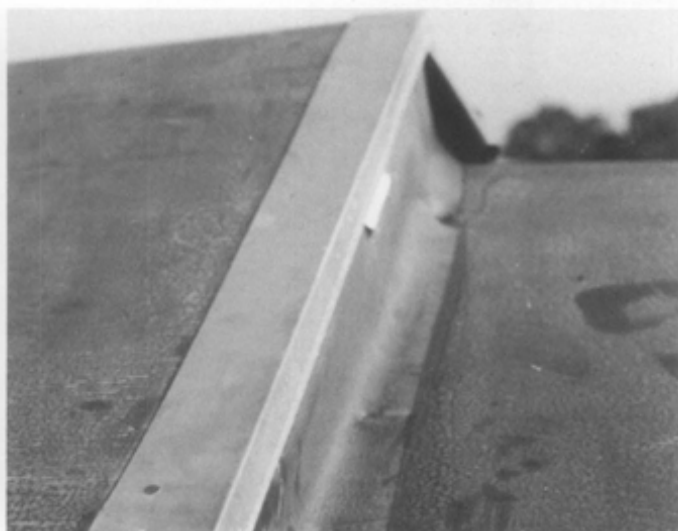
(a) Historic documentation was necessary to determine the historic configuration.

(b) Scaffolding was installed early to document existing conditions to determine extent of work.

(c) Slate was removed in sections to avoid stress on timber framing.

(d) Deteriorated sheathing was replaced and rafter tails were reinforced.

(e) Roofing felt was installed over decking; a rubberized membrane was used selectively at the eaves and under some flashing.

(f) Lead coated copper flashing was installed throughout. Seen is the offset between the portico roof and the main roof in progress.

Figure 22. Installing a new roof involves more than just slate. Above is a sequence of views of the roof replacement at Arlington House. Photographs courtesy of the National Park Service. (Sequence continued on page 14.)

If repair is not possible and a new slate roof must be installed, it is important to remember that more than just the replacement of the slate is involved (Figure 22). The old slate should be removed to prevent overloading of the roof timbers. Stripping should be done in sections, with felt installed, to avoid exposing the entire sub-roof to the weather. In the process, rotted wood sheathing should be replaced and the roof timbers checked for signs of stress, including deflection, cracking, and twisting. If such conditions are found, a structural engineer experienced in working with older buildings should be consulted. Other repairs, such as chimney repointing, which may require access to the roof should be completed before the new roof is put on.

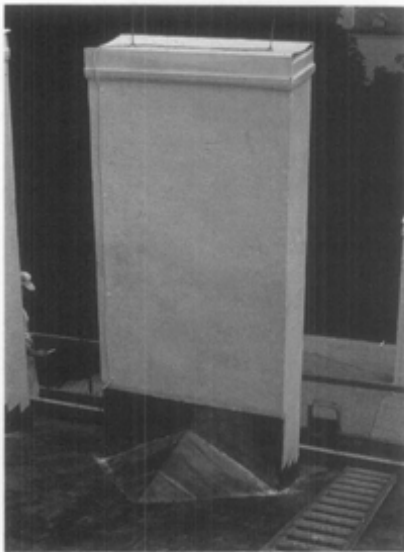
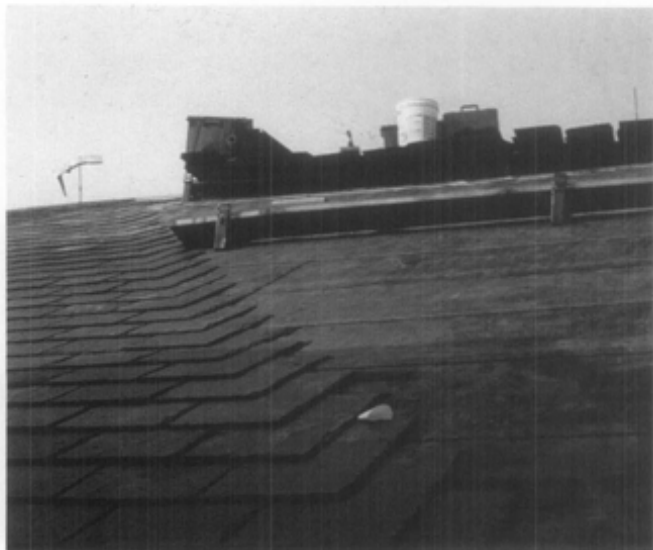
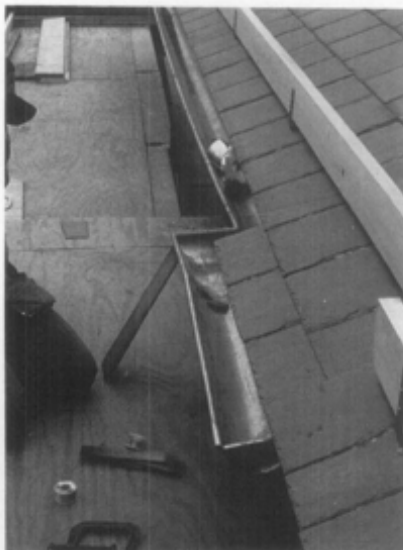
(g) Masonry chimneys were repaired and metal crickets were fabricated at the chimneys.

(h) This installation pattern allows the slates to be laid in courses leaving a temporary path of travel to avoid stepping on installed slates.

(i) Although the gutters and snow boards were the last elements installed, their support brackets were installed as the slates were laid.

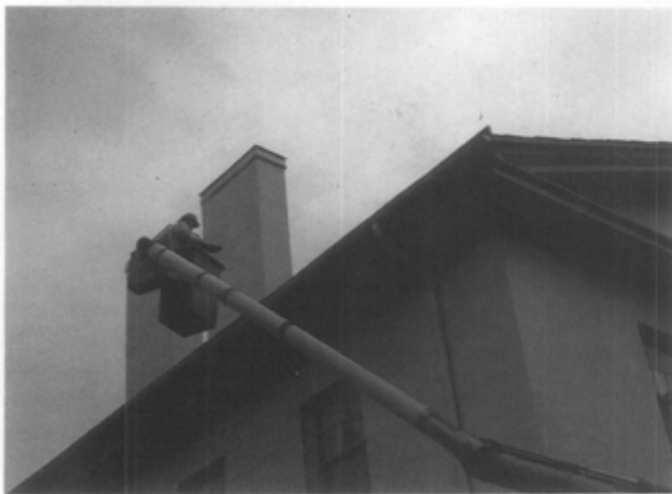
Figure 23. Slate roofs should not be walked on if at all possible. For large projects, lifts can be used to inspect roofs periodically to assess maintenance needs. Photograph courtesy of the National Park Service.

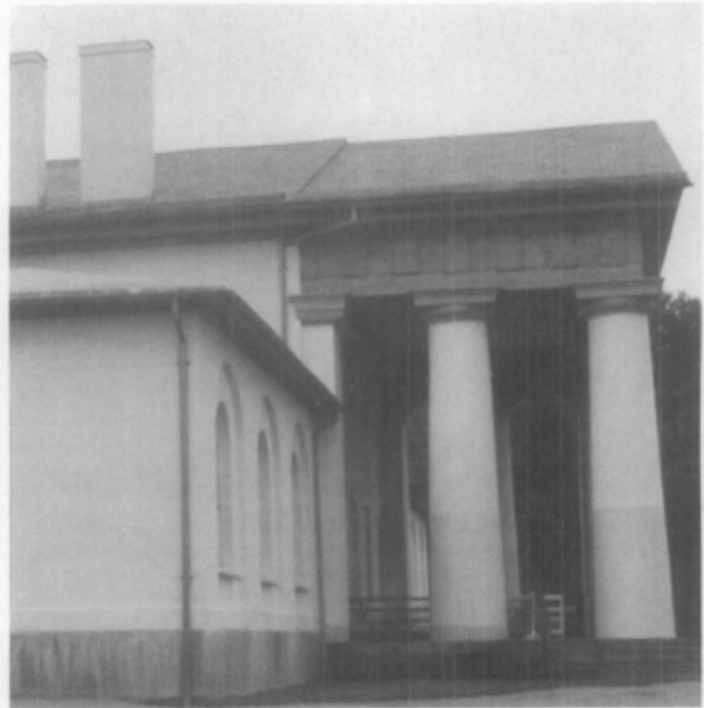
Figure 24. Although slate replacement roofs are expensive, the superiority of materials and craftsmanship will give years of continued service. If amortized over the life of the roof, the replacement cost can be very reasonable. Photograph courtesy of the National Park Service.

Slate roofs are a critical design feature of many historic buildings that cannot be duplicated using substitute materials (Figure 24). Slate roofs can, and should be, maintained and repaired to effectively extend their serviceable lives. When replacement is necessary, details contributing to the appearance of the roof should be retained. High quality slate is still available from reputable quarries and, while a significant investment, can be a cost effective solution over the long term.
