32 PRESERVATION BRIEFS

Making Historic Properties Accessible

Thomas C. Jester and Sharon C. Park, AIA

U.S. Department of the Interior
National Park Service
Cultural Resources
Heritage Preservation Services

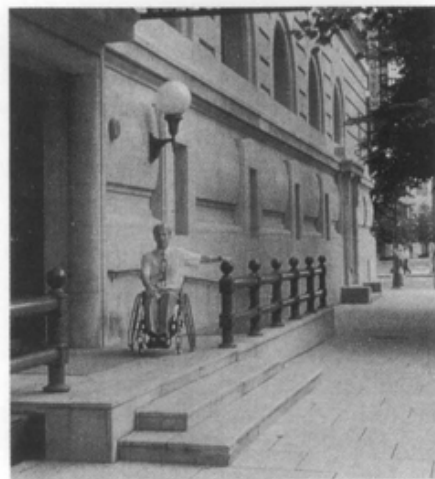
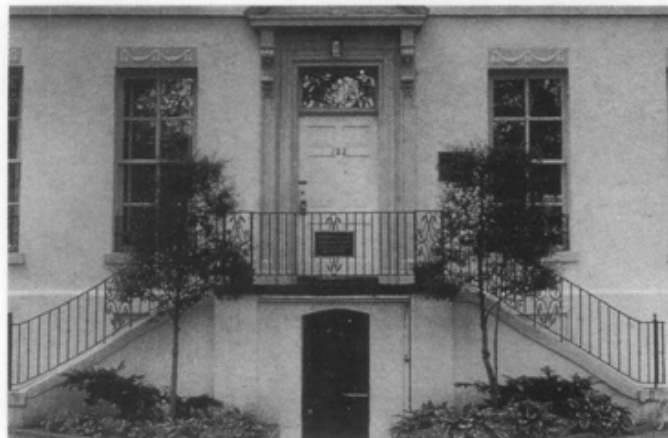
Figure 1. It is important to identify the materials, features, and spaces that should be preserved when planning accessibility modifications. These may include stairs, railings, doors, and door surrounds. Photo: National Park Service files.

decorative ornamental hardware, and narrow pathways and corridors, pose barriers to persons with disabilities, particularly to wheelchair users (See Figure 1).

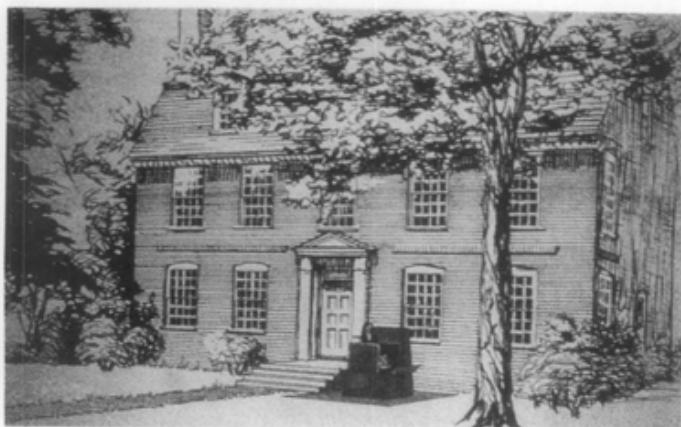
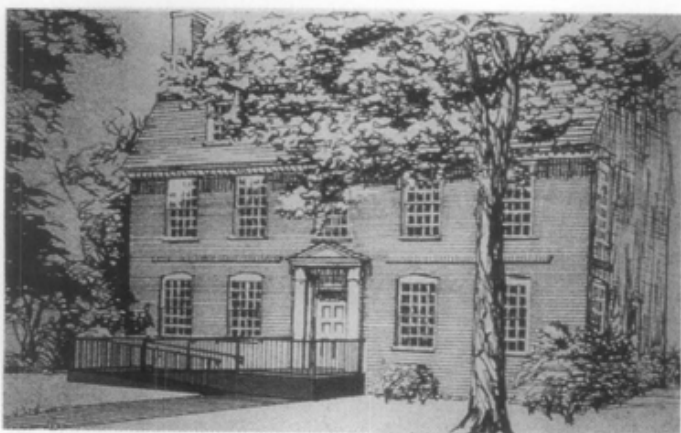
Figure 3. Before implementing accessibility modifications, owners should consider the potential effect on their historic property. At the Derby House in Salem, Massachusetts, several solutions to make the entrance accessible were considered, including regrading (a); a lift (b); and a ramp (c). The solution, an entrance on a secondary elevation, preserves the building's architectural significance and is convenient to designated parking. Drawings: National Park Service Files..

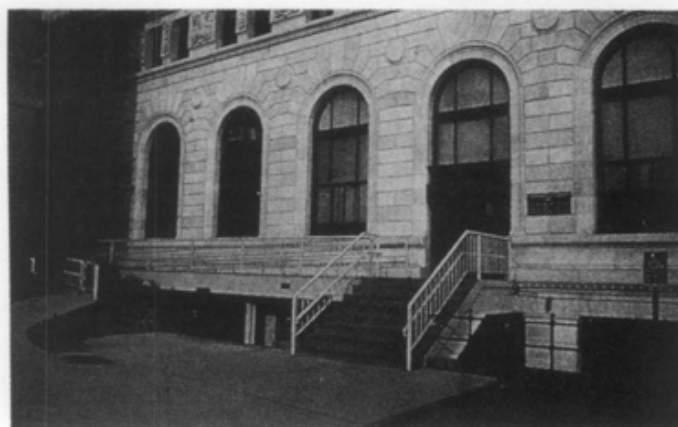
Figure 4. Parking designated for people with disabilities is provided near an accessible entrance to the Springfield Library in Springfield, Massachusetts. Photo: William Smith.

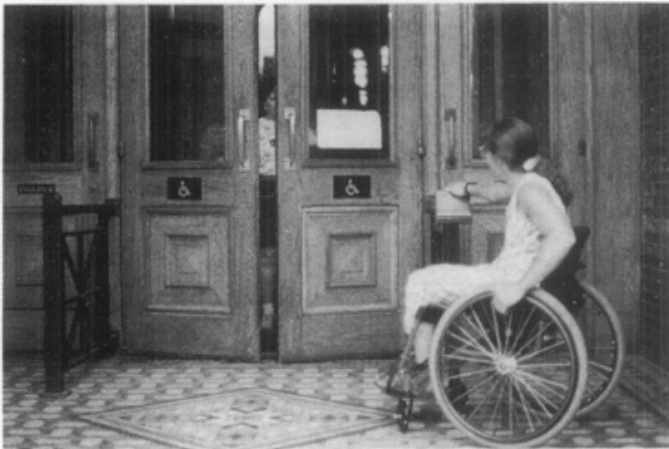
Figure 5. A universal access symbol clearly marks the Arts and Industries Building in Washington, D.C., and a push plate (right) engages the automatic door-opener. Photo: Thomas Jester.

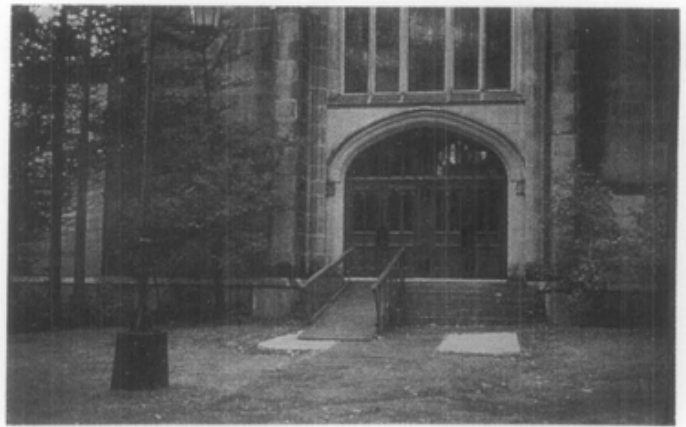
Figure 6. Entrances can be regraded to make a building accessible as long as no significant landscape features will be destroyed and as long as the building's historic character is preserved. The Houghton Chapel (a) in Wellesley, Massachusetts, was made accessible by regrading over the historic steps (b). Photos: Carol R. Johnson & Associates.

Regrading an Entrance. In some cases, when the entrance steps and landscape features are not highly significant, it may be possible to regrade to provide a smooth entrance into a building. If the existing steps are historic masonry, they should be buried, whenever possible, and not removed (See Figure 6).

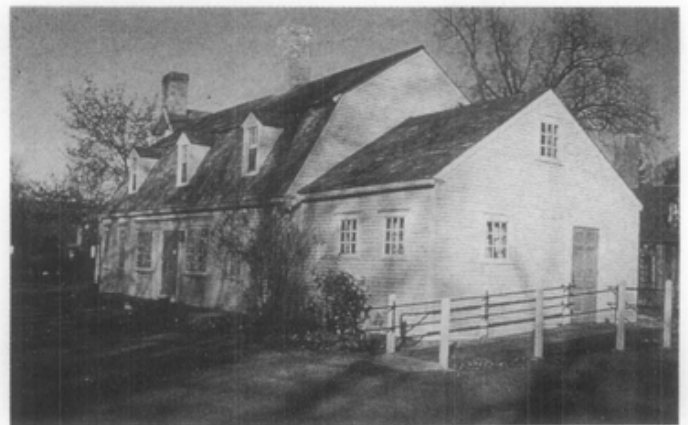
Figure 7. This ramp is convenient for visitors with disabilities and preserves the building's historic character. The design is also compatible in scale with the building. Photo: William Smith.

Incorporating Ramps. Permanent ramps are perhaps the most common means to make an entrance accessible. As a new feature, ramps should be carefully designed and appropriately located to preserve a property's historic character (See Figure 7). Ramps can be located at public

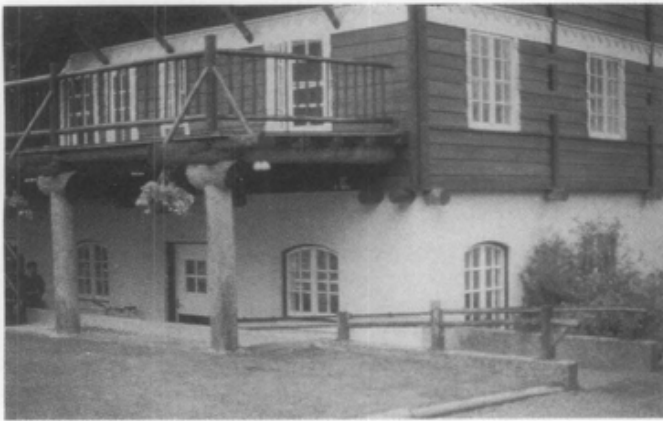
Figure 8. A new below-grade ramp provides access to Lake MacDonald Lodge in Glacier National Park. Photo: Thomas Jester

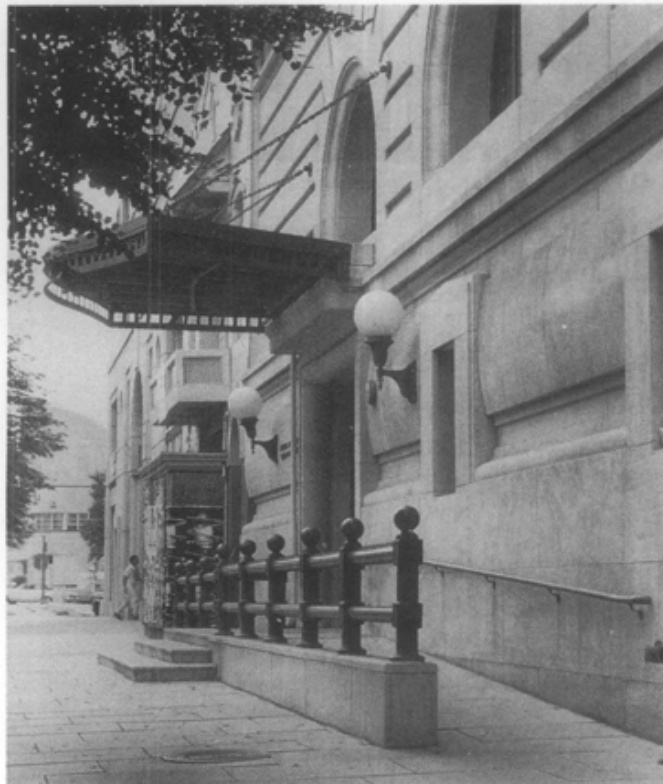
Figure 9. This ramp was created by infilling the window-well and slightly modifying the historic railing. The ramp preserves this building's historic character. Photo: Thomas Jester.

historic features, such as cheek-walls or railings, to minimize the visual effect (See Figure 9).

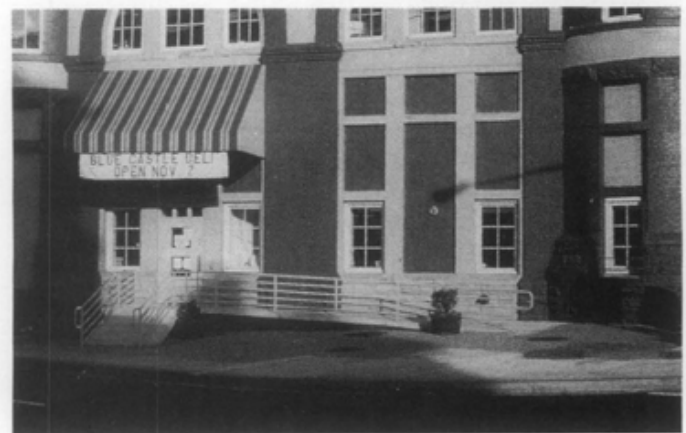
Figure 11. Simple, contemporary railings that extend beyond the ramp slope make this ramp compatible with the industrial character of this building. Photo: Thomas Jester.

should be simple in design, distinguishable from other historic features, and should extend one foot beyond the sloped area (See Figure 11).

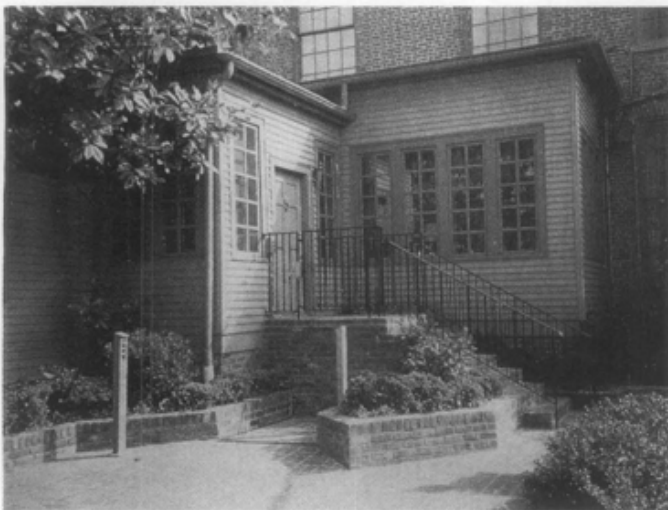
Figure 14. At the Lieutenant Governor's Mansion in Frankfort, Kentucky, a retracting lift (b) was installed to minimize the visual effect on this historic building when not in use (a). Photos: Aging Technology Incorporated.

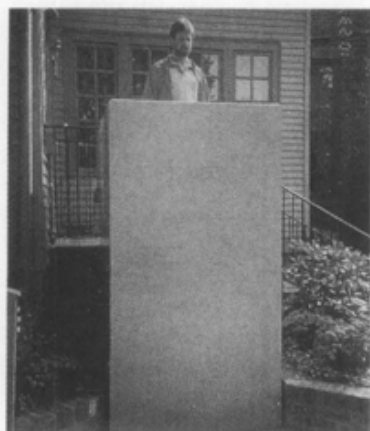
Figure 15. A new entrance to the elevator lobby replaces a window at Faneuil Hall in Boston, Massachusetts. The new entrance is appropriately differentiated from the historic design. Photo: Paul Holtz.

Considering a New Entrance. When it is not possible to modify an existing entrance, it may be possible to develop a new entrance by creating an entirely new opening in an appropriate location, or by using a secondary window for an opening. This solution should only be considered after exhausting all possibilities for modifying existing entrances (See Figure 15).

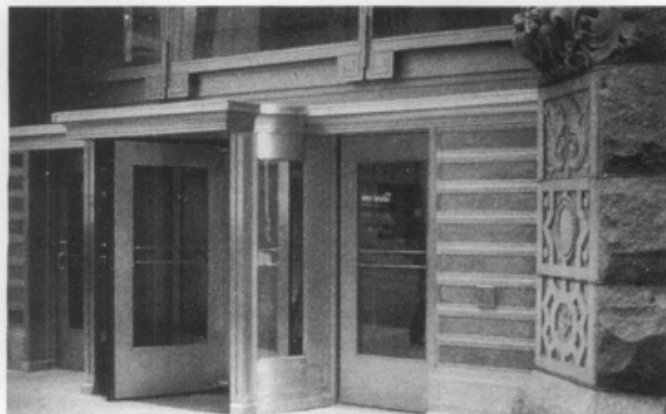
Figure 16. During the rehabilitation of the Rookery in Chicago, the original entrance was modified to create an accessible entrance. Two revolving doors were replaced with a new one flanked by new doors, one of which is operated with a push-plate door opener. Photo: Thomas Jester.

(operated by push buttons, mats, or electronic eyes) and power-assisted door openers can eliminate or reduce door pressures that are accessibility barriers, and make single or double-leaf doors fully operational (See Figure 16).

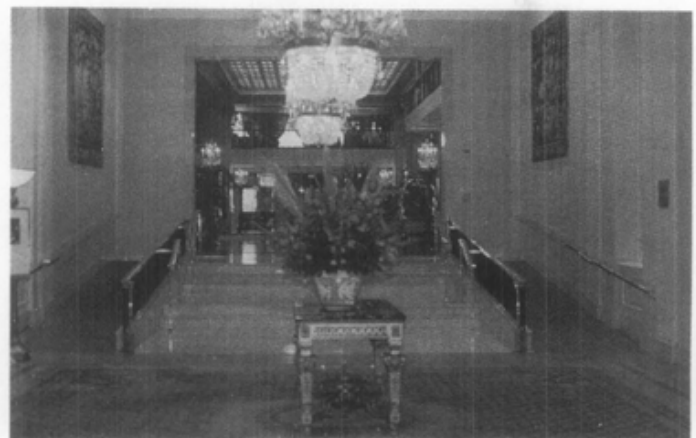
Figure 18. Symmetrical ramps at the Mayflower Hotel in Washington, D.C., provide access to the hotel's lower level. The design for the ramps respects the historic character of this landmark building. Photo: Thomas Jester.

Installing Ramps and Wheelchair Lifts. If space permits, ramps and wheelchair lifts can also be used to increase accessibility inside buildings (See Figures 18 & 19). However, some States and localities restrict interior uses of wheelchair lifts for life-safety reasons. Care should be taken to install these new features where they can be readily accessed. Ramps and wheelchair lifts are described in detail on pages 4-6.

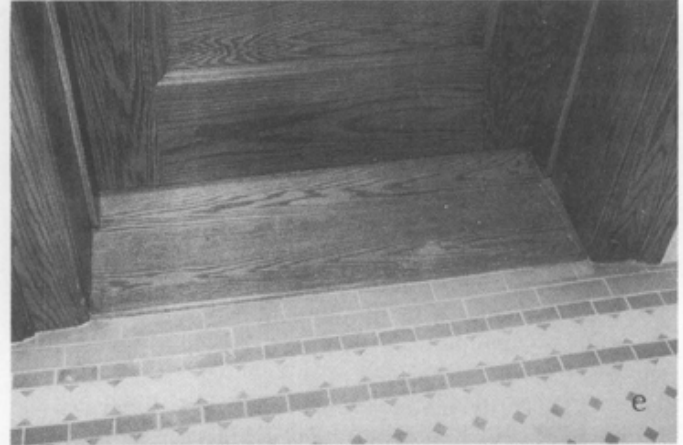
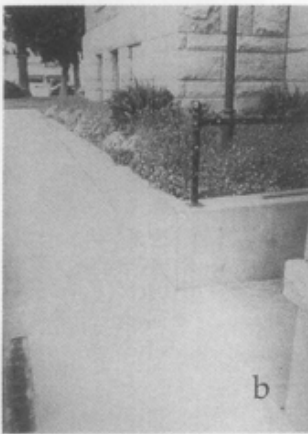
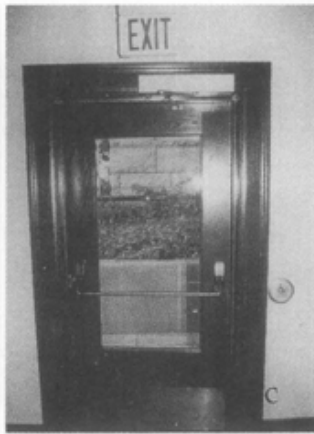
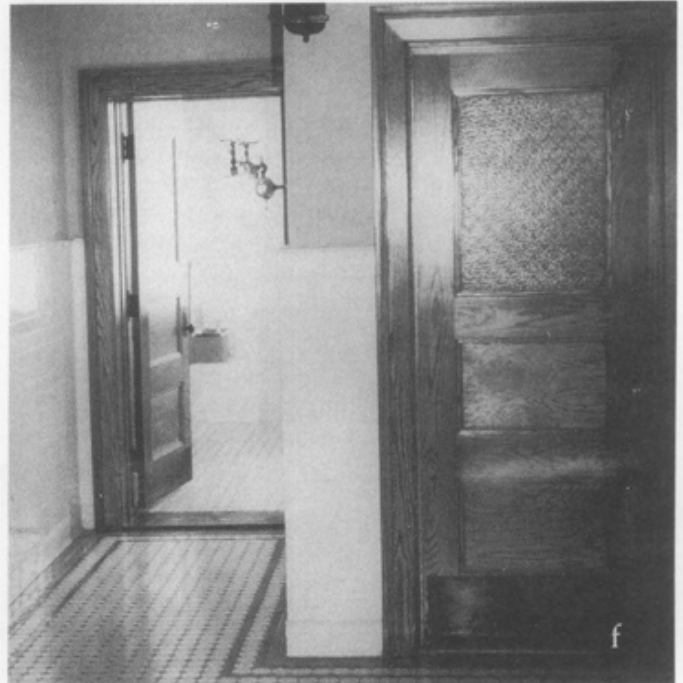
MAKING A HISTORIC BUILDING ACCESSIBLE

The Orange County Courthouse (a), located in Santa Ana, California, was rehabilitated in the late 1980s as a county museum. As part of the rehabilitation, the architect sensitively integrated numerous modifications to increase accessibility. To preserve the building's primary elevation, a new public entrance was created on the rear elevation where parking spaces are located. A ramp (b) leads to the accessible entrance that can be opened with a push-plate automatic door-opener (c). Modifications to interior features also increased accessibility. To create an accessible path of travel, offset hinges (d) were installed on doors that were narrower than 32 inches (81.3 cm). Other doors were rethreaded to reduce the door pressure. Beveling the 1" high thresholds (e) reduced their height to approximately 1/4 inch (.64 cm). The project architect also converted a storeroom into an accessible restroom (f). The original stairway, which has open grillwork, was made more accessible by applying slip-resistant pressure tape to the marble steps (g). And the original elevator was upgraded with raised markings, alarm lights, and voice floor indicators. Photos: Milford Wayne Donaldson, FAIA.

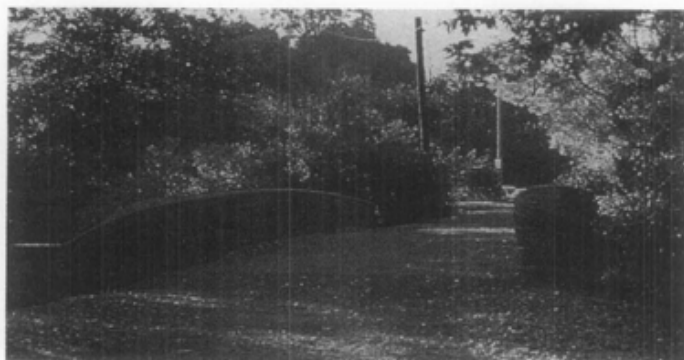
(a.) To improve accessibility in Boston's Emerald Necklace Parks, standard asphalt paving was replaced in selected areas with an imbedded aggregate surface that is more in keeping with the landscape's historic appearance. Photo: Charles Birnbaum.

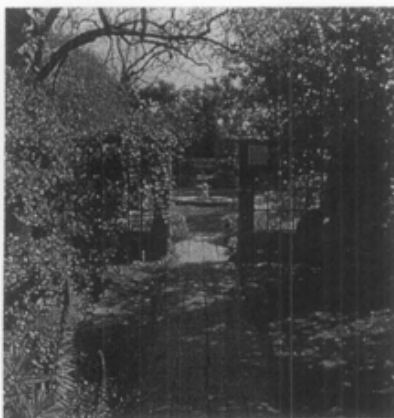
(b.) The Friendly Garden at Rancho Los Alamitos, a historic estate with designed gardens in southern California, was made accessible with limited widening of its existing approach path. Photo: Rancho Los Alamitos Foundation.

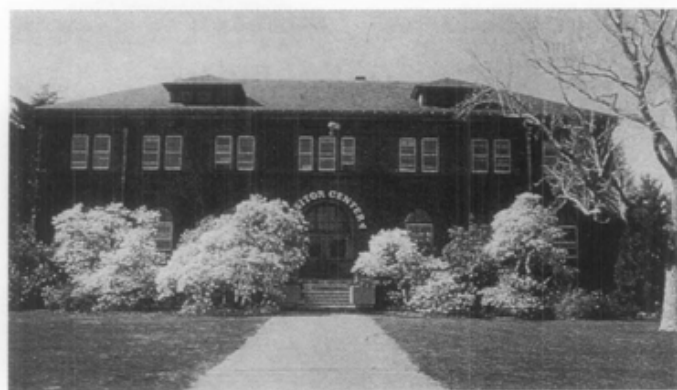
(c.) Hunnewell Visitor's Center before rehabilitation, revealing the altered landscapes. Photo: Jennifer Jones, Carol R. Johnson and associates.

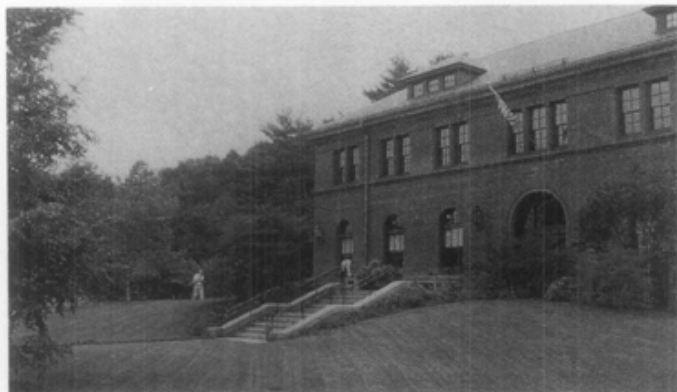
(d.) Hunnewell Visitors Center's entrance following rehabilitation, integrating an accessible path (left), platform, and new steps. Photo: Charles Birnbaum.

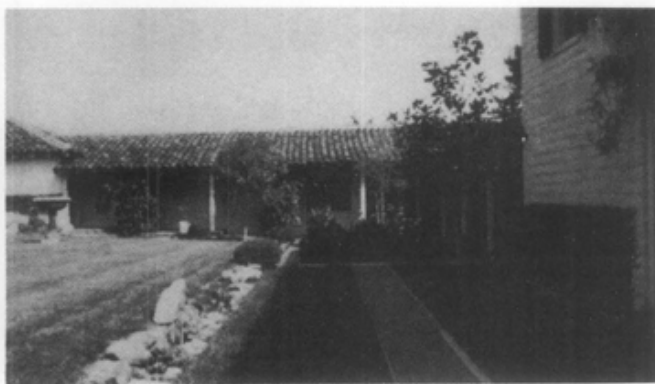
(e.) This view shows the new reinforced turf path at the Eugene O'Neill National Historic Site that preserved the narrow Historic Path. Photo: Patricia M. O'Donnell.

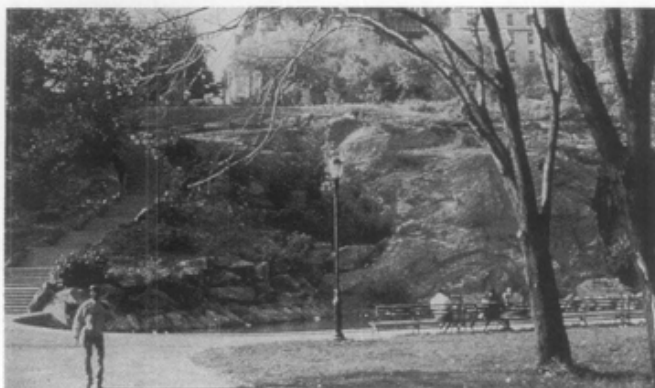
(f.) Steep terrain at Morningside Park in New York City cannot be made accessible without threatening or destroying this landscape's integrity. Photo: Quennell Rothschild Associates.

3. Morningside Park in New York City, New York, designed by Frederick Olmstead, Sr., and Calvert Vaux in 1879, is sited on generally steep, rocky terrain (f). Respecting these dramatic grade changes, which are only accessible by extensive flights of stone stairs, physical access cannot be provided without destroying the park's integrity. In order to provide some accessibility, scenic overlooks were created that provide broad visual access to the park.

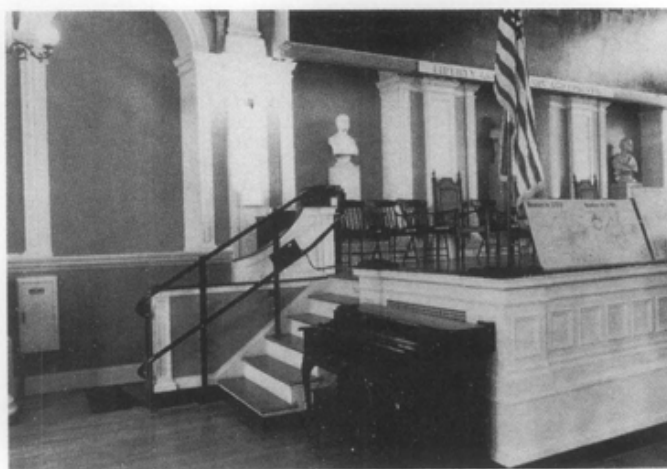
Figure 19. Inclined lifts can sometimes overcome interior changes of elevation where space is limited. This lift in Boston's Faneuil Hall created access to the floor and stage level of the State Room. Photo: Paul Holtz.

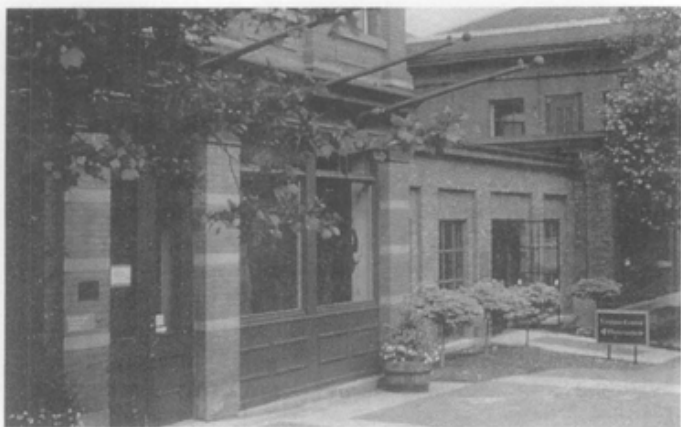
Figure 23. New additions to historic buildings can be designed to increase accessibility. A new addition links two adjacent buildings used for the Albany, New York, Visitor's Center, and incorporates an accessible entrance, restrooms, and signage. Photo: Clare Adams.
