33 PRESERVATION BRIEFS

The Preservation and Repair of Historic Stained and Leaded Glass

Neal A. Vogel and Rolf Achilles

National Park Service
U.S. Department of the Interior

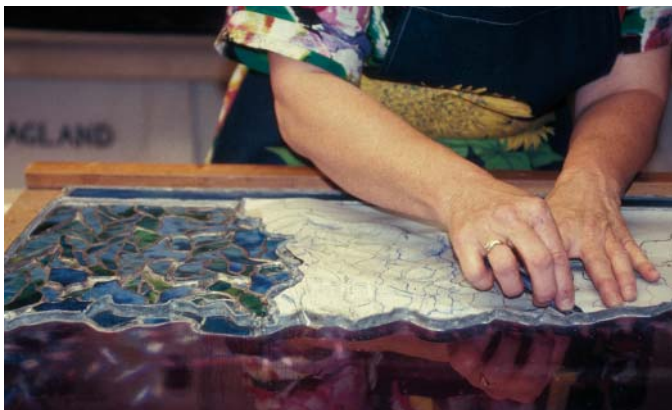
Figure 14. The external glass plate has been removed to clean the interlayer of this plated Tiffany Studios window.
