45 PRESERVATION BRIEFS

Preserving Historic Wood Porches

Aleca Sullivan and John Leeke

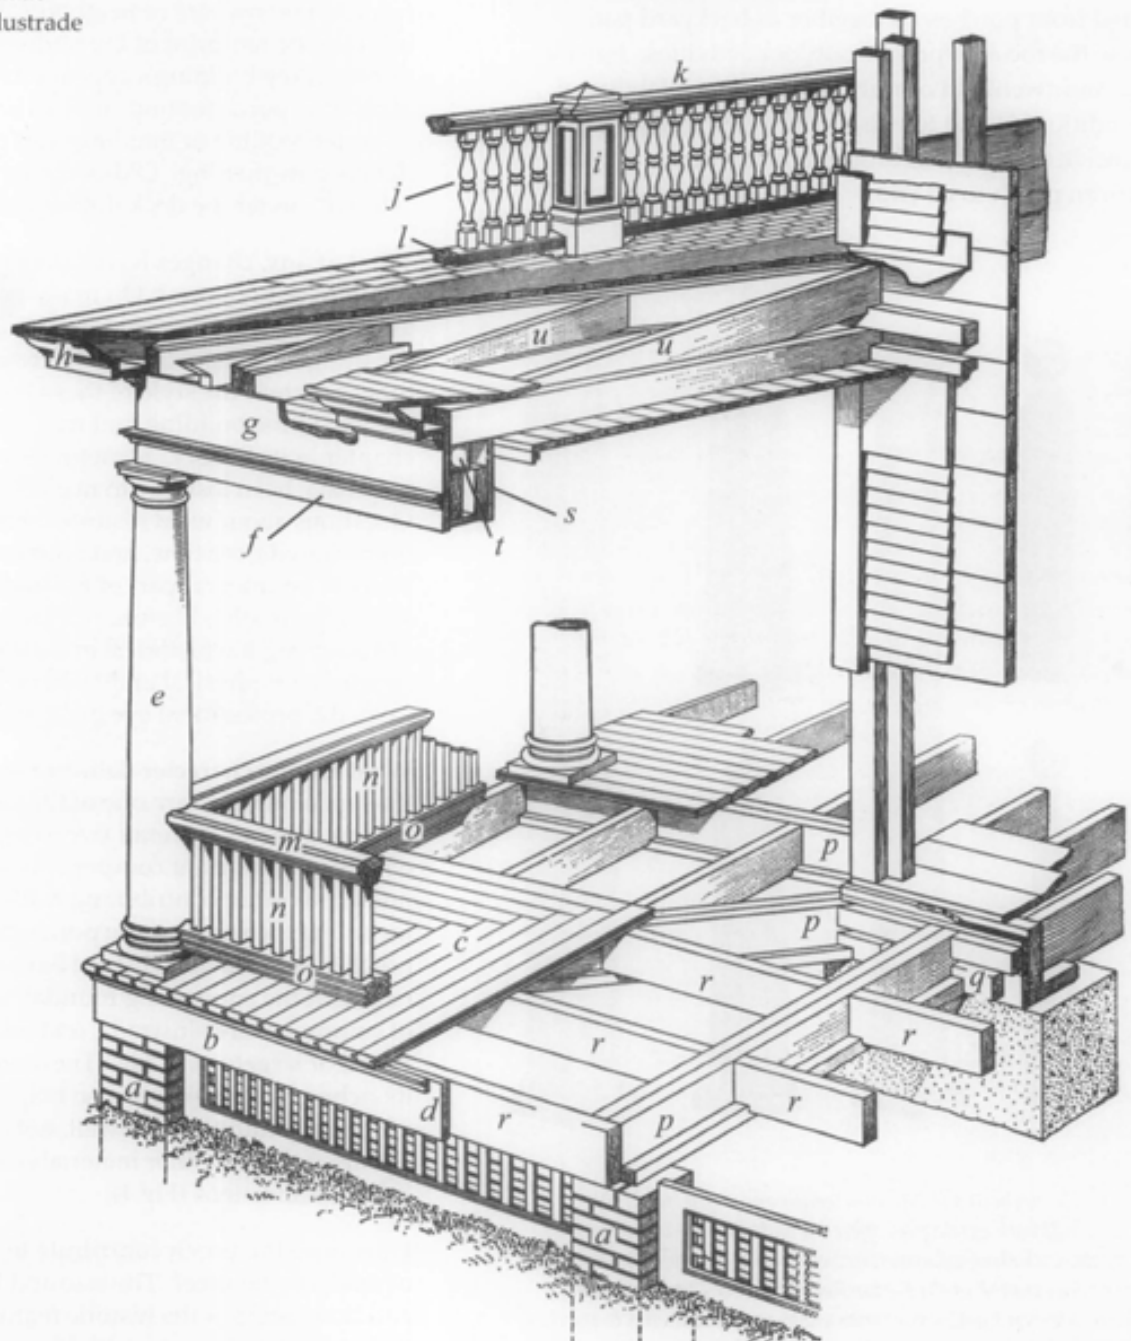
Roof Structural System (s, t, u)

- s - Beams inside the entablature span from column to column, support plate
- t - Plate of the entablature rests on beams, supports roof rafters and ceiling beams
- u - Rafter of the roof structural system

Drawing courtesy of Thomson Education Direct.

The open qualities are one of the key features of most historic porches. Overall size, shape and design are obviously important components as well. There are numerous other contributing features which may exist, including the shape of the porch roof, the way a large porch is divided into distinct bays as with columns, the nature of the supporting foundation, the style and size of columns and balustrade, and whether the porch is raised or largely at grade. The simplicity of a porch or its richness in detail will also help define it. Materials are usually important as well, not just the wood features, but also whether other materials exist such as masonry columns and steps (Fig 4).

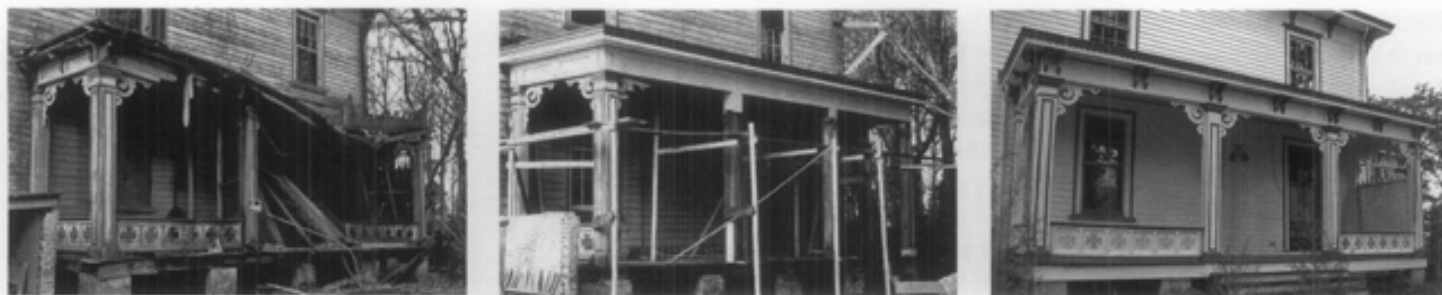
Figure 5. Even historic porches that appear to be in total disrepair may be repairable. While the roof needed replacement, much of this porch was repaired, including such features as the decorative columns, ornamental brackets, and balustrade. Photos: John Leeke.

engineer or building contractor familiar with old buildings. For an adequate assessment, it may be necessary to remove facing boards to check for potential decay in the structural sill behind (Fig 5).

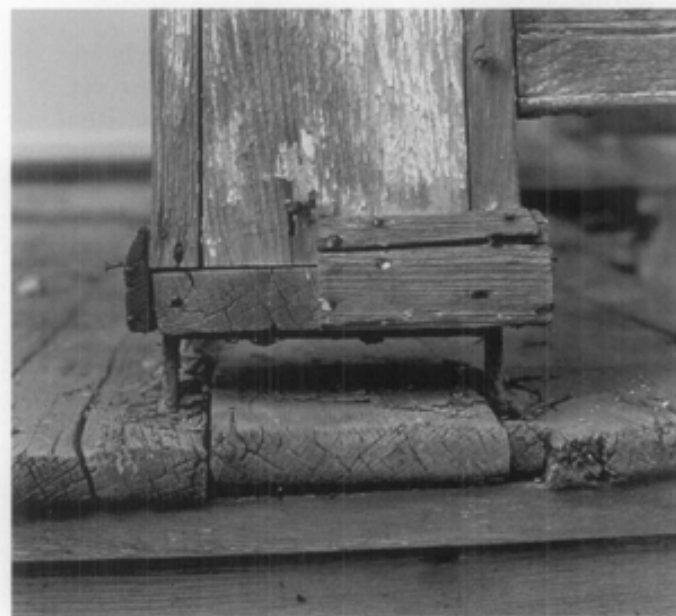
Figure 6. A traditional way to extend the life of porch posts was to place posts on metal feet, thereby providing a separation between the wood post and wood deck. This helped to prevent the wood post from rotting at the base. Early post feet were simple iron bars bent unto a stirrup shape. By the late nineteenth century manufactured cast-iron feet were common, consisting of a pair of disks separated by a short pipe. Post feet are still available today. Courtesy of Old-House Journal/Brian McNeil.

are made of and how they are constructed will aid in understanding how they function and may deteriorate over time (Fig.6). Although the posts on a wood porch are commonly made of wood, they may be of masonry or metal or a combination of materials. Large round columns usually are made of wood staves similar to the way barrels are constructed; smaller diameter columns may be solid. A sag in the deck below or a faltering foundation can impact the supporting role of a column or post above. Wood columns and posts are prone to water seeping into open joints, particularly in the base and the lower end of the shaft. It is not uncommon to find that older columns have had patches and replacement bases.

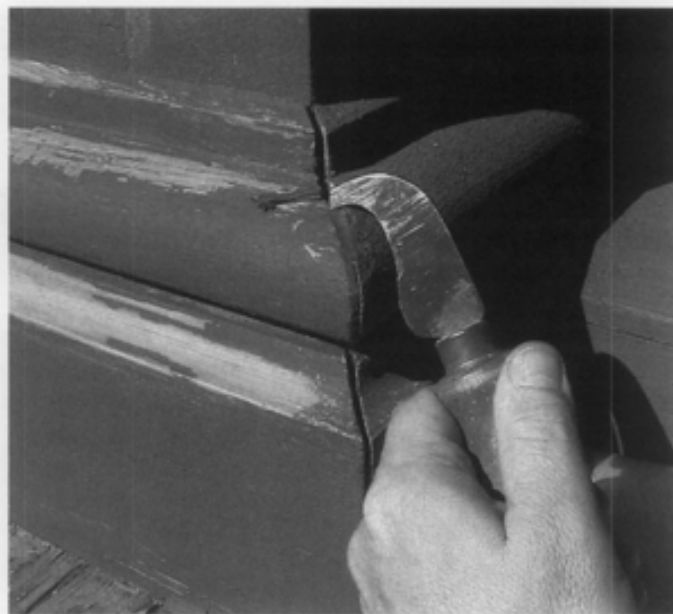
Figure 7. Common problems with porches that can contribute to serious wood decay include cracks in woodwork and joints that have opened up. Both provide an easy path for water seepage. Trapped moisture can foster peeling paint, wood decay and insect infestation. Open joints and cracks should be checked for evidence of more serious decay and marked for caulking or repair. Photo: John Leeke.

Tightly sealed connections keep water out. Where individual boards come together, cracks in woodwork and joints can eventually become a major problem (Fig.7). Cracks are primarily caused by movement and water penetration. Movement of structural members beneath the finished woodwork can shift the position of individual boards and trim, breaking open the thin coating of paint over joints. This condition is common on porches with shallow foundations that are subject either to annual winter frost heaving or where soil conditions undergo major seasonal changes in moisture content. Changes in the moisture content of the wood itself due to repeated wetting and drying or changes in seasonal humidity can also cause noticeable expansion and shrinkage across the width of a board. This provides opportunities for water to penetrate unprotected areas.

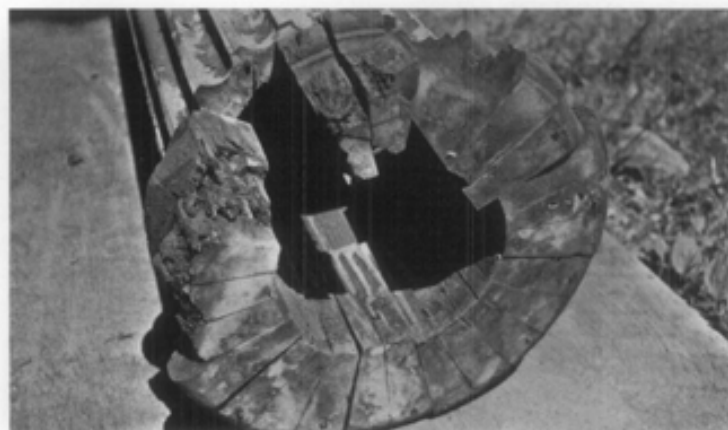
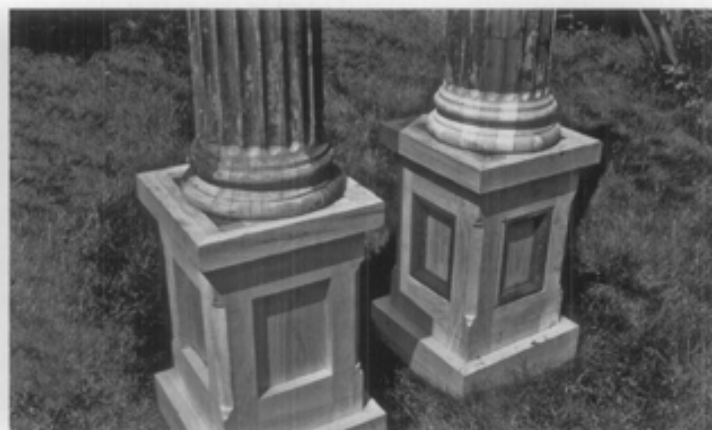
Figure 10. This nineteenth century porch column is made of wood staves, similar to the way a wood barrel is put together. After replacing the torus and making dutchman repairs to the apophyge along the base, the column and pedestal are ready to be reinstalled on the porch. Photos: NPS files.

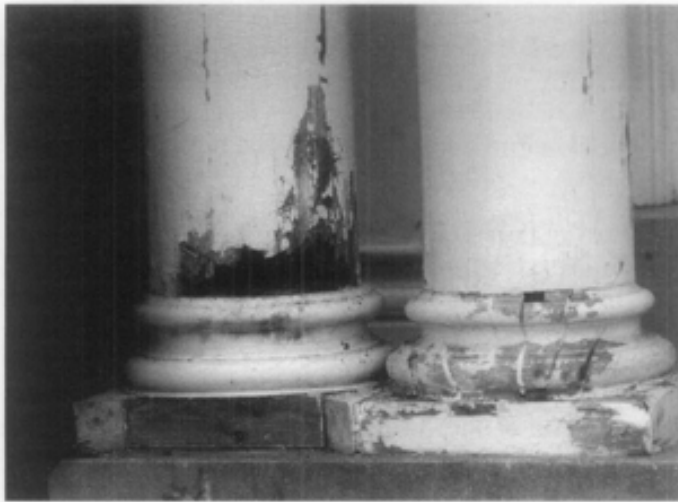
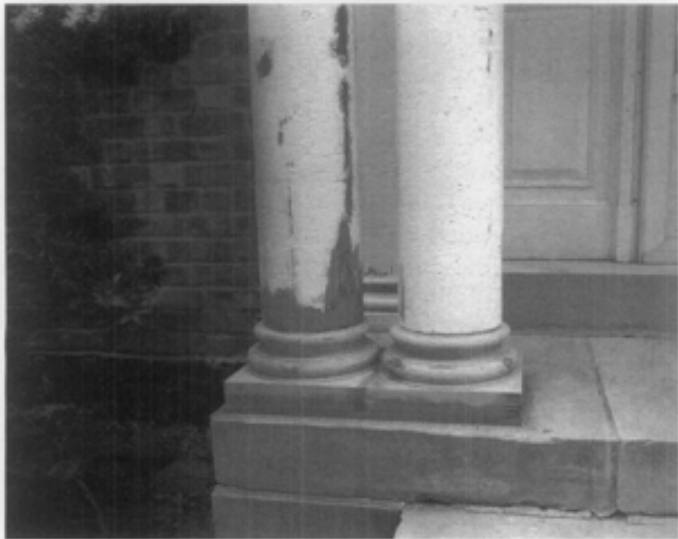
Figure 11. The lower shaft of the porch columns had decayed as water wicked up through the end grain (top). The column shafts were repaired in place by cutting out the deteriorated wood and making repairs using epoxy consolidants and fillers. (bottom). The column bases were replaced. Photos: Paul Marlowe, Marlowe Restorations.

When plinths and bases are deteriorated beyond repair, they can be replaced without replacing the column shaft, which may still be in good condition or require only minor repairs at the bottom. Such replacement will involve temporary shoring for the roof. One-story columns and shafts are often more easily removed during this work, while taller columns are sometimes supported in place. If only a few plinths or bases are deteriorated, it is often economical to have new ones made of wood to match. If numerous plinths and bases are deteriorated, replacing with bases made of rot-resistant materials can make economic sense; however, care must be taken to ensure that all the visual qualities including design, size, shape, color and texture of the historic part are matched (Fig. 11).

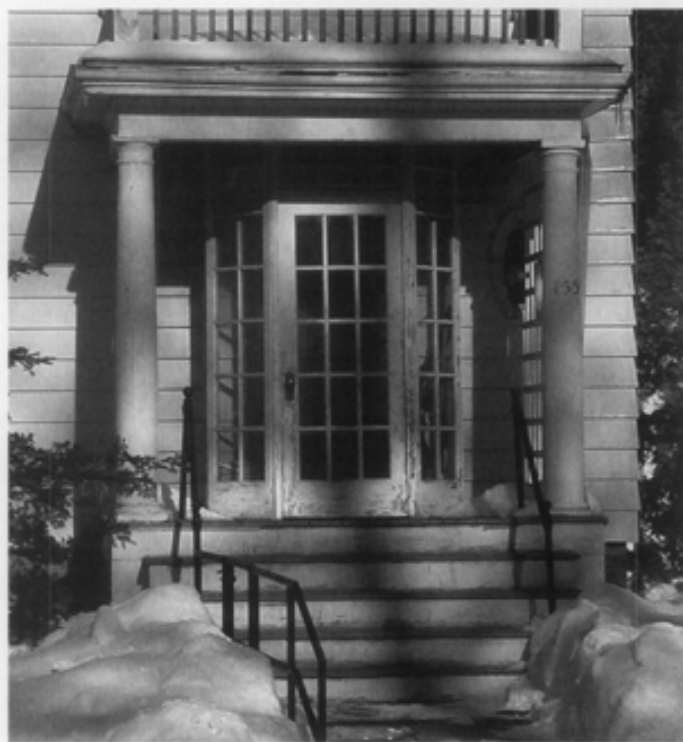
Figure 13. Particularly in New England, there is a cold weather tradition of installing temporary glass and wood panels at entrance doors, thereby creating an enclosed vestibule. These enclosures with their small divided lights were generally removed in the spring.

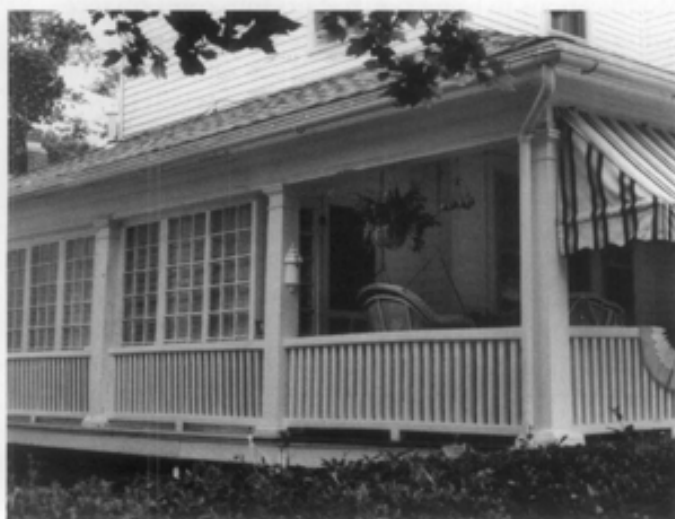
Figure 15. A traditional technique of porch enclosures still used today involves the insertion in each column bay of one or more glass enclosures set in wood frames. This enclosure is properly set back an entire porch bay from the front of the house and utilizes traditional light divisions and wood frames. The balustrade, added here for illustration purposes, shows the importance of retaining this linear feature within the enclosed bays. Photo: Charles Fisher.

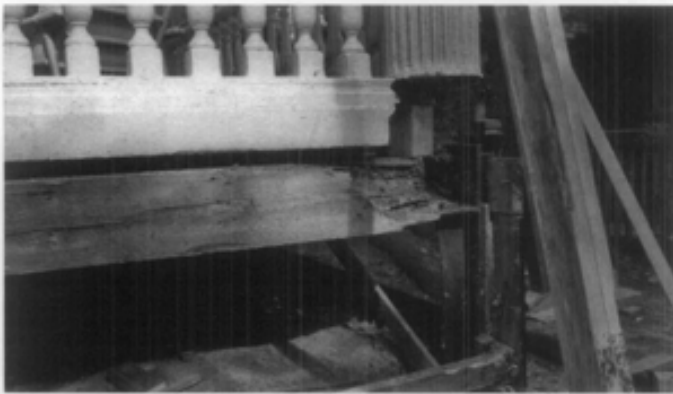
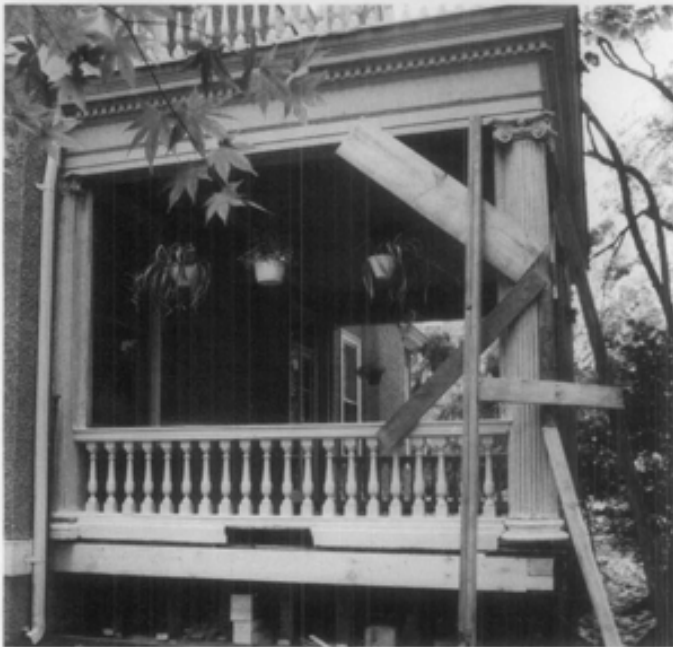
Figure 17. The porch's structural system must be capable of supporting today's loads. In this case moisture led to the deterioration of the wood girder at the corner, creating a major structural deficiency (top). A new solid timber was installed to replace the girder (middle); alternatively a built-up girder could have been used since a fascia board would conceal it. The column base was repaired and portions replaced and the balustrade and column reset and secured (bottom). Photos: Paul Marlowe, Marlowe Restorations.

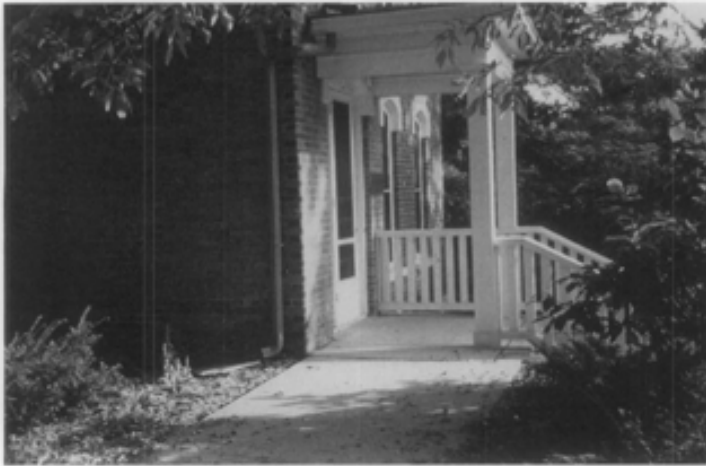
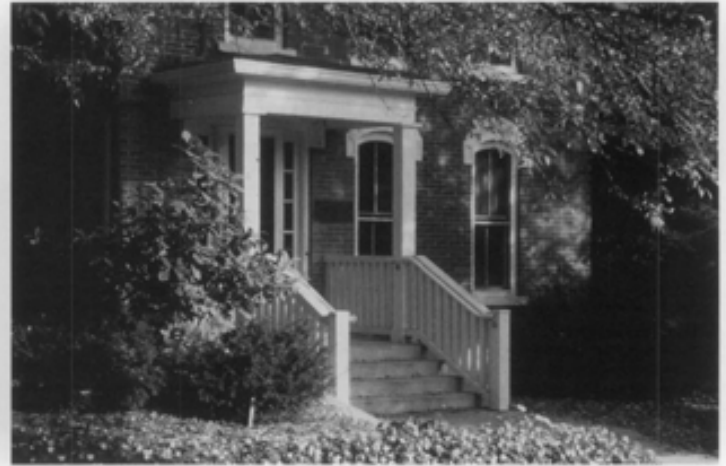
Figure 18. When a porch is used as a wheelchair accessible entrance, it may be possible to retain the historic stairs by adding a ramp parallel to the building. Through plantings and some re-grading, the new ramp built parallel to the building (left) allows retention of the historic stairs and does not impact the historic character of the entrance (right). Photo: Iowa State University Extension.

entrance alternative. It may be possible to retain the historic stairs by adding another entrance to the porch with the construction of a ramp parallel to the building (Fig. 18).
