Fort Davis National Historic Site, Texas

CULTURAL LANDSCAPE STUDY

Landscape History, Statement of Significance,  
Documentation Package

November 2000

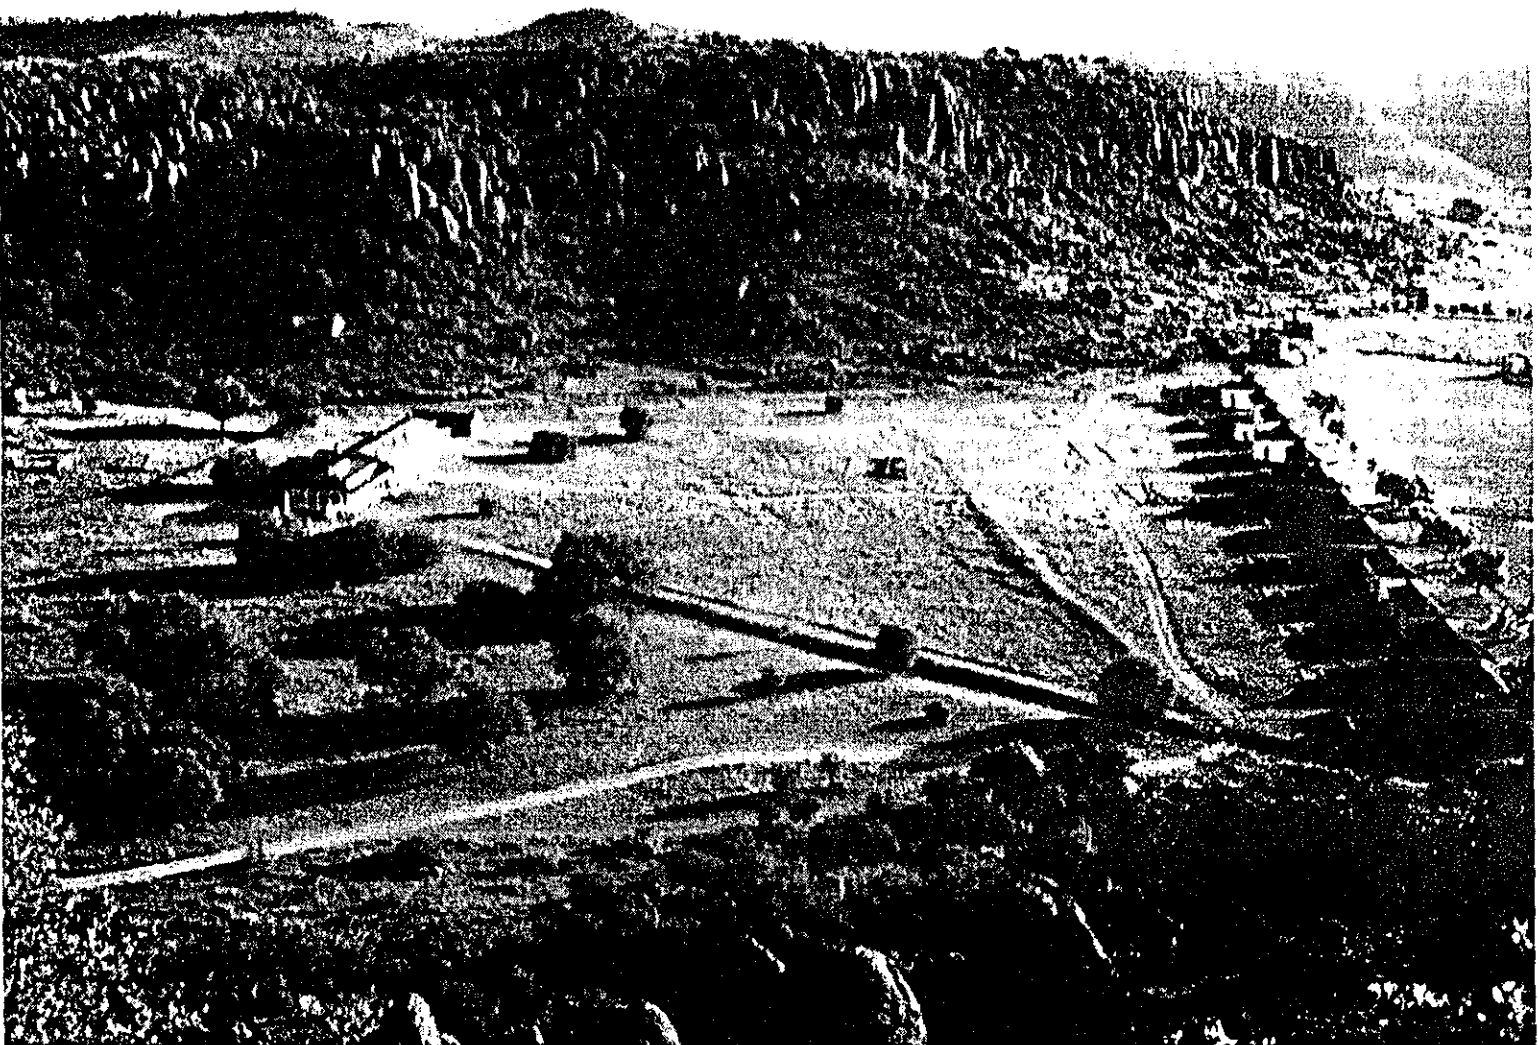
Figure 20. Photograph. Remnants of Hospital Canyon drainage system. 1999 (Source: Author)

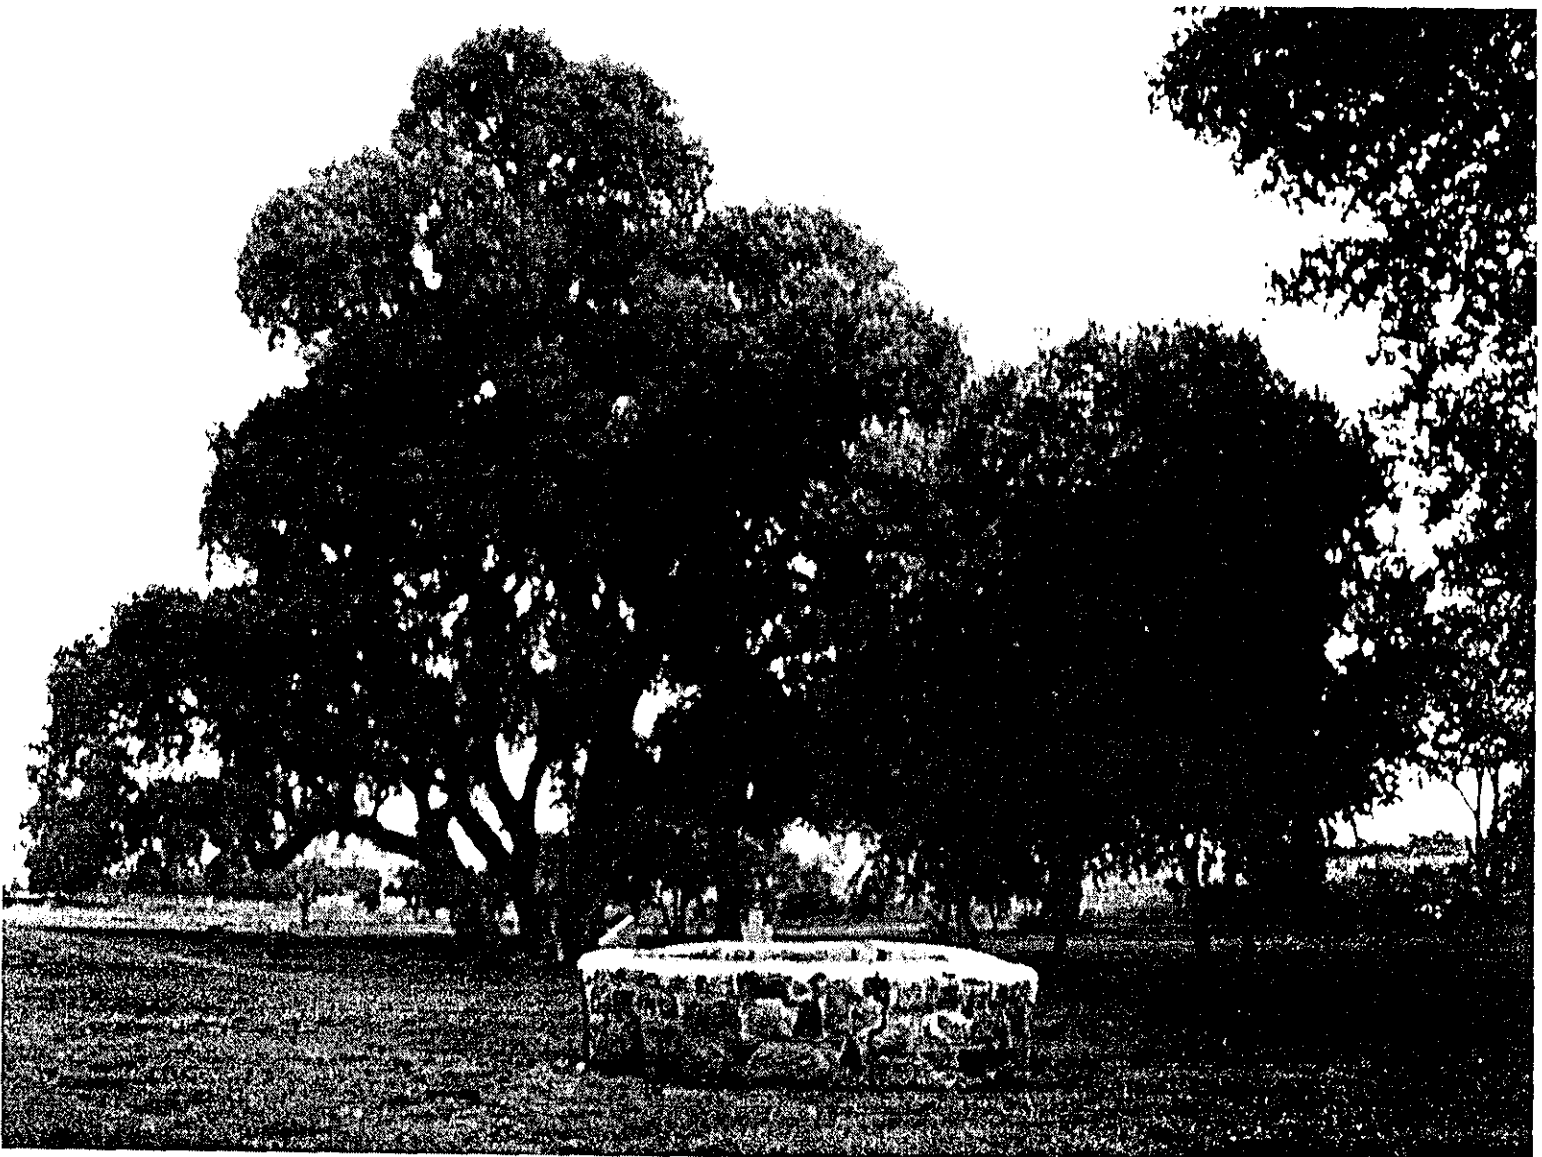
Figure 21. Photograph. Cottonwood grove and spring enclosure. 1999 (Source: Author)

In the area of the spring and historic cottonwoods, remnants from the second fort period include irrigation ditches and a circular masonry wall around what was the spring (see Figure 21). The Park Service has added modern picnic benches to this cluster of features.
