## Cultural Landscape Report

# FORT LARNED

NATIONAL HISTORIC SITE • KANSAS

MAY 1999

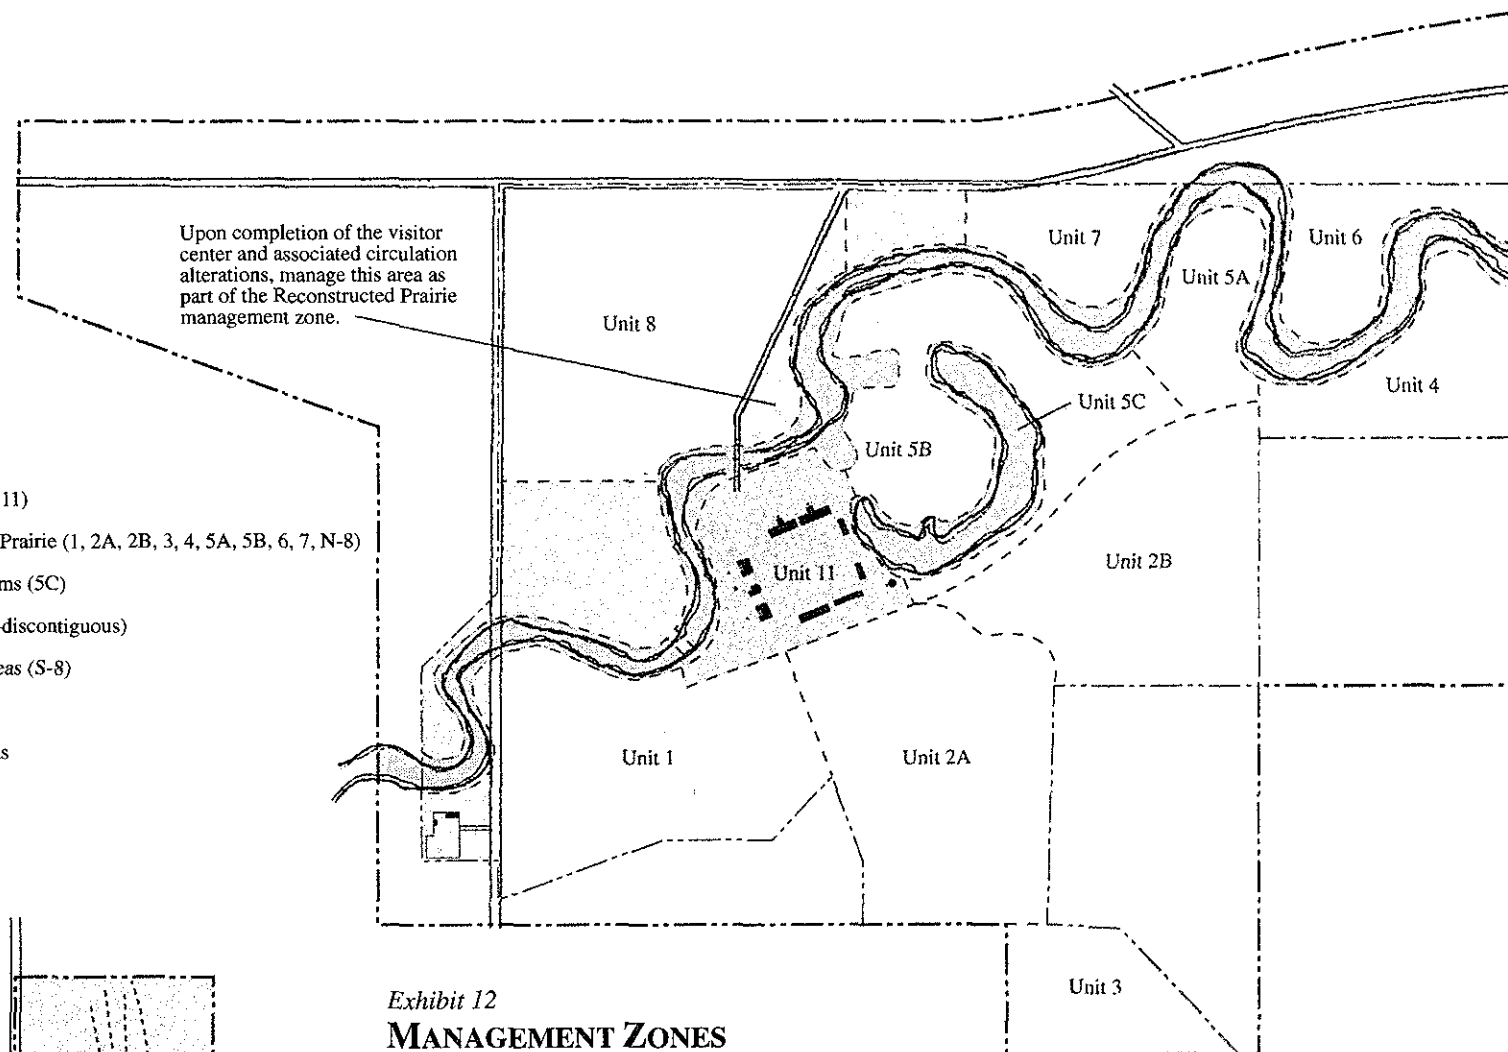
Exhibit 12  
MANAGEMENT ZONES

Upon completion of the visitor center and associated circulation alterations, manage this area as part of the Reconstructed Prairie management zone.

Seven cultural landscape management zones within the NHS have been identified to serve as the basis for implementing the CLR treatment recommendations. Recommendations address specific issues related to the historic core, reconstructed prairie, Pawnee River and oxbow corridors, the Trail Ruts unit, visitor use areas, maintenance area, and adjacent easement properties. Recommendations for each of these areas as well as the entire NHS have been organized by related concerns such as buildings and structures, circulation and parking, vegetation, site furnishings and objects, signage and interpretation, viewshed protection, utilities and site management, special events, and future research needs. While most of the recommendations can be implemented as funds become available, a few require additional research before determining a final course or scope of action. Other recommendations—particularly those related to circulation alterations and improvements—are dependent upon completion of the new visitor center, currently planned for construction on the north side of the Pawnee River; collectively such recommendations constitute a second phase of implementation.

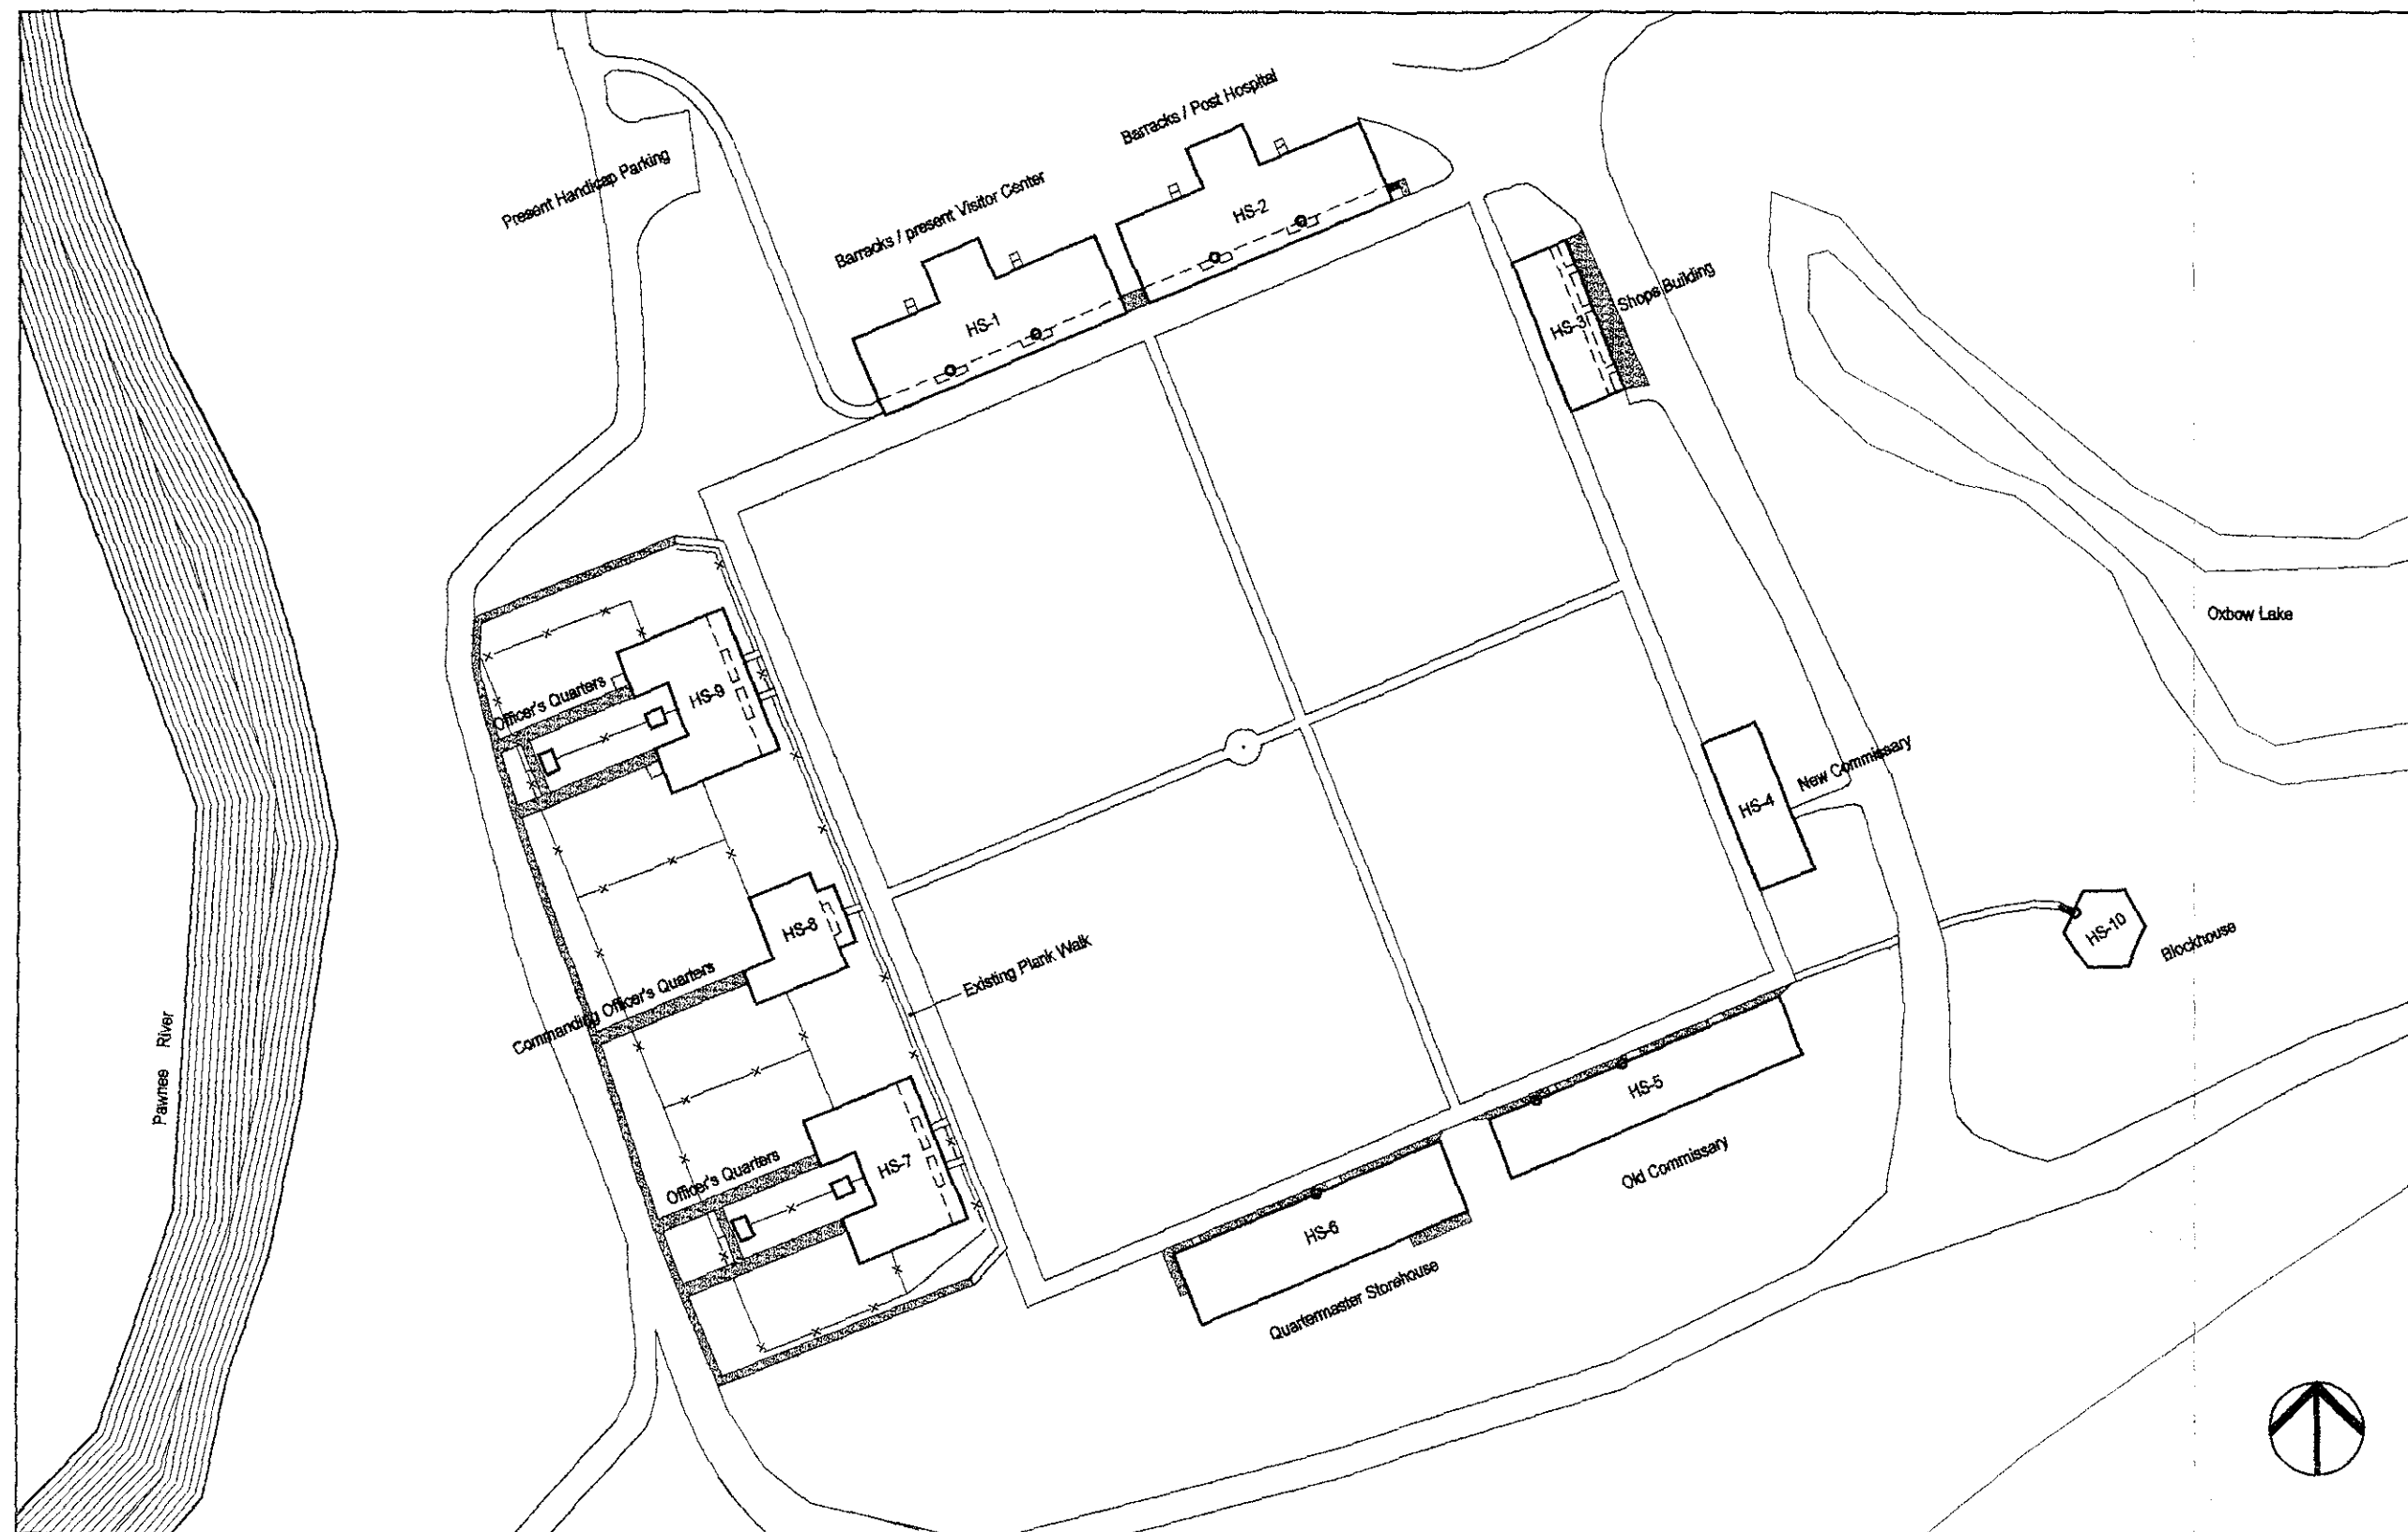
This Key Map  
shows the general location of proposed additions for universal access and  
is not to scale

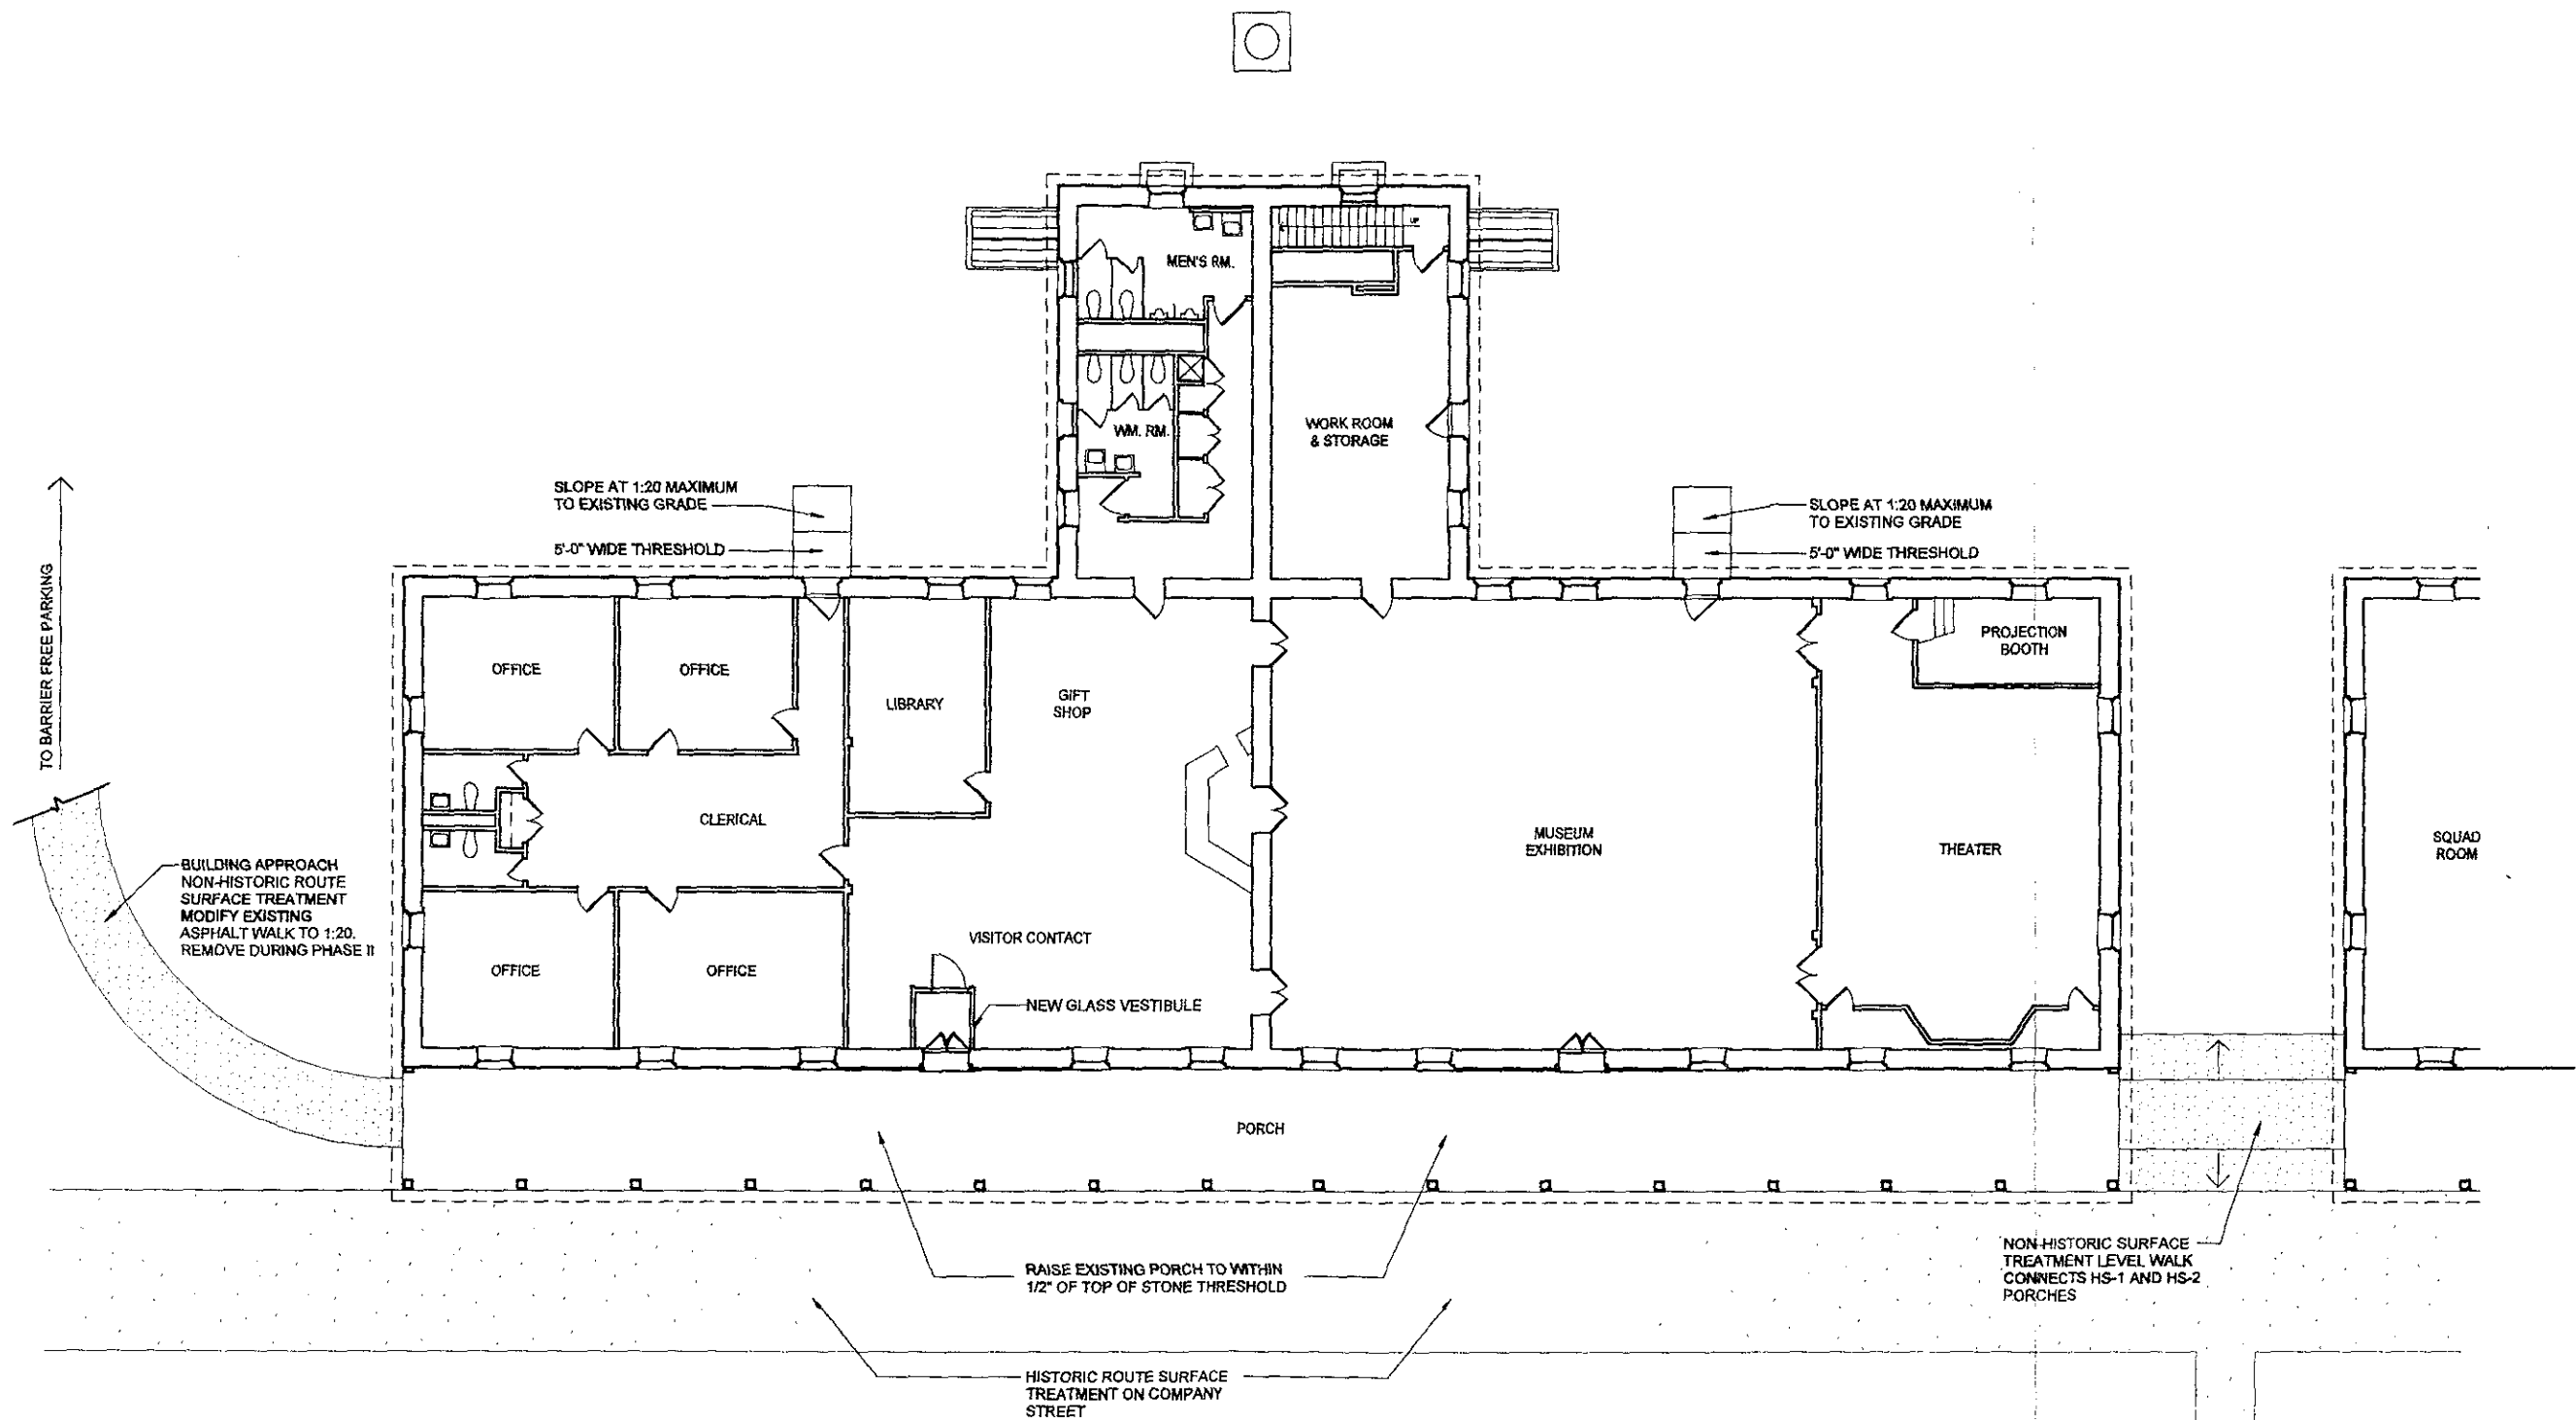
*Exhibit 15b / Recommended Treatment*

FIRST FLOOR PLAN

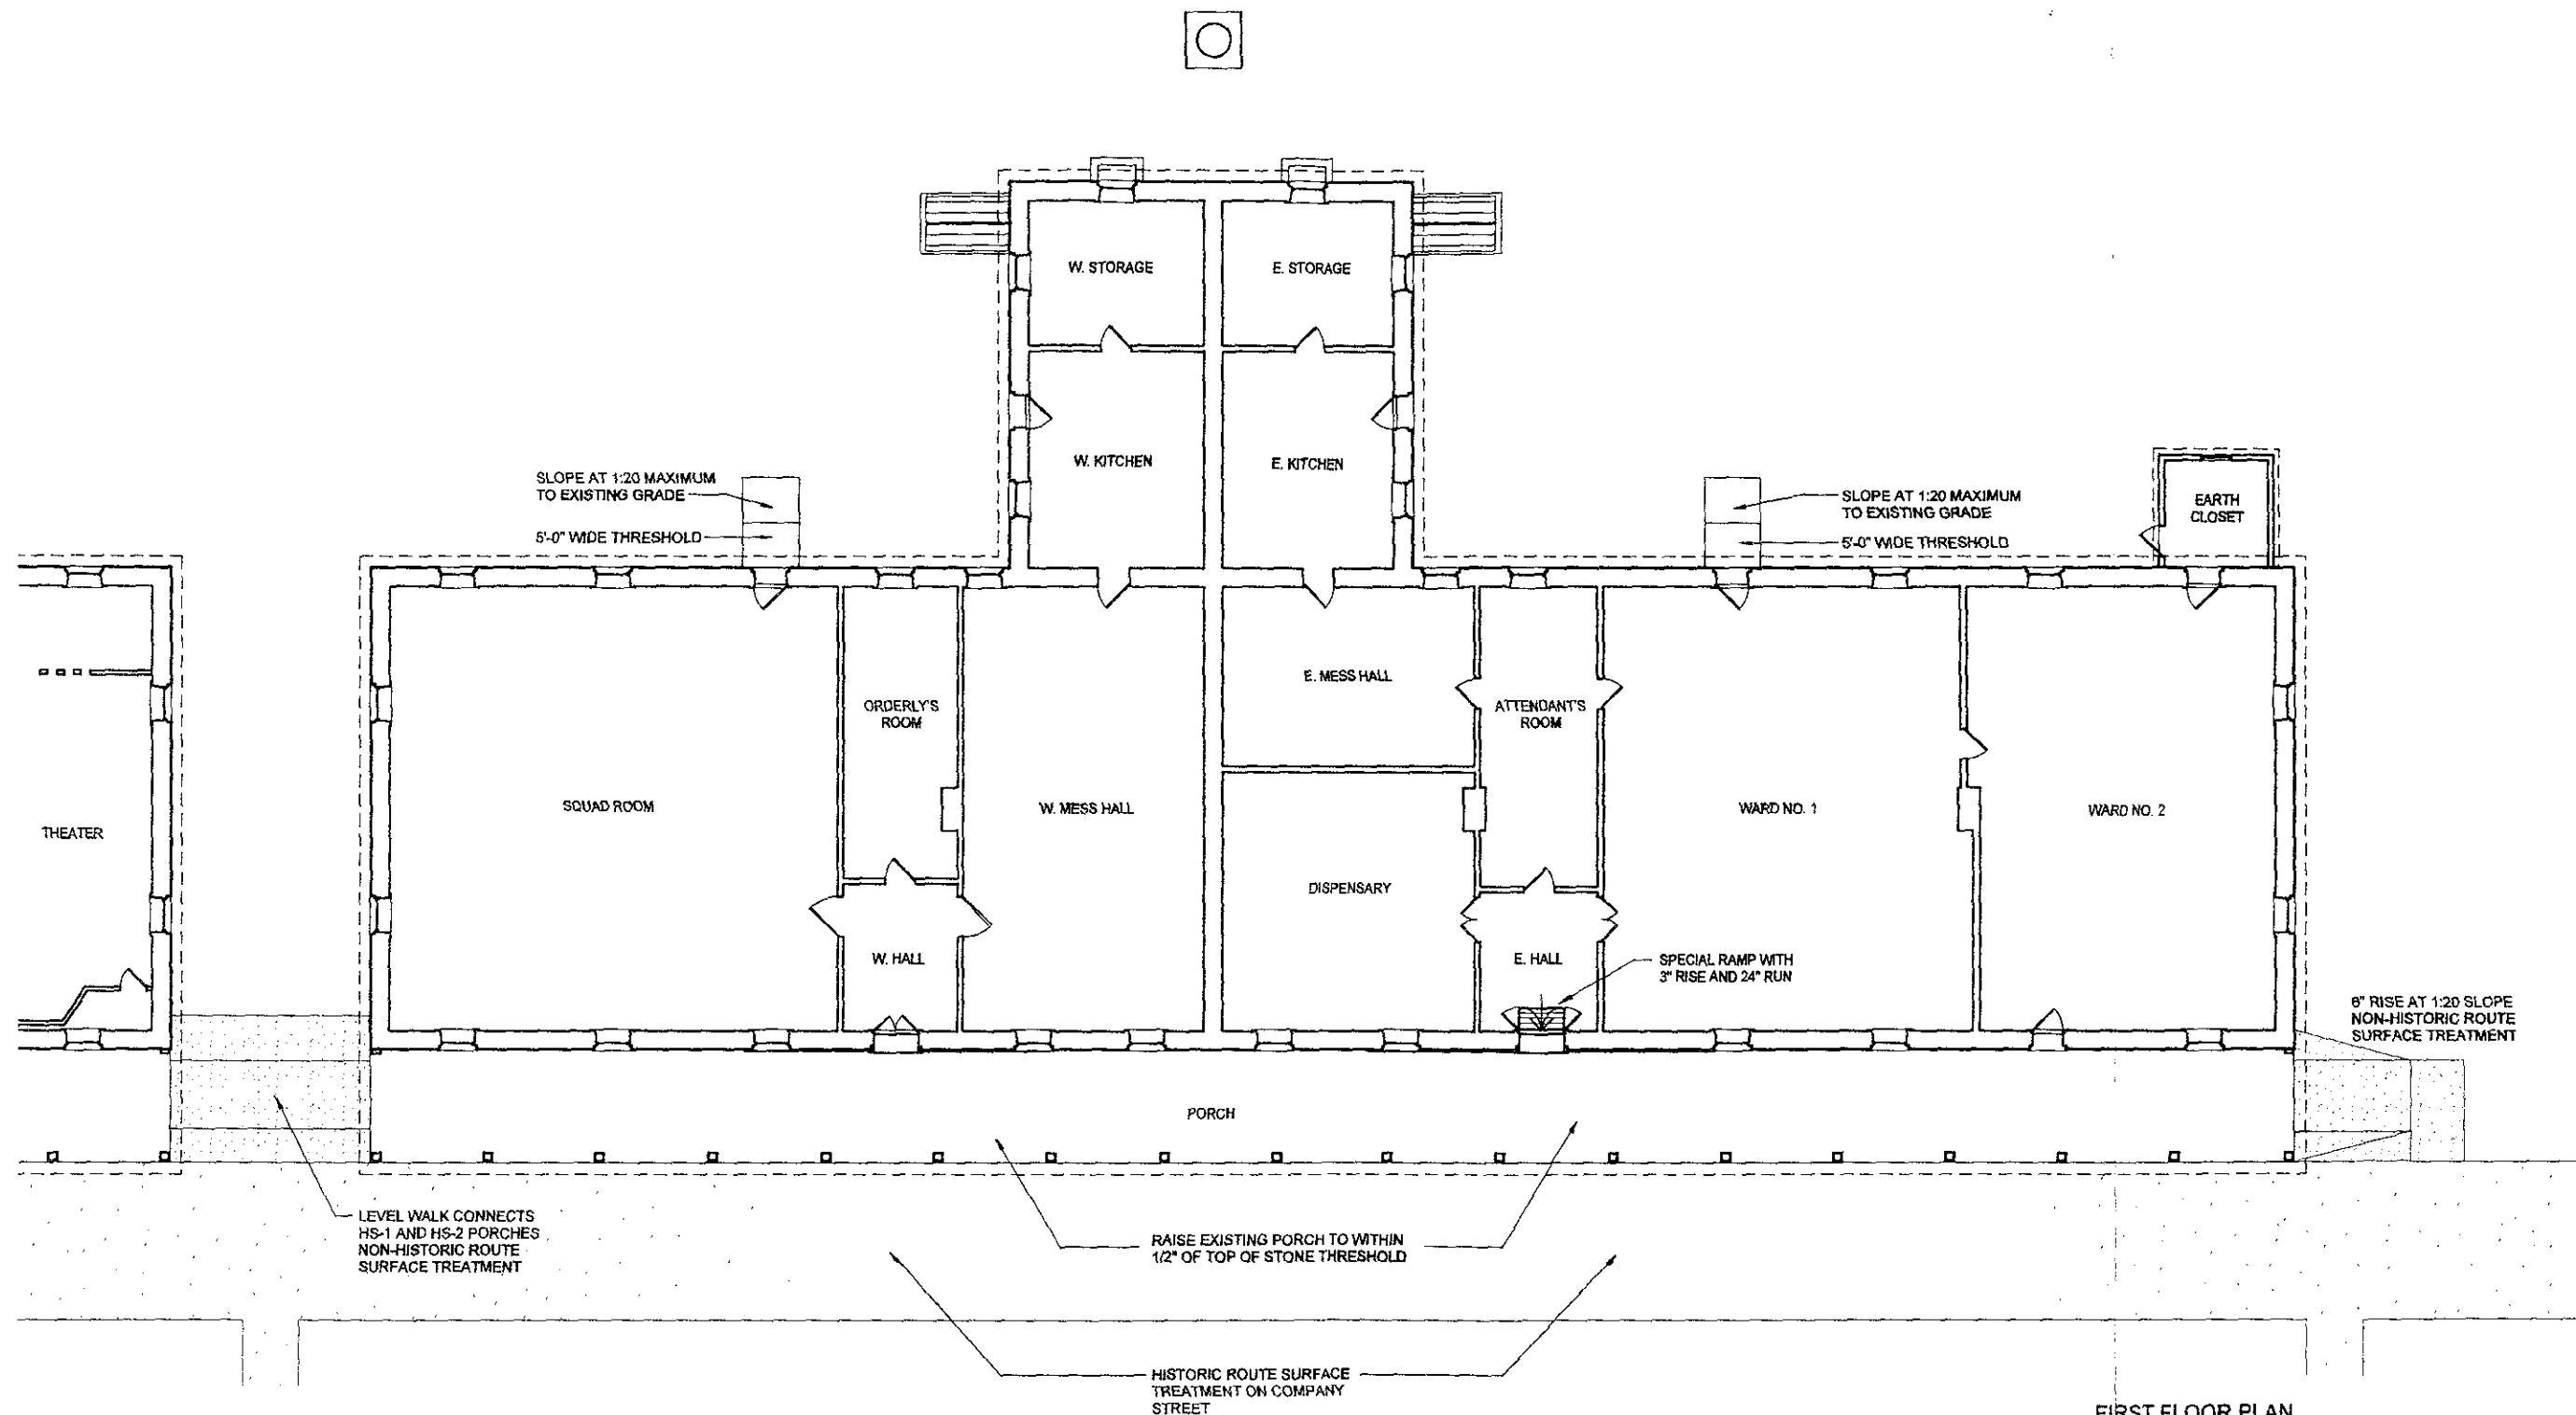
Exhibit 15c / Recommended Treatment

FIRST FLOOR PLAN

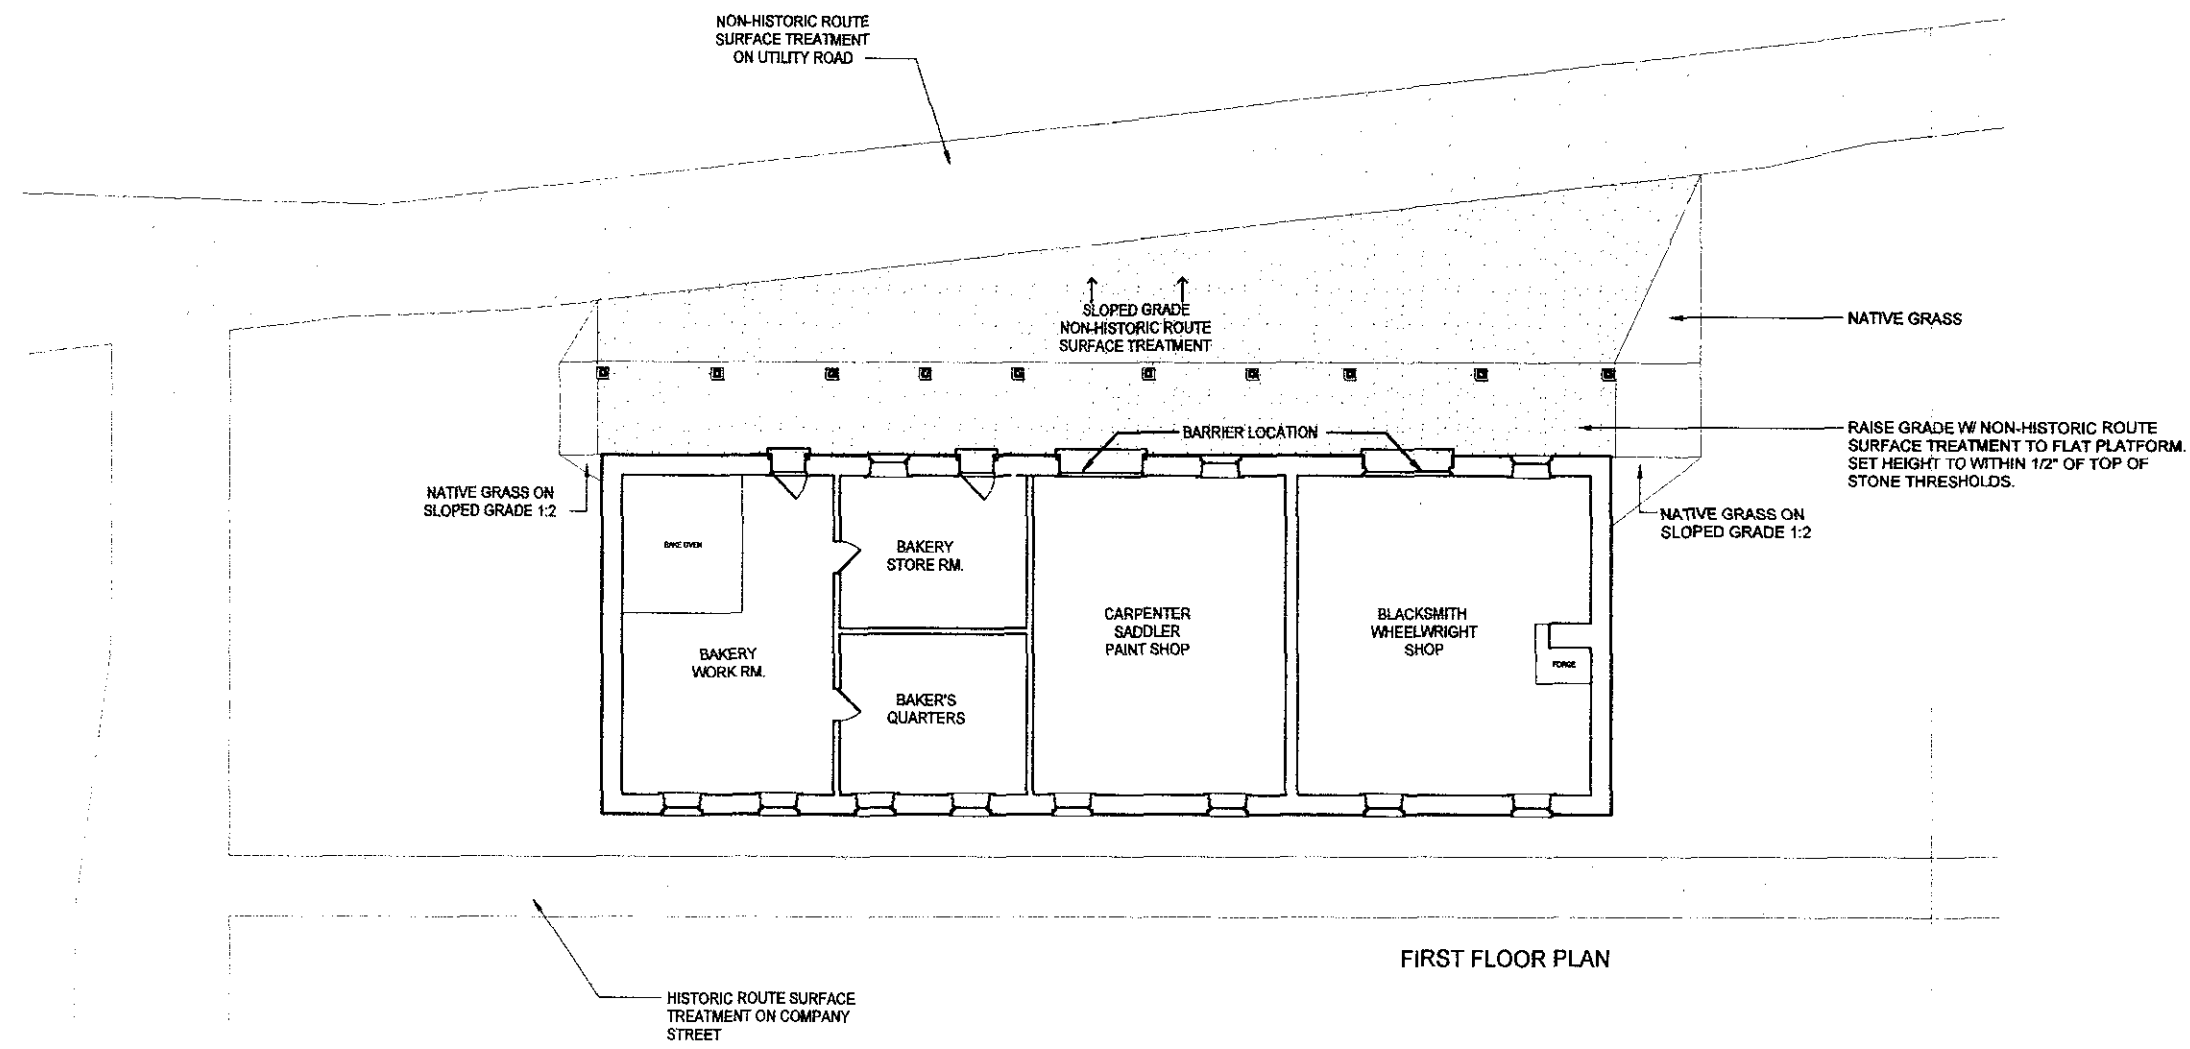
Exhibit 15d / Recommended Treatment

FIRST FLOOR PLAN

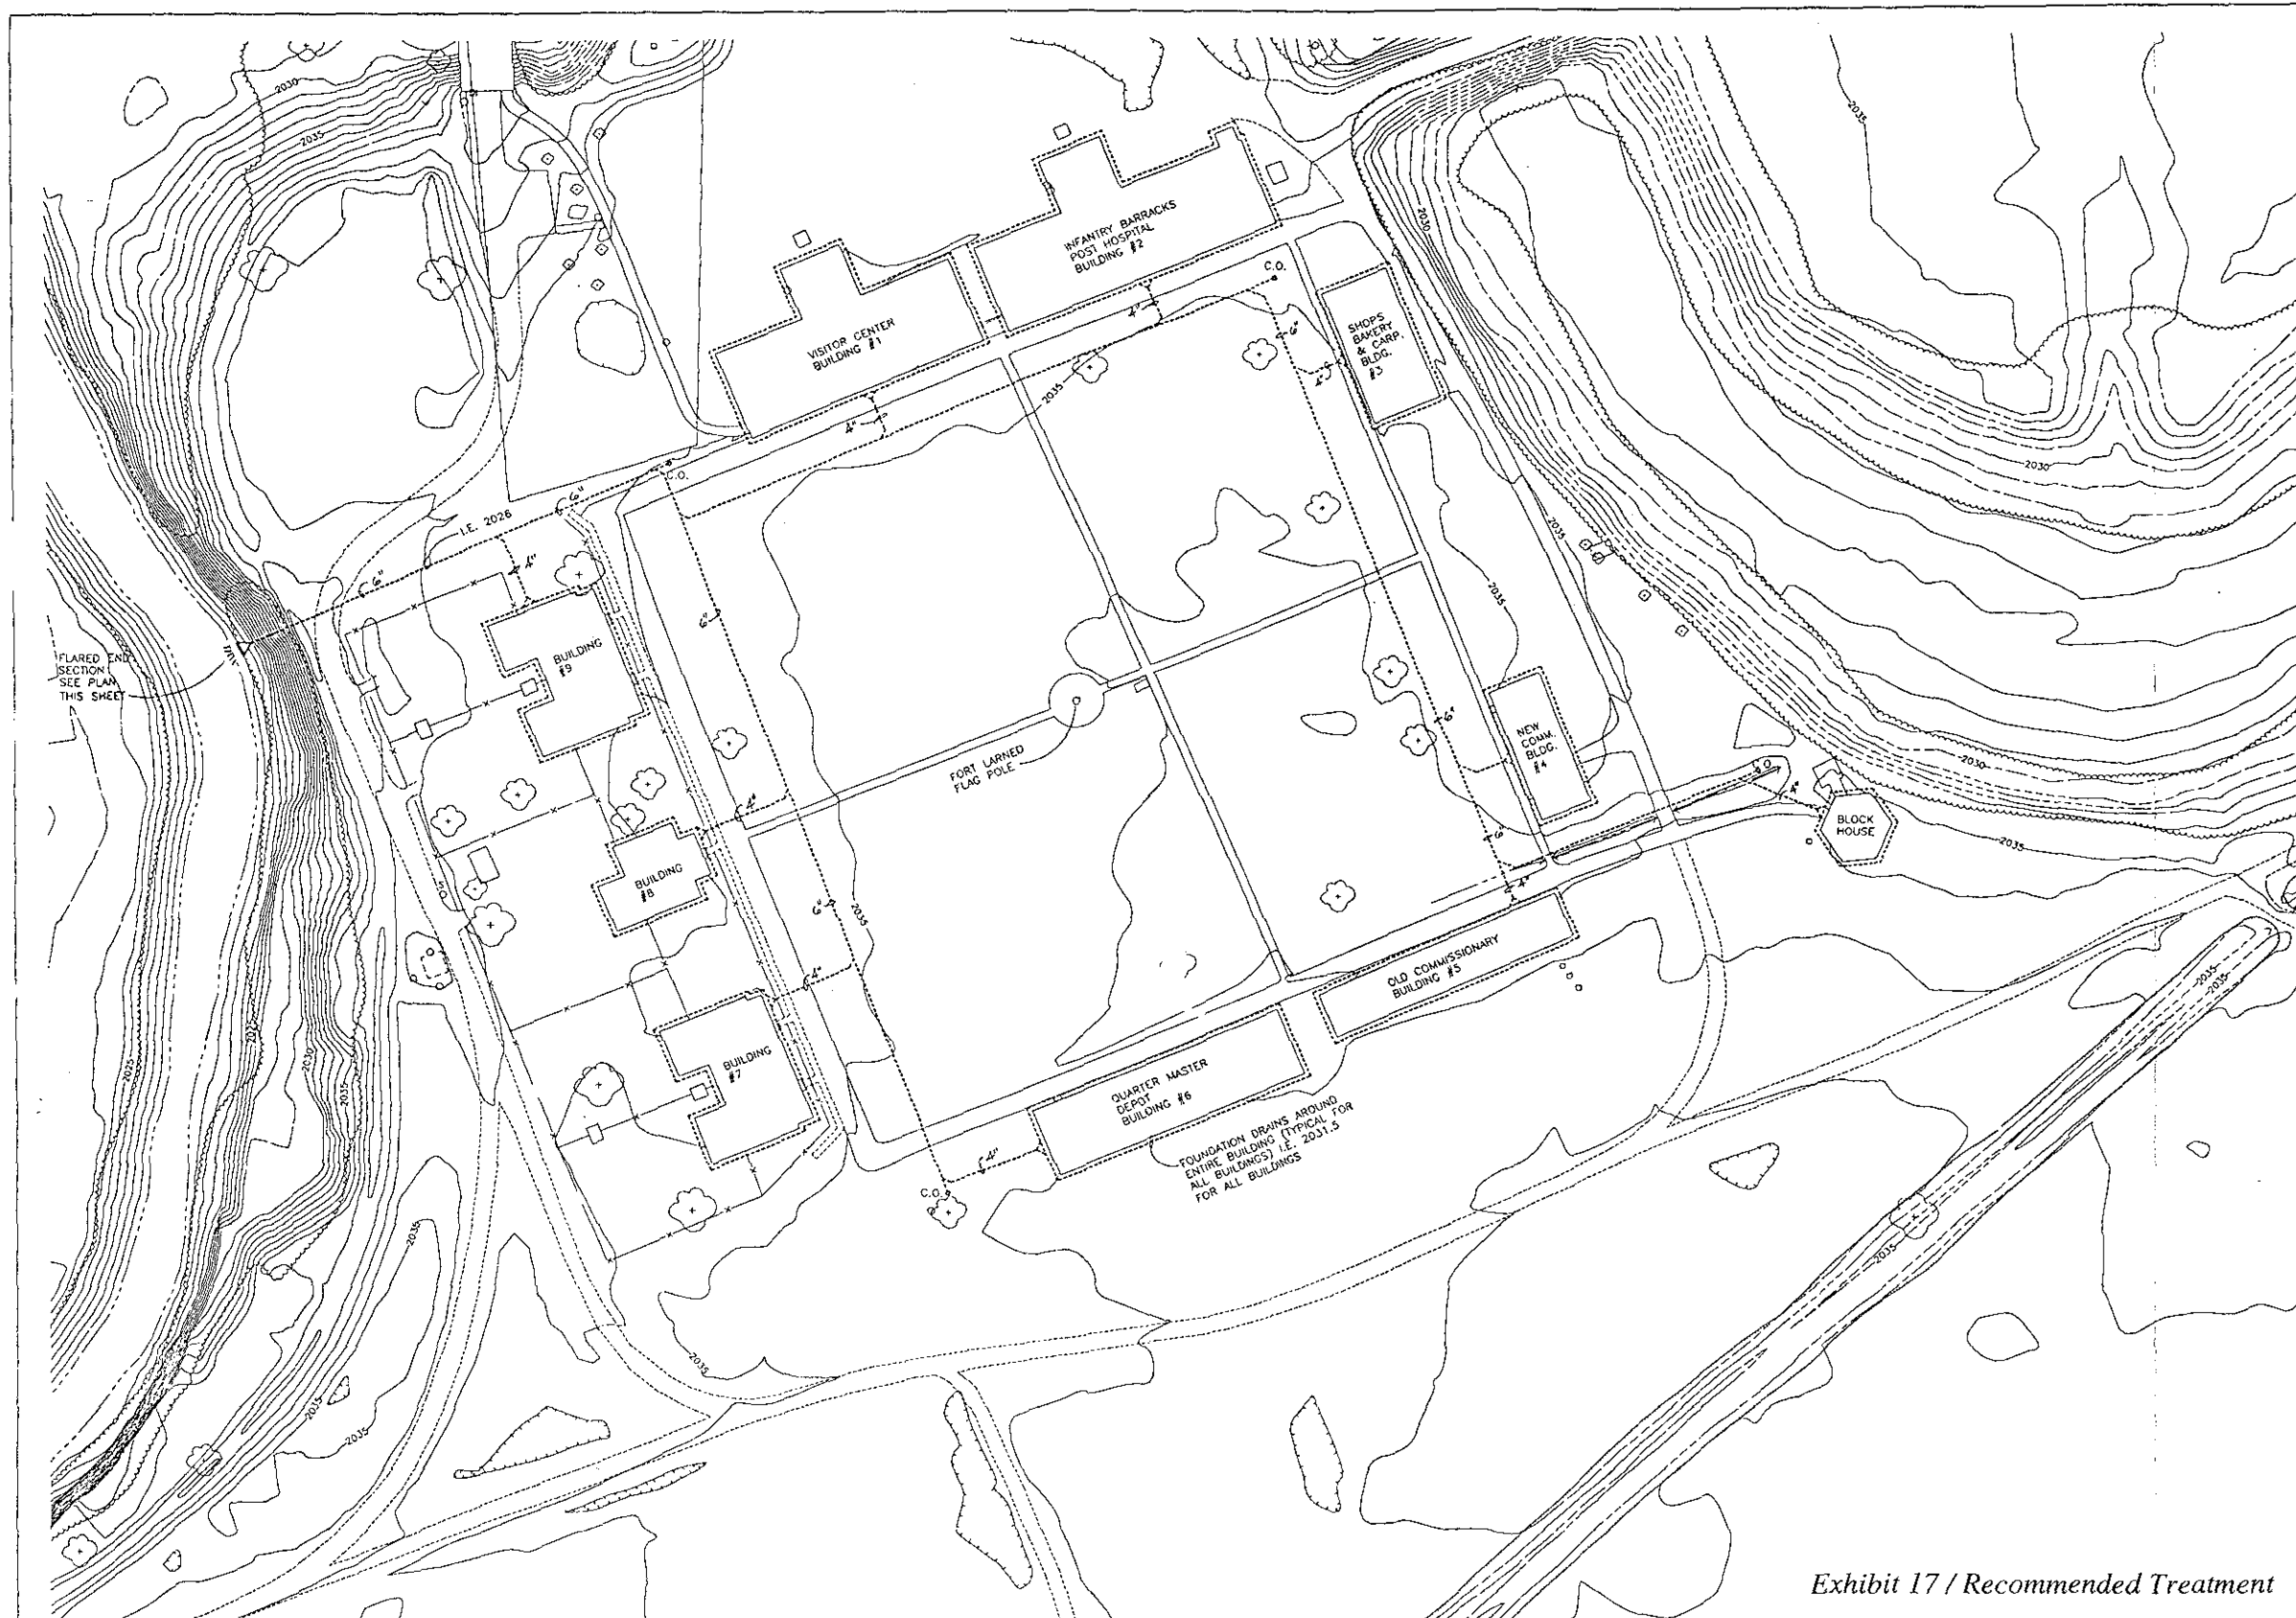
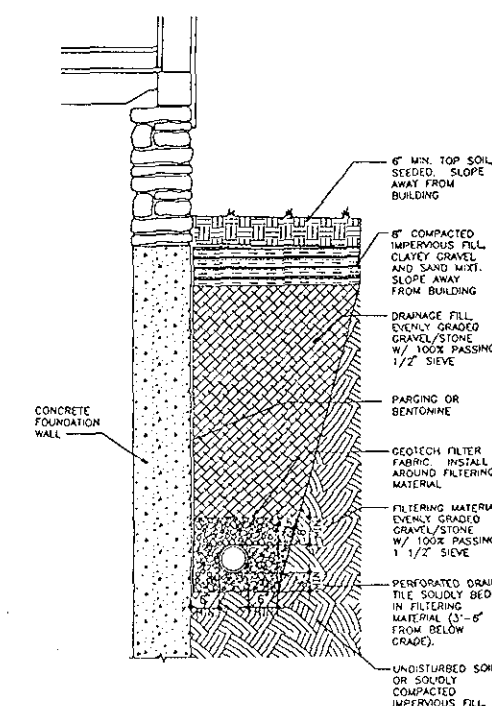
Exhibit 17 / Recommended Treatment

FLARED END SECTION  
NO SCALE

FOUNDATION DRAIN DETAIL  
@ CONCRETE WALLS  
NO SCALE

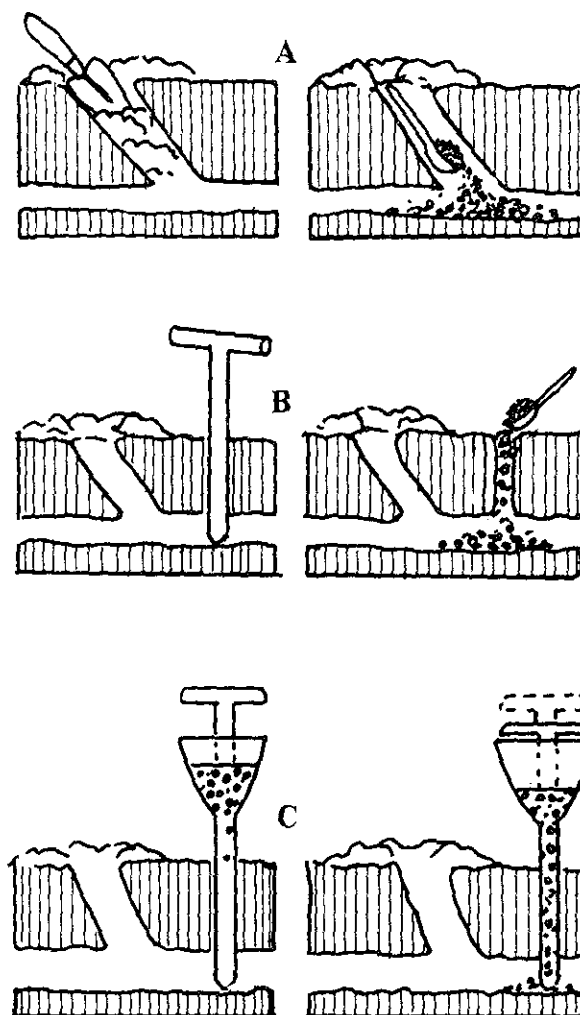
**Figure 5. Methods of applying gopher bait by hand or with a probe.**

(A) Hand application: remove plug in tunnel, starting from gopher mound. Place quantity of bait into main tunnel with a long-handled spoon. Seal tunnel with sod, taking care not to cover bait with soil.

Bait can be placed through the probe hole into the tunnel. A reservoir-type bait probe dispenser is also available for poisoning gophers (Figure 5). A button is pushed on the bait probe when it is pushed in the burrow and a metered dose of bait drops into the burrow. Place the recommended amount of bait down each of 2 or 3 probe openings and then cover the probe holes with sod.
