TURNING THE CORNER:  
THE LANDSCAPE HISTORY OF THE ADMINISTRATION BUILDING  
HOT SPRINGS NATIONAL PARK

Laura Soullière Harrison  
Architectural Historian  
Hot Springs National Park  
January, 1990

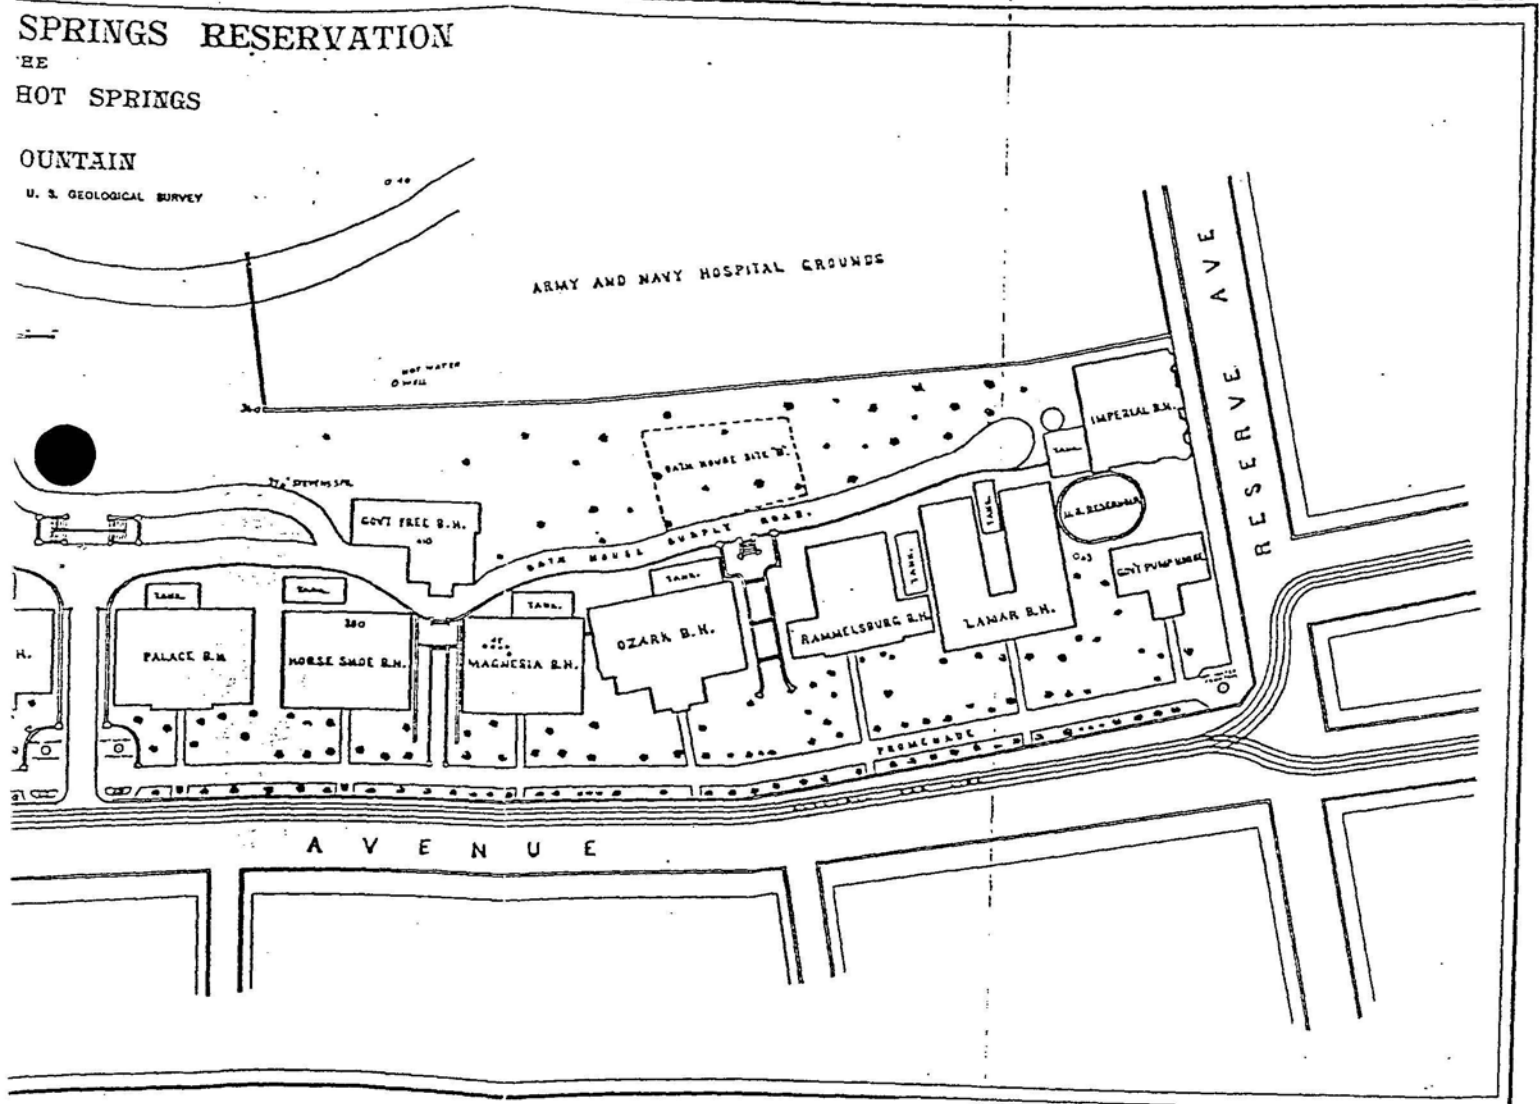
In this 1902 map, the government pump house occupied the corner of Central and Reserve Avenues close to the sidewalk on Reserve. The Noble Fountain, at its original location, occupied the polygonal site at the corner. The streetcar railway serving the train station to the south of the Reservation turned the corner at the site. Beginning in 1989, the federal government used this corner for visitor information.

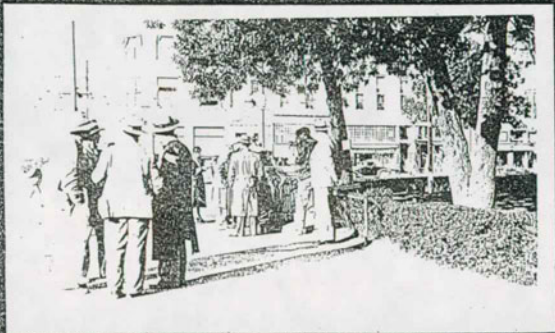
In this photograph taken prior to the construction of the new Administration Building in 1935-36, the edge of the planted landscape wrapped around the north side of the Noble Fountain. Following construction of the Administration Building, the sidewalk expanded toward the base of the magnolia trees.

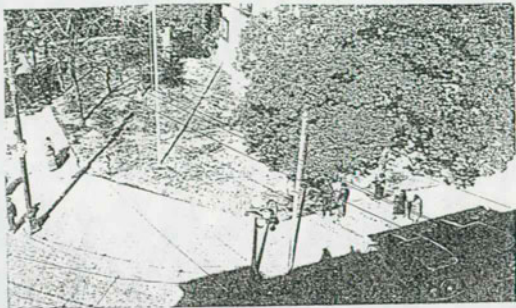
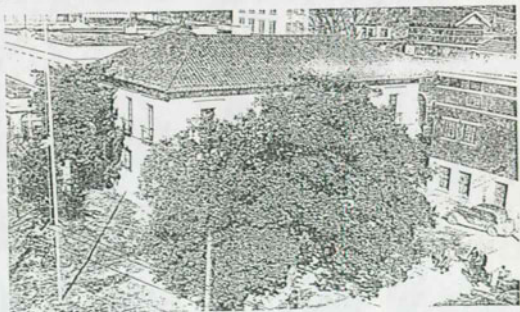
The National Park Service moved into its new Administration Building in the spring of 1936. These photographs accompanied construction completion reports. When they were taken, the landscaping work at the site had not begun. The flagpole was in place, and the grassy boundary extended partially around the base of the Noble Fountain. The scar of the former sidewalk leading from Central Avenue to the former building remained visible. The new sidewalk that provided access to the Administration Building followed the same path as the old. In other words, people had been walking down that short path to an information mode since 1898 -- the time that the Department of the Interior first began providing onsite information.

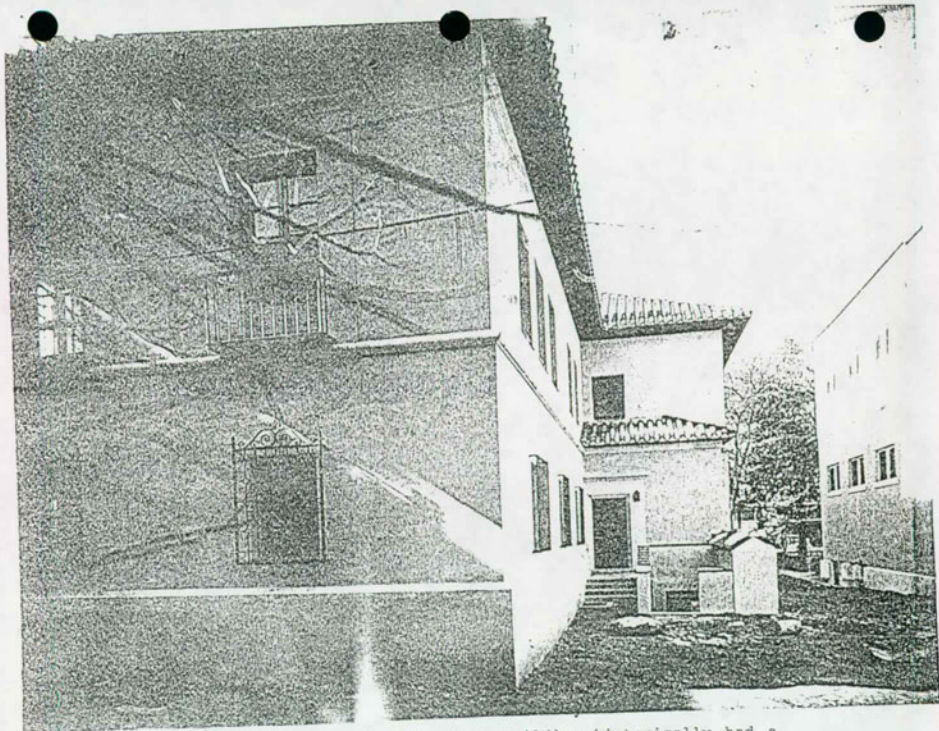
The rear of the new Administration Building historically had a lower grade. Four steps provided access to the back door of the building.

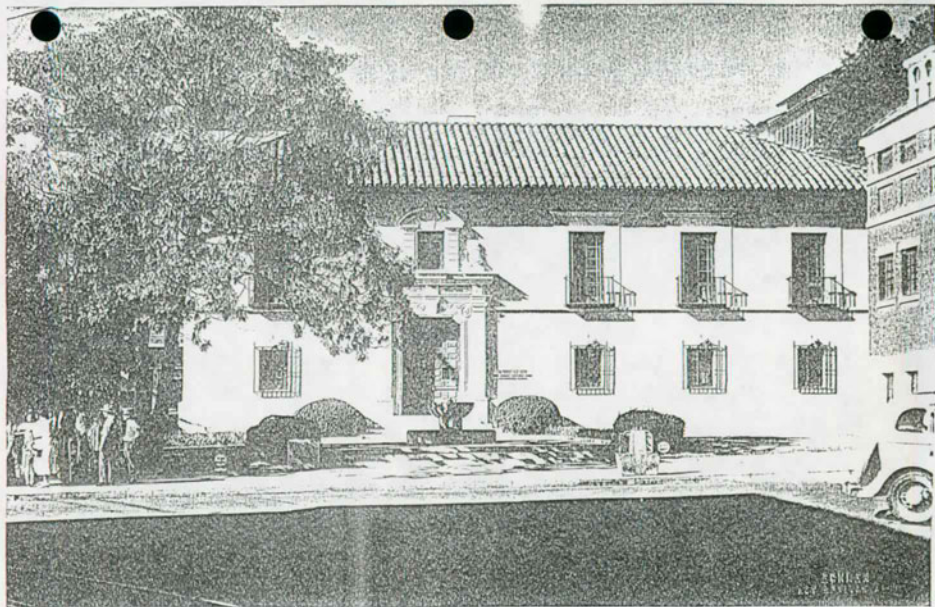
In this 1936 photograph, the designer's use of foreground, middleground, and background in the landscaping is evident. The low foreground includes the jug fountain at the street, the Noble Fountain, the paved sidewalk, and the curb. The middleground includes the fountain plaza, hedges, and round shrubs marking key edges. The background is the building. The Imperial Bathhouse is on the right side of the photograph.

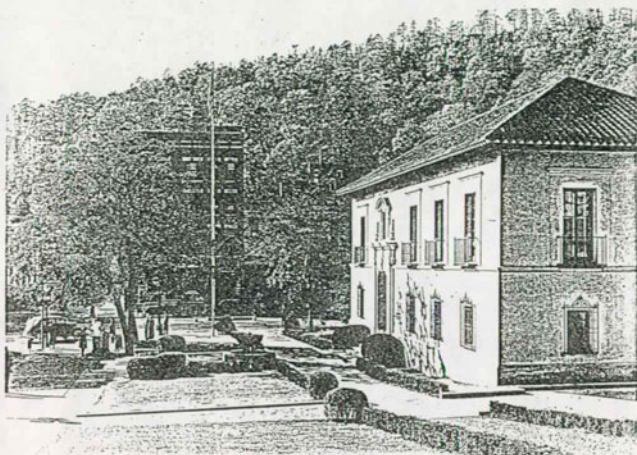
In this photograph, circa 1939, the landscaping for the temporary design solution for the south end of the Promenade was completed. The opposition of Secretary of the Interior Harold Ickes to the construction of a formal promenade delayed work on it for two decades.

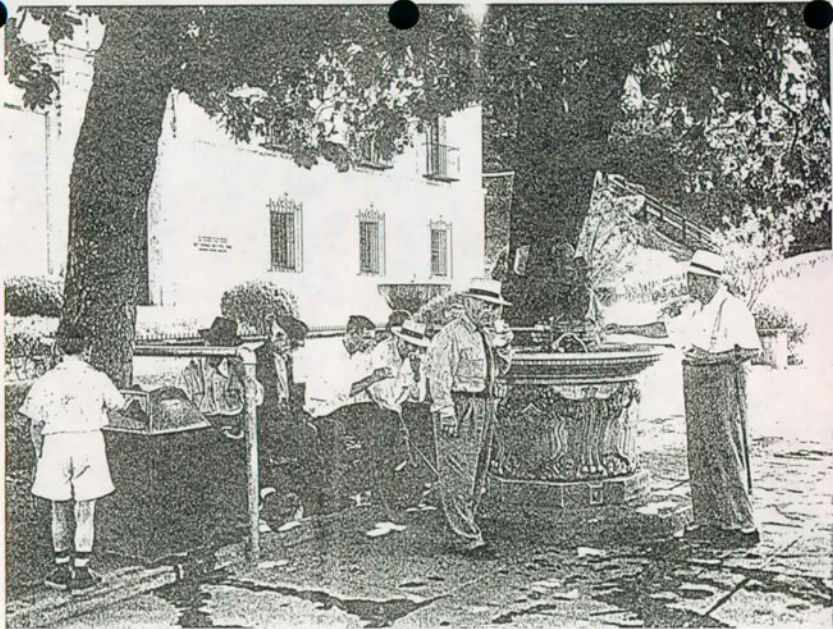
In 1952, people using the Noble Fountain often rested on the bench between the two magnolias. The pipe railing had spikes to discourage fence-sitters and to control access to the grass behind the bench. At this time no ivy had been planted.

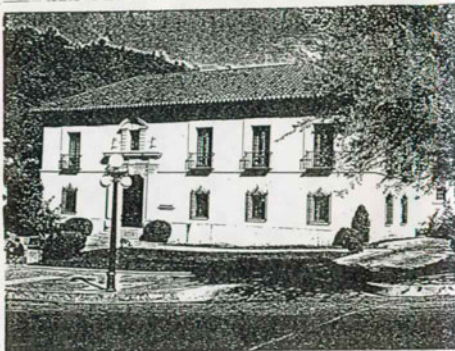
In 1952, the jug fountain (not visible in the photograph) sat at the edge of the curb. The walkways had no hedges bordering them. All of the walkways were paved. The tufa boulders were in evidence by this time. Some vegetation grew at the southeast corner of the building where none had been planted earlier.

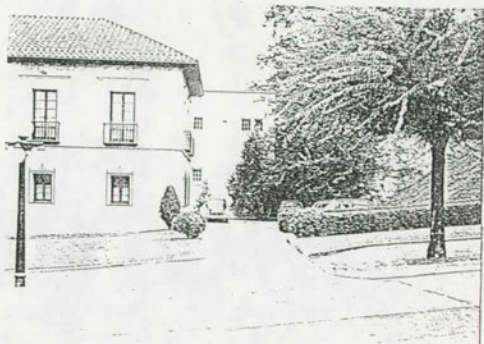
In 1952, the parking lot was quite small. The light pole adjacent to the curb was a target for cars, so the park safety committee had it moved. Vegetation between the parking lot and the Lamar Bathhouse had taken hold. The landscape design along the front elevation was simple and formal.

- 1953 The park safety committee recommended that the light pole adjacent to the jug fountain "be moved back onto the walk approximately one foot or that a guard rail be put around it. This pole is always being hit by a car and one or more of the large light globes knocked off" (File A7619, Safety Meeting Minutes, 1943-53, January 9, 1953).

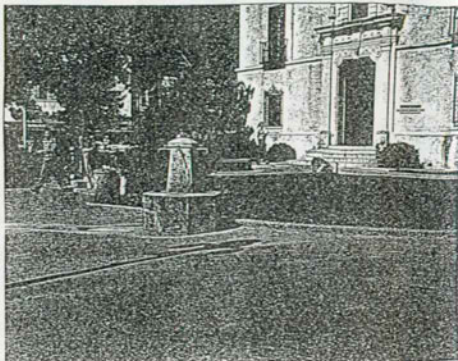
In this photograph, taken between 1952 and 1957, the jug fountain has been moved back toward the curb bordering the Administration Building lawn. A tufa boulder marks the corner of the sidewalks adjacent to the display fountain. Hedges along those sidewalks no longer exist. A small redbud tree has been planted near the curb adjacent to the display fountain.

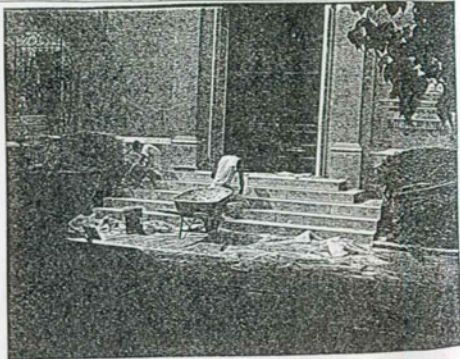
During 1965, the park let a contract to enlarge the steps of the Administration Building. Originally the top step was flush with the inside portion of the base of the pilaster. When the steps were expanded, the top step hit the middle of the pilaster base. Despite this change, the east-west width of the bottom step remained the same. Shortly thereafter, the iron railing appeared on the steps.

- 1960 Old air-conditioning system replaced in the Administration Building (Rhodes, 248).
- 1965 Steps on Administration Building enlarged. Also see the photograph in the Illustrations section.

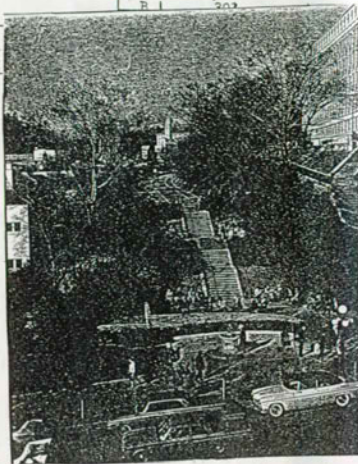
The completion of the south entrance to the promenade in 1957 finally provided a design solution to the long-unfinished project. Although this design varied from the 1930s proposals, some of the elements in the 1957 promenade had been carried over from earlier proposals. Among those are the combination of ramp and stairs, the use of a fountain as a focal terminating feature, and the use of a relatively formal paving surface.

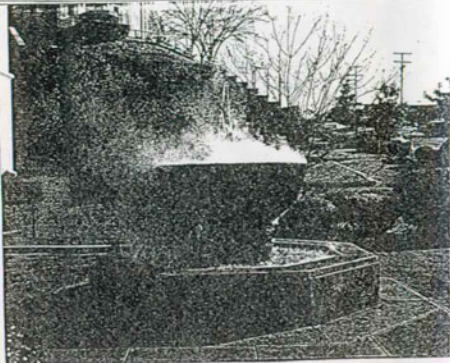
In this 1963 photograph, the hedge along the building foundation is visible. Also of note is the varied concrete pattern: exposed aggregate squares and brushed concrete borders along the curbs.

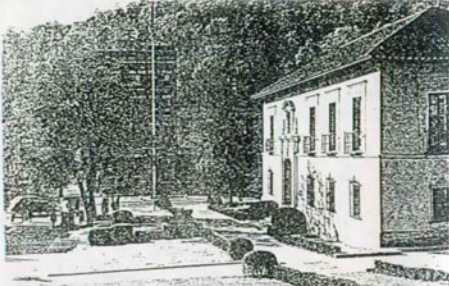
Circa 1952. By this time no change had occurred in paved and gravel walkways. Two of the walkways directly in front of the building no longer had hedges. A bench remained north of the Noble Fountain under the magnolias. The area retained a manicured appearance.

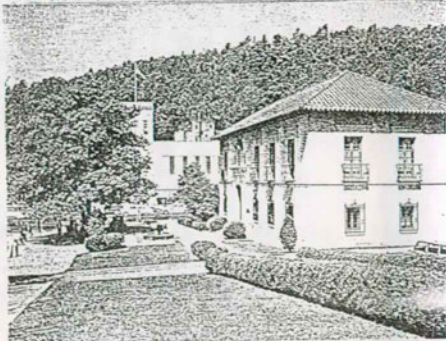
The construction of the promenade in 1957 also brought about distinct changes in the approach to landscape. The bushy shrubs and low trees that were planted started to make the landscape appear less formal.
