Cape Hatteras National Seashore Bodie Island Coast Guard Station Historic Structure Report

2005

Joseph K. Oppermann - Architect, P.A.

2005 Historic Structure Report Bodie Island Coast Guard Station Cape Hatteras National Seashore Manteo, NC LCS#: 07238

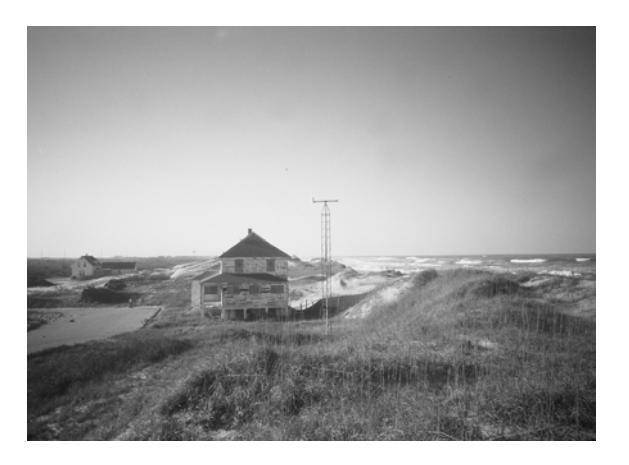
Figure C-1 Station from the south, showing dunes to the east and the relocated 1879 Station to the west

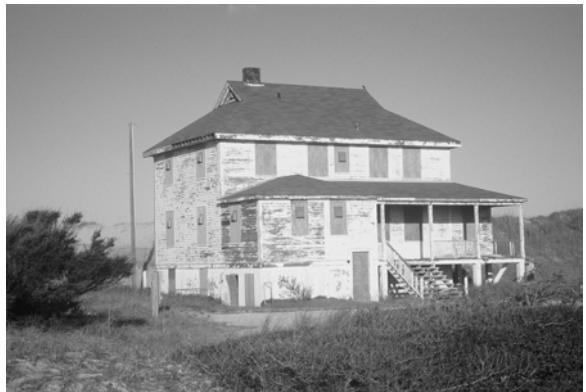
Figure C-2 Station from the northwest

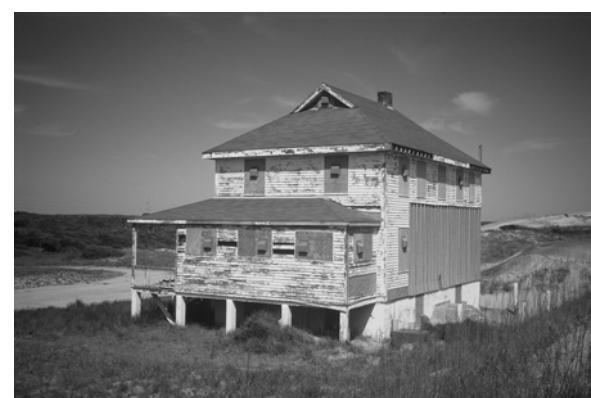
Figure C-3 Station from the southeast

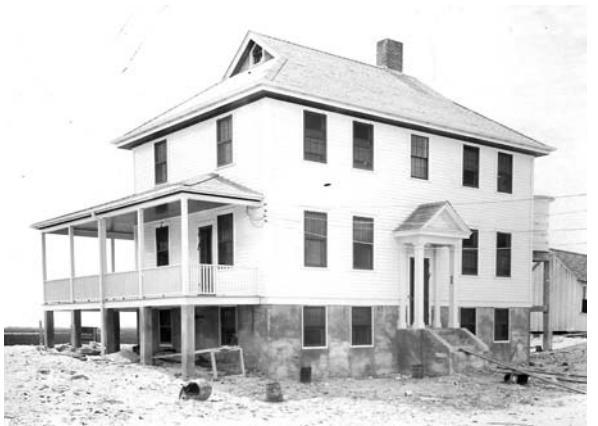
Figure C-6 Early photo of station from the southeast (CAHA)

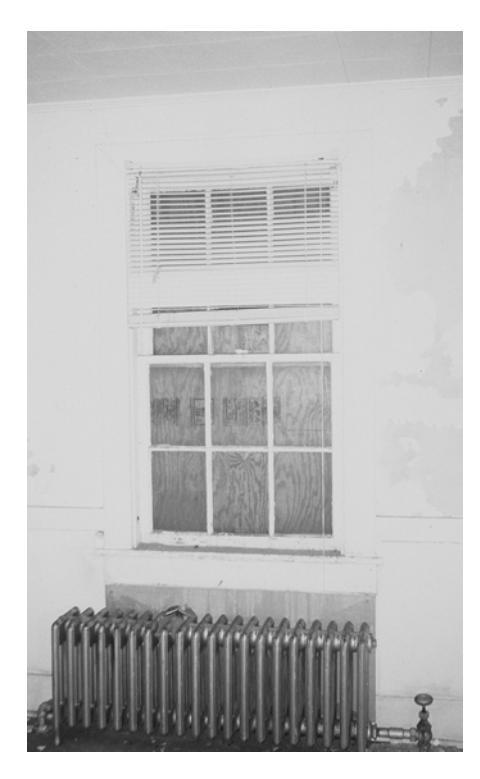
Figure C-7 Six-over-six window and radiator, probably both dating to 1925

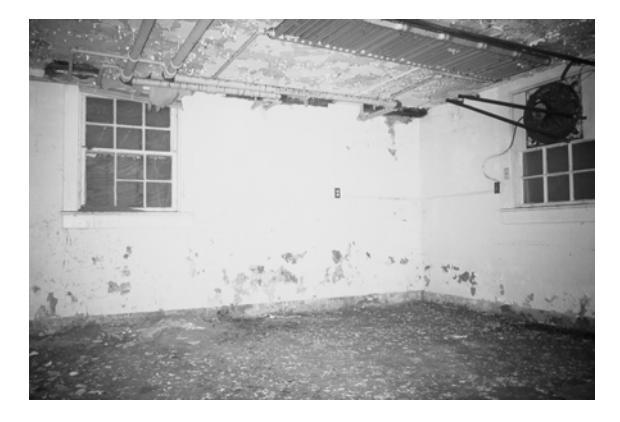
Figure C-9 Southeast corner of Room 001

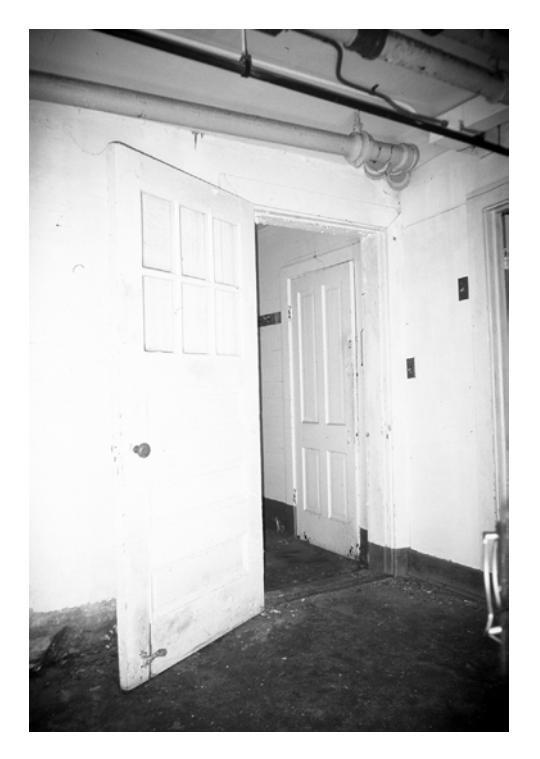
Figure C-10 1933 Doorway leading from the added west stair tower (Room 007)

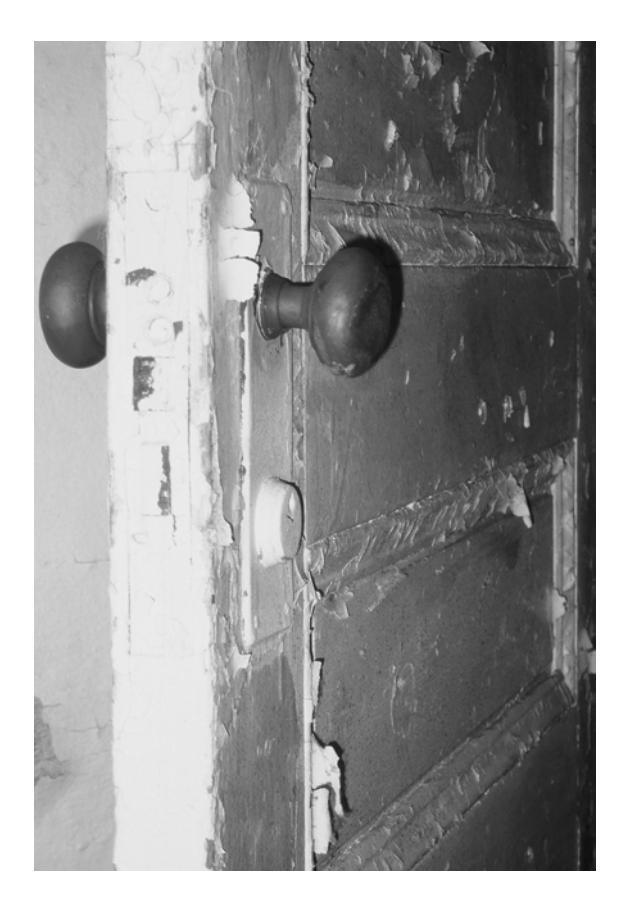
Figure C-11 Early back door's mortise lock

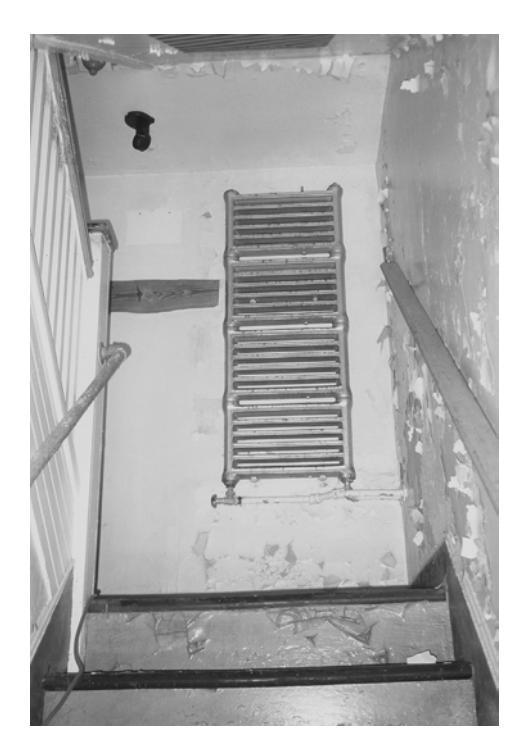
Figure C-14 Landing between first floor and basement

• *Mechanical & Electrical Systems:* Mounted on the east wall of the landing is a 24-fin, 1'-8" x 4'-6" wall radiator. Above the landing is a 1970s-vintage ceiling light missing the globe.

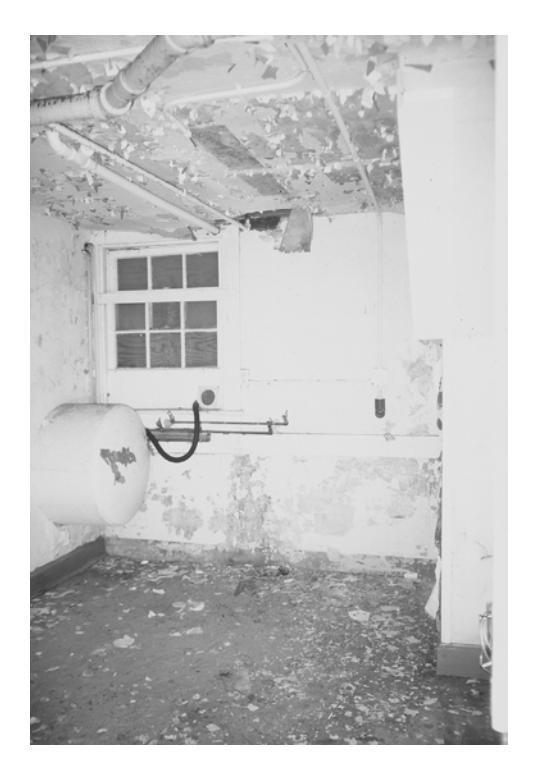
Figure C-15 Tank in Room 003

• *Other Features:* In the northeast corner of the room, part of the metal tank from the adjacent room is visible.

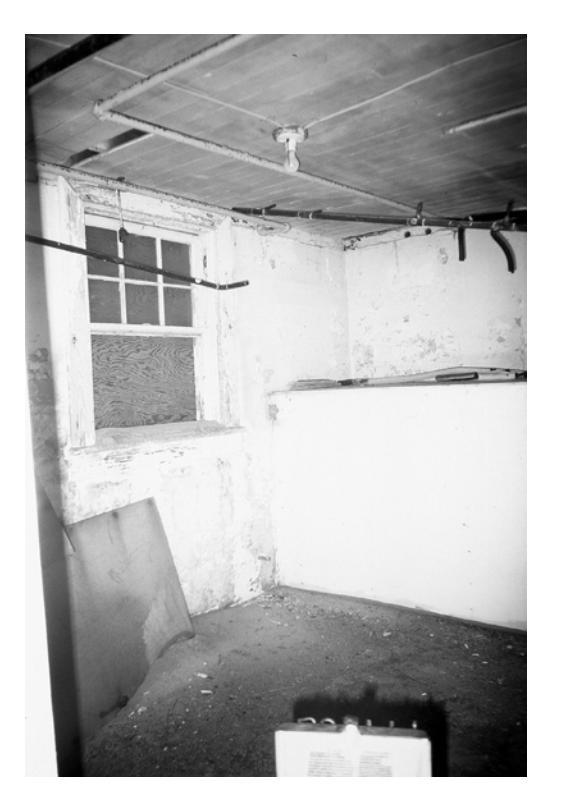
• *Windows:* The room's one window, a six-over-six light window with Type M-1 muntins, is on the north wall and has the original 1925-vintage Type C-1 casings. Its

Figure C-16 Northeast corner of Room 004

bottom sash is missing all three muntins and all of its panes of glass.

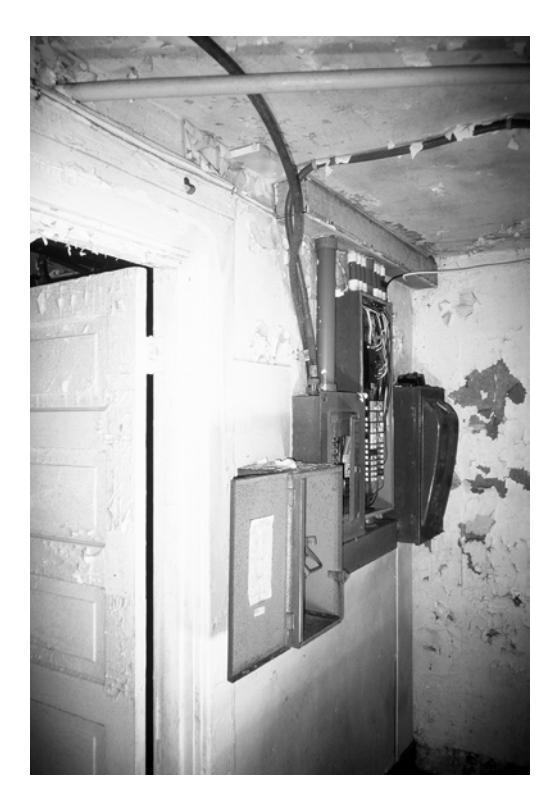
Figure C-17 Electrical Panels in Room 005

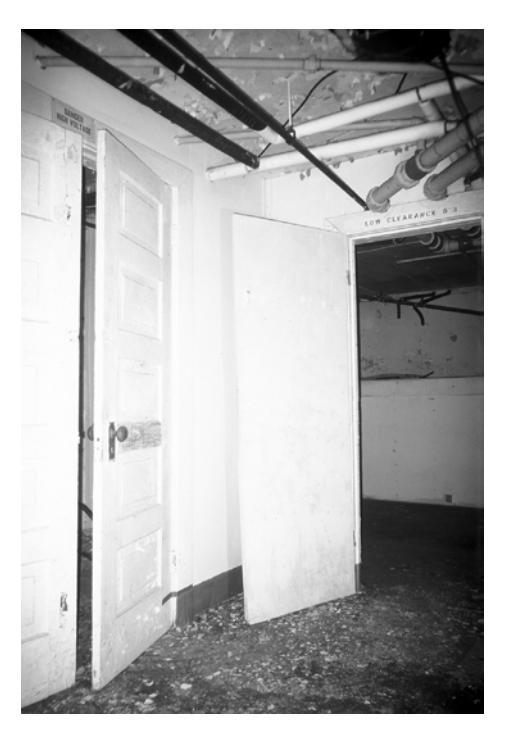
• *Doors:* A 2'-4" x 6'-2" doorway connects to Room 004. It has original, 1925-vintage, Type C-1 mitered casings that have been cut down to a reduced height. A door constructed of plywood is currently in place. The original doorway was apparently reduced when the overhead oil boiler and pipes were installed. The casing on the door to the kitchen (Room 001), probably dating to the 1974 remodeling, is Type C-17, with square-cut corners. Centered on the north wall is a pair of 1925-vintage, double doors, each five-panel and 2'-0" x 6'-6". The doors have a mortise lock, 3¹/₂" five-knuckle butt hinges, and stile-mounted overhead and foot locks. The casing is also 1925-vintage, reused Type C-1.

Figure C-18 Reused 1925 double doors from Room 005 (L) and shortened doorway from Room 004 with modern door (R).

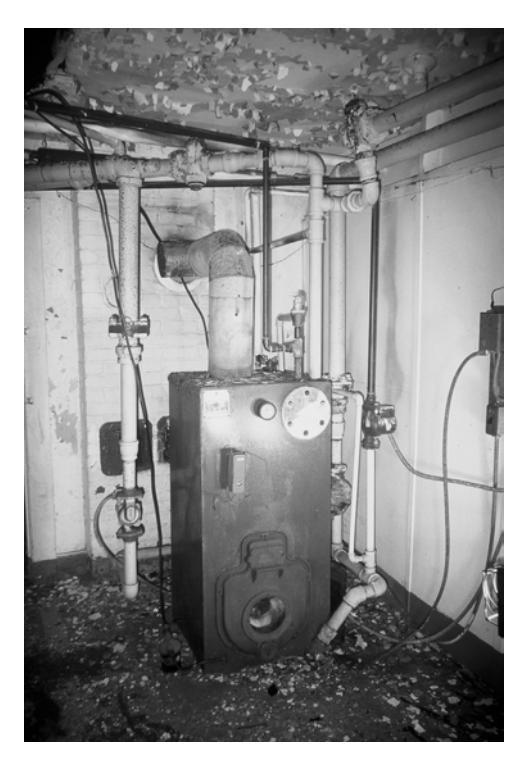
Radiator and Sanitary Corporation is in the southeast corner of the room. The model is A-3 # A35P series 1B J1. It is vented into the chimney with a 6" galvanized vent pipe. Production of this oil boiler stopped in 1968, when the company ceased operation. The company records no longer exist. The installation date is not known. The large fuel oil tank does not appear on the last NPS drawings of 1974. Electric wiring in flexible metal conduit is exposed on the walls. One ceramic ceiling light fixture is in place. In the northwest corner of the room is a Rheem

Figure C-19 Oil Boiler in Room 006

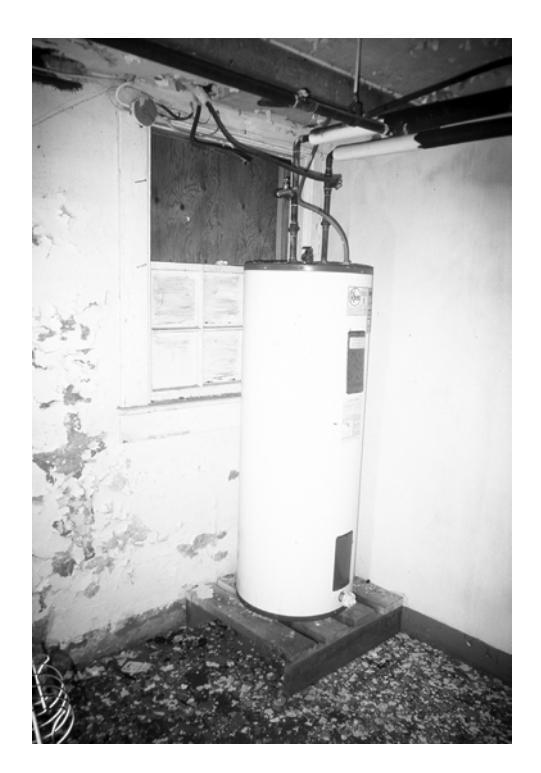
brand, 65-gallon electric water heater serial number R 048 8C02249 model 81V-66D; according to company records, the unit was constructed in April 1988.

Figure C-20 Electric water heater in Room 006 *Other Features:* None are present.

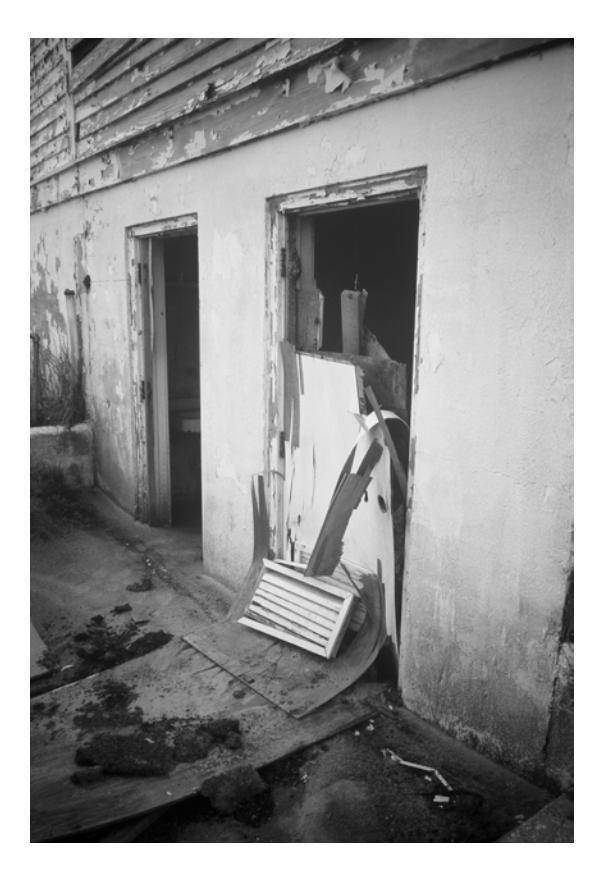
Figure C-22 Public Restrooms

• *Doors:* A wood slab door provides access from the exterior. The door has severe water and termite damage.

• *Doors:* The wood slab door providing access from the exterior is severely damaged by water and termites.

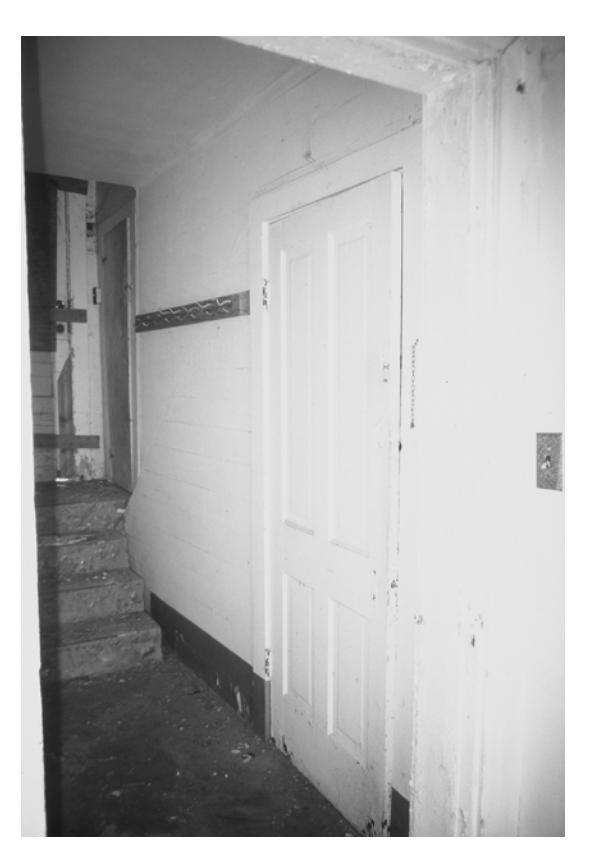
Figure C-21 Room 007

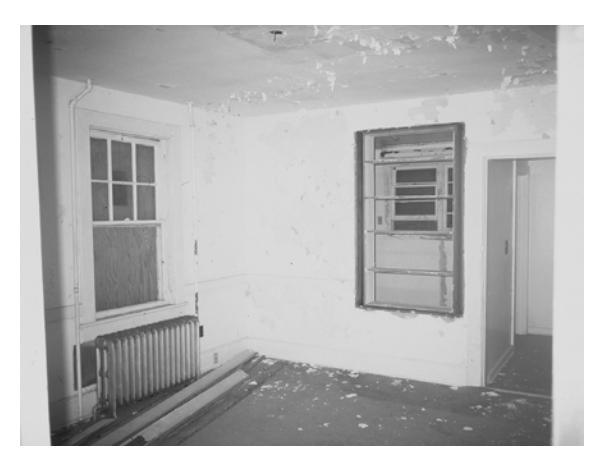
Figure C-23 Southeast corner of Room 101 with original window converted to an open bookcase

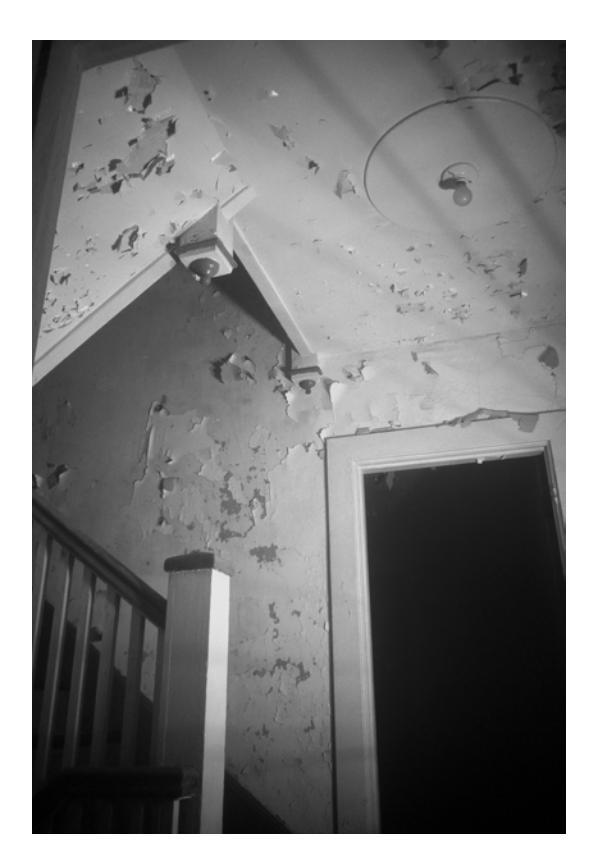
Figure C-24 Room 102 with plywood ceiling medallion and central light, staircase newel, balustrade, handrail, and pendants

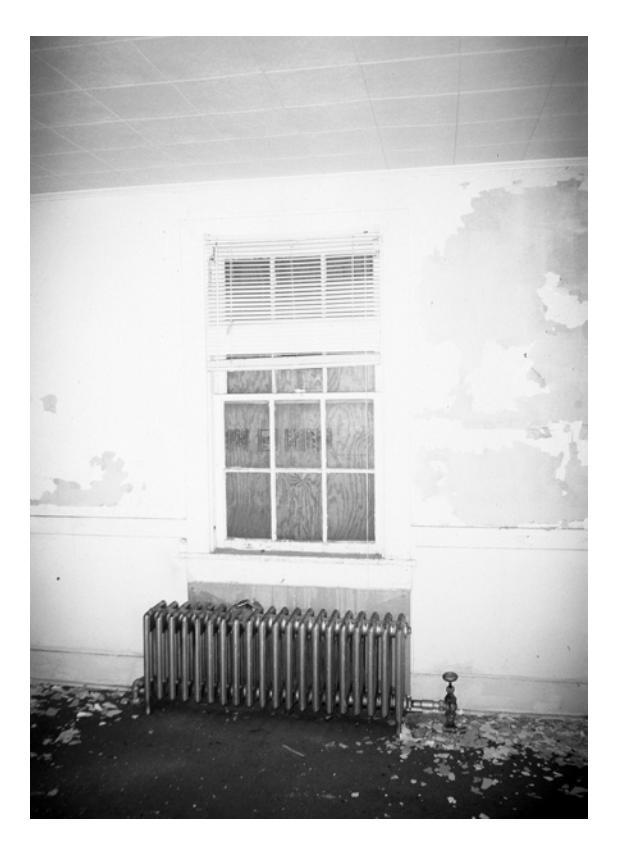
Figure C-25 Original window, Room 104

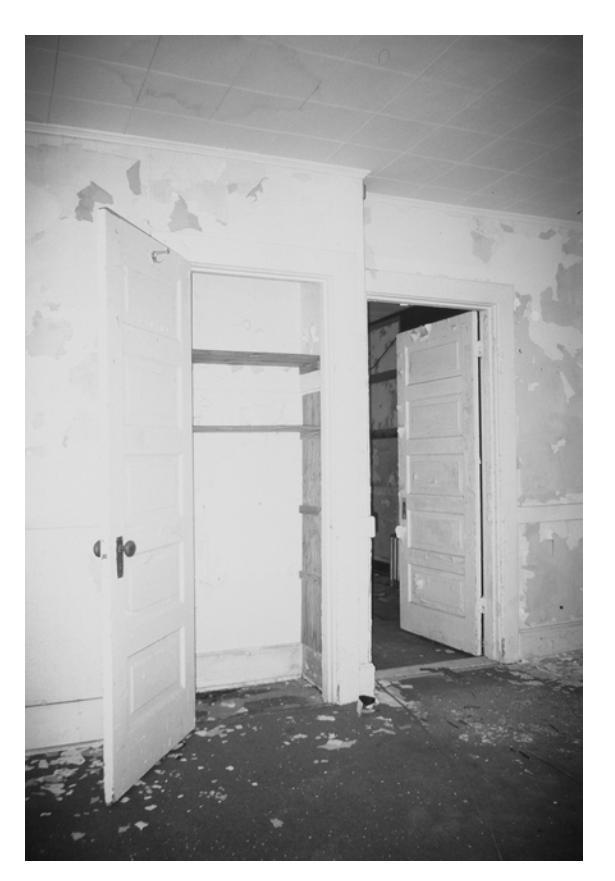
Figure C-26 Closet in Room 104

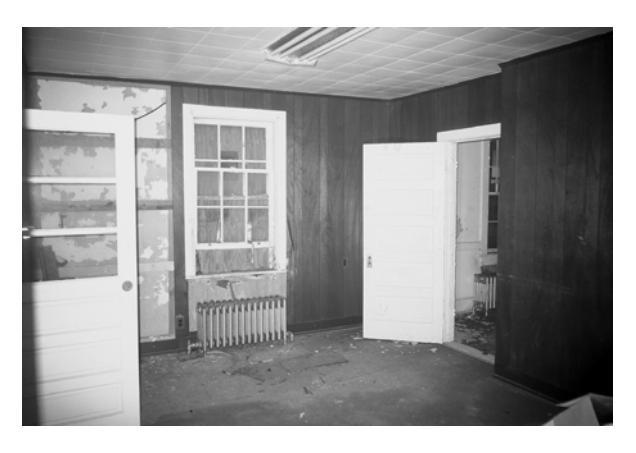
Figure C-27 Room 105

• *Ceiling:* The early gypsum or plaster board ceiling has been covered by modern 12" square, acoustical ceiling tile added at an unknown date. The gypsum or plaster board is exposed in the southeast quadrant where a plumbing leak occurred. An exposed waste pipe is on the east wall of the room.

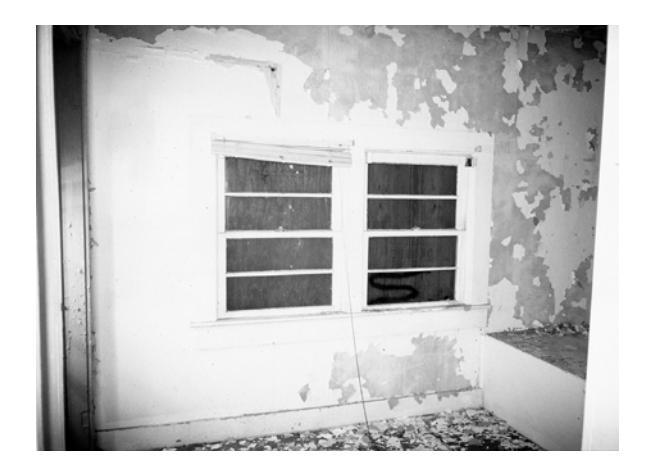
Figure C-29 Paired windows in the south wall of Room 109

• *Windows:* One pair of 1974-era twoover-two aluminum windows measuring 2'-4" x 3'-2" is on the south wall. It has 1974 Type C-11, mitered casing. One 1933-era four-over-four double-hung wood window with Type M-1 muntins and 1933 Type C-4 casing is on the west elevation.

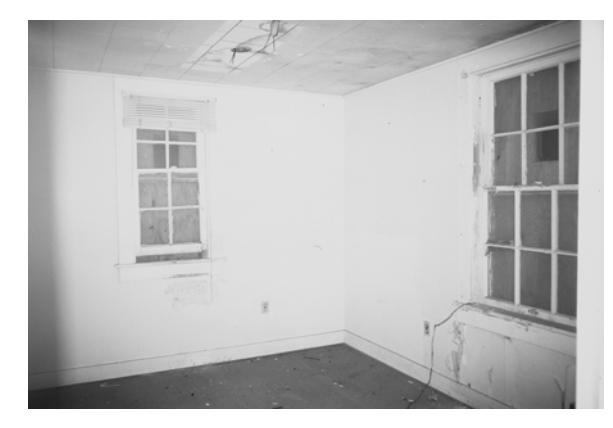
Figure C-30 Northwest corner of Room 110

• *Walls:* On the east wall there are exposed diagonal boards, the original wall sheathing with weatherboard ghost marks. The diagonal boards are tongue-and-groove, 4¹/4" pine. The other walls are gypsum or plaster board over studs. On the south wall there is a pass-through opening to the adjoining office (Room 109). There is water damage to the wall material under the windows on the north and west walls.

• *Ceiling:* The ceiling is made of modern 12" square, acoustical tiles. There is rainwater damage in the northeast corner of the room.

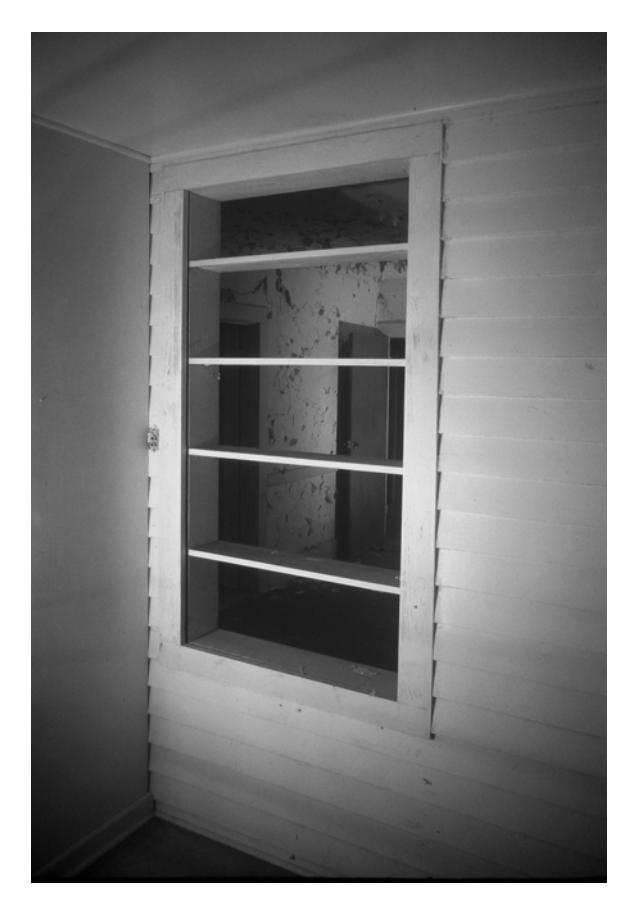
Figure C-31 Bookshelf created in original window opening in Room 111

- *Finishes:* The walls, ceiling, and trim are painted and peeling extensively.
- *Mechanical & Electrical Systems:* The room was lit by one fluorescent, ceiling-mounted light fixture.
- *Other Features:* An open bookshelf is located between this room and Room 101 in the original window opening on the north wall.

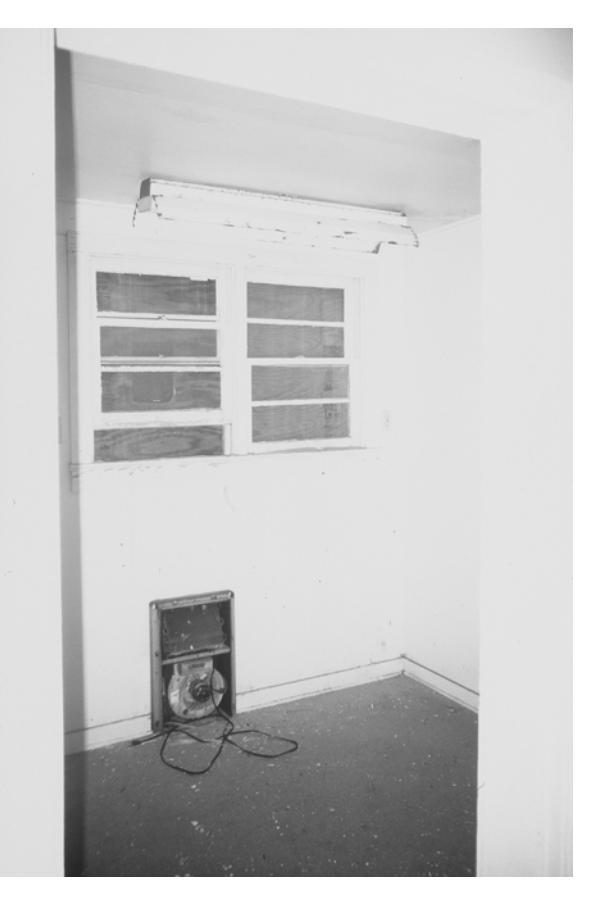
Figure C-32 Room 112

• *Finishes:* The walls, trim, and ceiling are all painted and are peeling extensively.

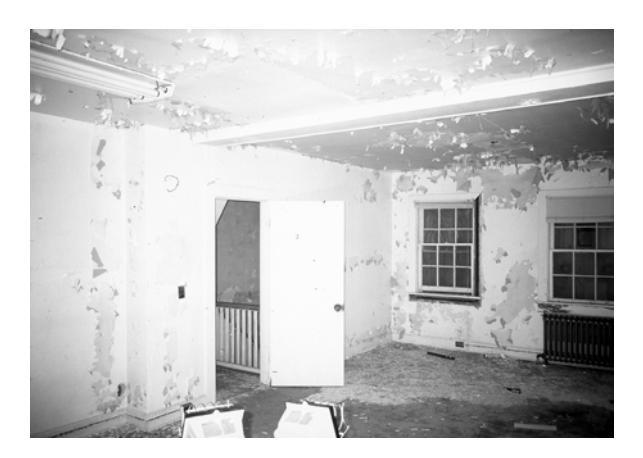
Figure C-33 Room 201

• *Walls:* The walls are sheathed with gypsum or plaster board on stud framing. There is a crack extending from the west corner of the doorjamb to the ceiling. Water damage is visible below the northernmost window on the east wall.

Windows: The room's six windows are the original 1925 six-over-six Type M-1 windows, each with original Type C-1 mitered casings. All window units measure 3'-0" x 4'-6". The northernmost window on the east wall is missing its south section of casing, its apron, and two panes of glass. The southernmost window on the east wall has the bottom rail out of position in both sashes. The easternmost window on south wall is in good condition, while the westernmost is leaking above the lintel. The southernmost window on the west wall is missing one pane of glass from both the top and bottom sash. The northernmost window on the west wall is in good condition.

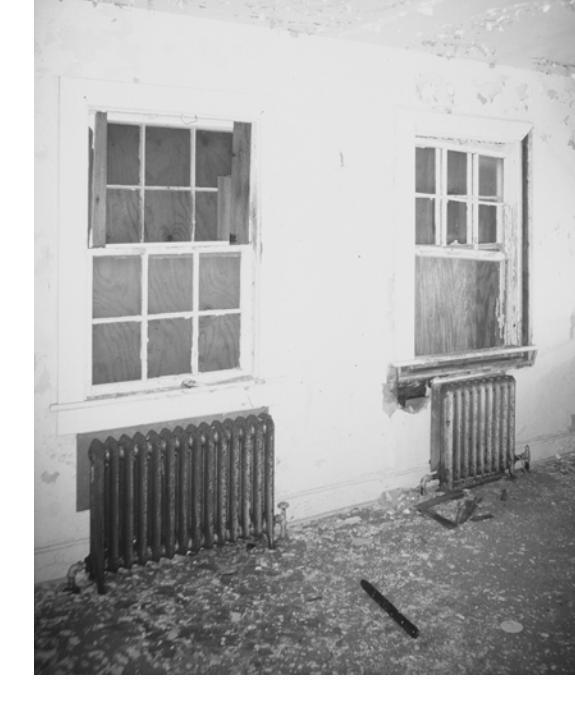
Figure C-35 Room 204

Windows: The room's three windows. one on the north wall and two on the east wall, are the 1925 six-over-six Type M-1 windows. Both of the sashes are in place on the window on the north wall, but there is extensive water infiltration at the sill and damage to the wall below the window. The northernmost window on the east wall is missing three panes of glass from its top sash. The southernmost window on the east wall is missing a section of casing on the south jamb apron, its bottom rail is out of position, and its sash is out of square. The bottom sash is missing six panes of glass. This window also shows signs of water infiltration at the sill. All three windows have 1925-era Type C-1 casings.

• *Ceiling:* The ceiling is sheathed with gypsum or plaster board. It has a crack running east-to-west that corresponds to cracks on the east and west walls, and patches in the baseboards along those walls, where a dividing wall was removed in 1945.

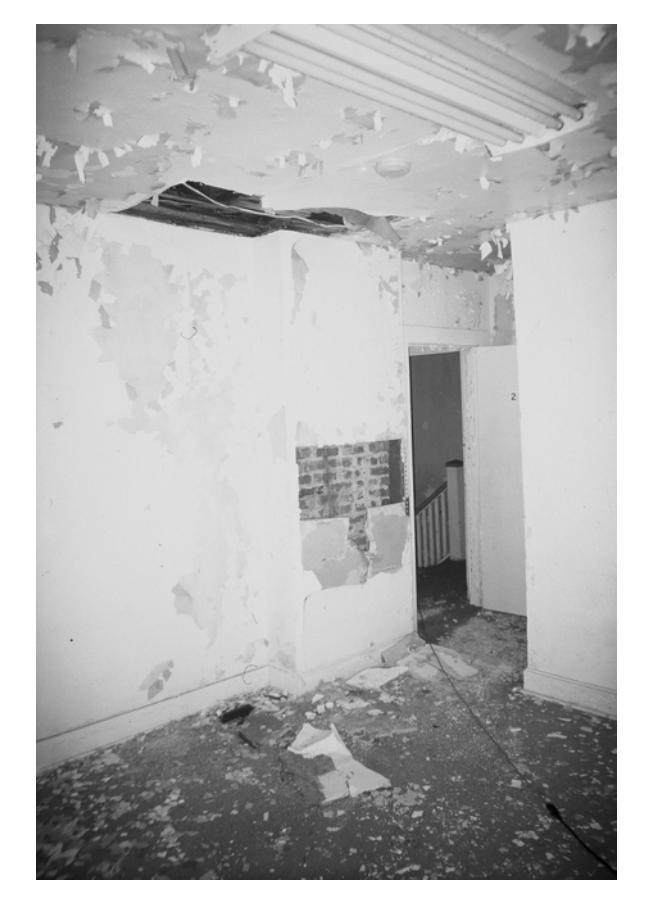
• *Other Features:* A previous leak around the chimney stack has damaged the surrounding ceiling and associated wall elements.

• *Walls:* The walls are sheathed with gypsum or plaster board. There is water damage to the walls in proximity to the chimney stack on the west wall. Water damage is also present below the windows on the west and north wall elevations.

Figure C-36 Chimney in Room 205

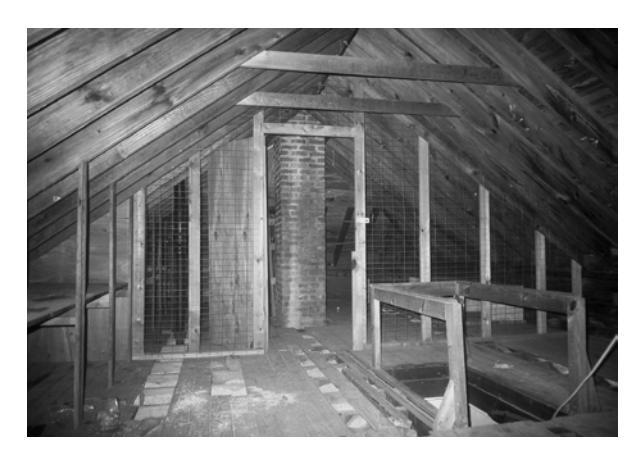
Figure C-38 Attic, Room 301

• *Windows:* The attic has two windows in small gables extending above the hipped roof, one on its north end and the other on its south end. Both the sash and subsill are out of place in the north window; water damage to the surrounding framing is visible. The south window's top sash is in

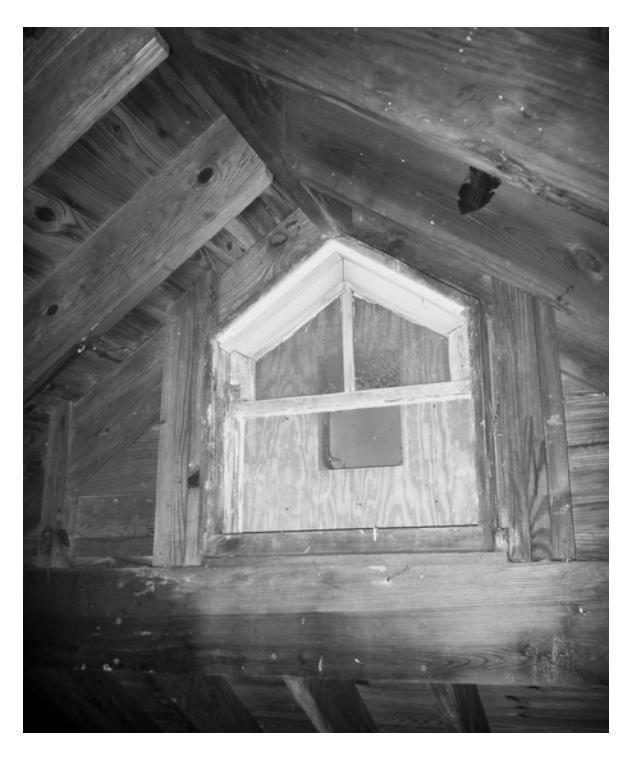
place; however, the bottom sash has been replaced with a ventilation cover. The original sash is stored in the attic. There is some water penetration and minor damage at the window's subsill.

Figure C-39 Window in attic gable
