**Cane River Creole National Historical Park**  
**Magnolia Plantation**  
**Overseer's House**  
**Historic Structure Report**

2004

2004  
Historic Structure Report  
Overseer's House  
Magnolia Plantation  
Cane River Creole National Historical Park  
Natchez, LA  
LCS#: 091558

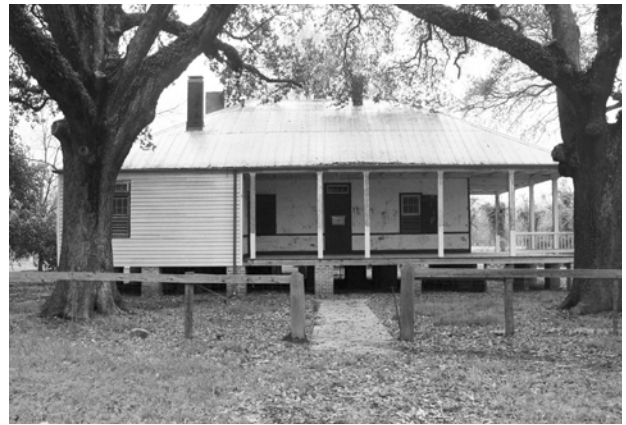
FIGURE 1. Southwest elevation, front entrance to Overseer's House.

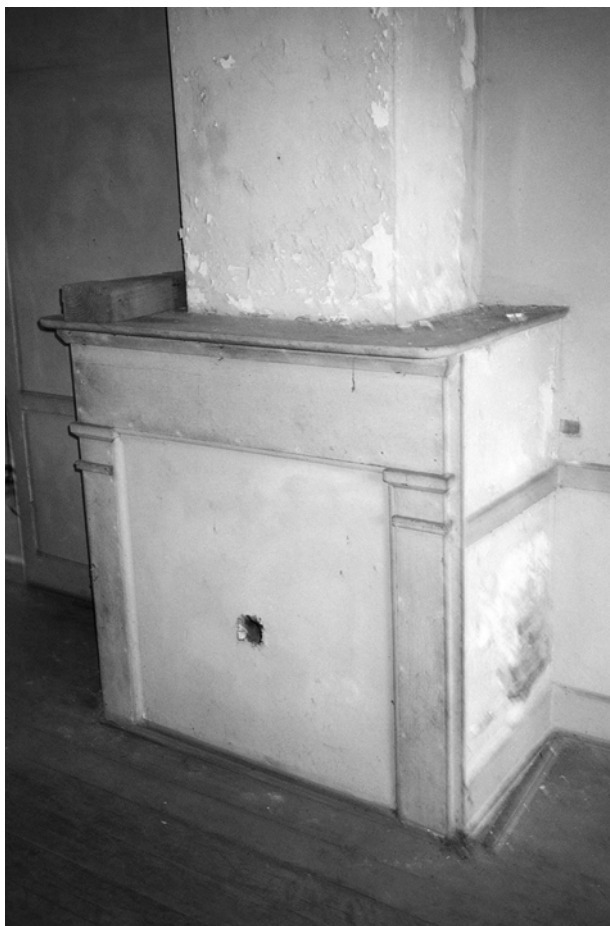
FIGURE 43. Fireplace #4 in Room 101.

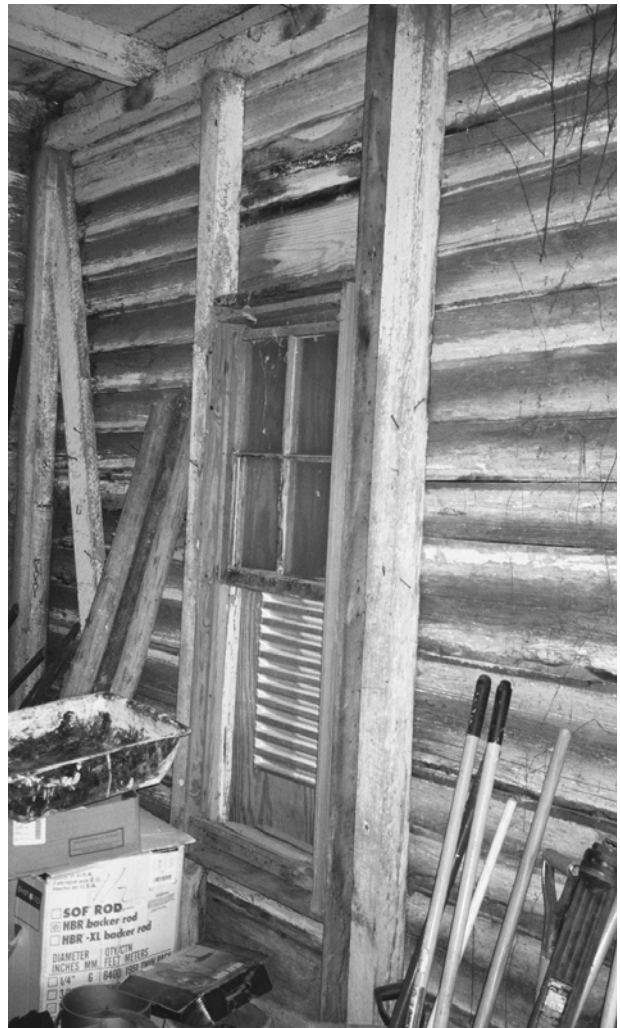
FIGURE 65. Northwest wall, Room 110.

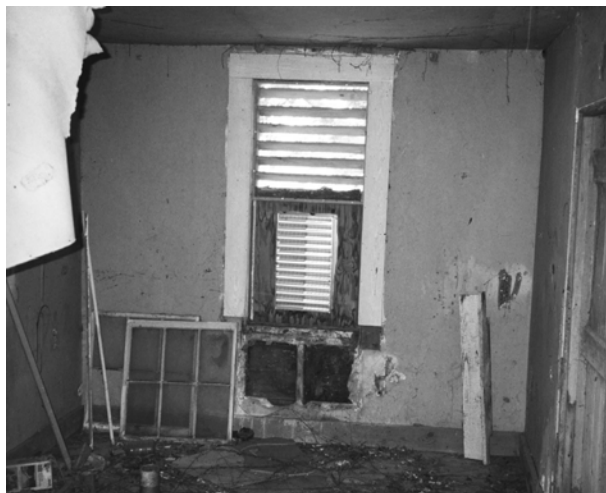
FIGURE 67. Northeast wall, Room 111.
