## Alcatraz Barracks Building 64

Abbreviated Historic Structure Report

September 2003

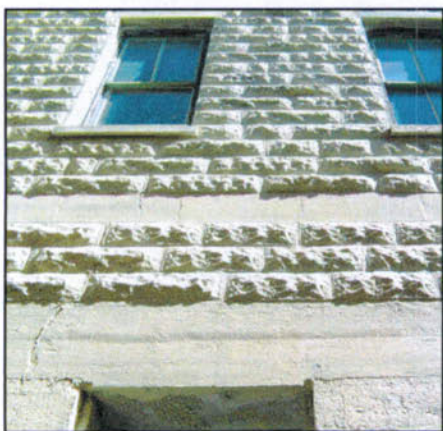
Bottom: Closeup of concrete block exterior wall, 2003 Photo Credit: John Martini.

The walls of the upper three floors are constructed of unreinforced hollow concrete masonry units approximately 10"x32" in a running bond pattern. The block at the first floor is 16" thick, the second 14", and the third 12". The hollow concrete blocks were molded with a rock-faced ashlar pattern on the outside. The resulting appearance is that of a stone barracks building. The block walls appear to be generally in good condition, however there is some localized damage to the block at the third floor on the southwest end of the building as a result of the recent windstorm and a previous fire. This area was repaired in February of 2003. Paint on the block walls is peeling and there is mold in several locations.

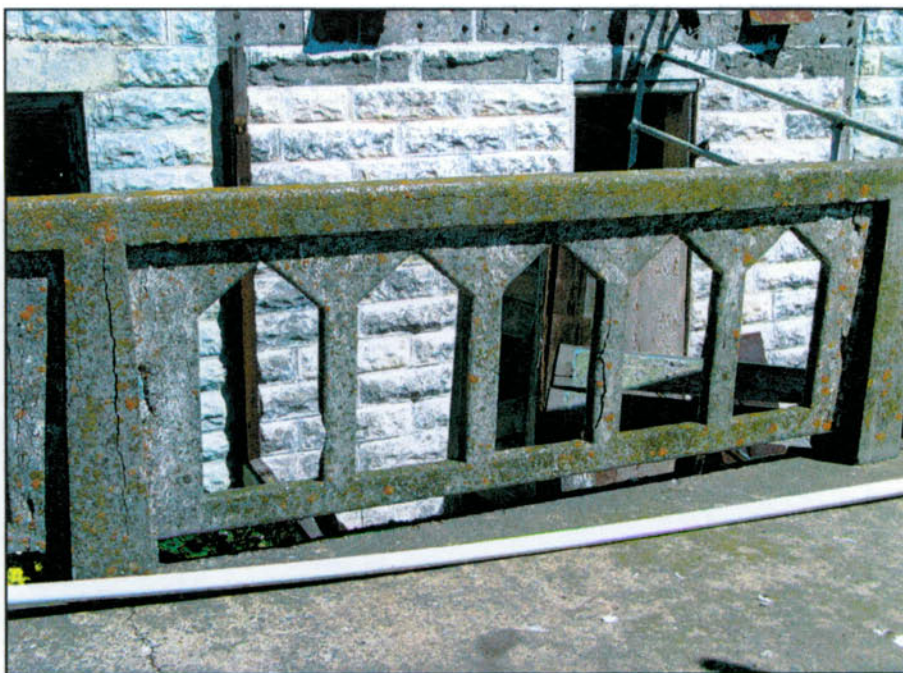
Top: View of historic concrete railing, 2003. Photo Credit: Jane Lehman.

concrete railings in this area were replaced in 2001. These are in good condition. Railings that were not replaced show large spalls with exposed and rusted reinforcement steel. One section of concrete railing in this area collapsed when roof debris fell on it during the November 2002 storm.

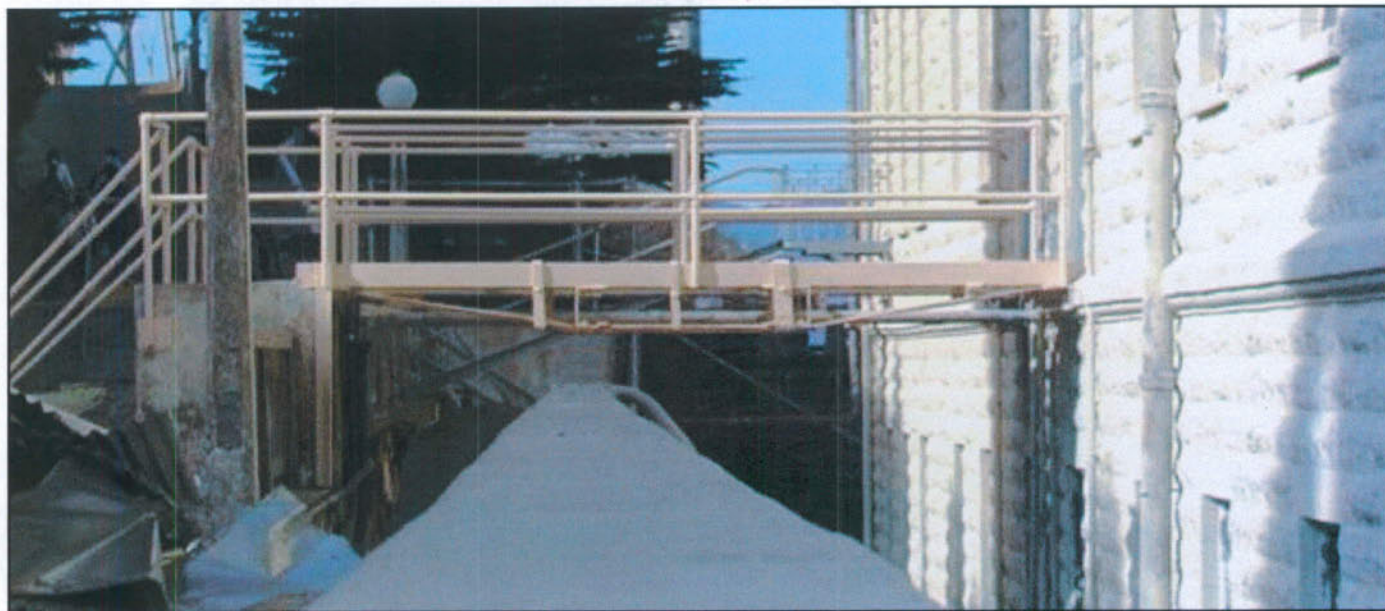
Bottom: Second floor balcony railing before repair, 2003. Photo Credit: Jane Lehman.

The railings at the concrete balconies consist of a cast-in-place concrete top rail between concrete posts with chain link wire mesh infill panels. This railing style also appears on the stairway that connects the First Floor balcony and the Dock at the south end of the building. Overall, it is generally in very poor condition, shows numerous areas of rusted metal and spalled concrete, and has collapsed in several places. There is one area of at the south end of the First Floor balcony where the chain link wire mesh infill panels have been replaced with decorative concrete block that is red in color. This replacement appears to be associated with a project from the Bureau of Prison era that was never completed.

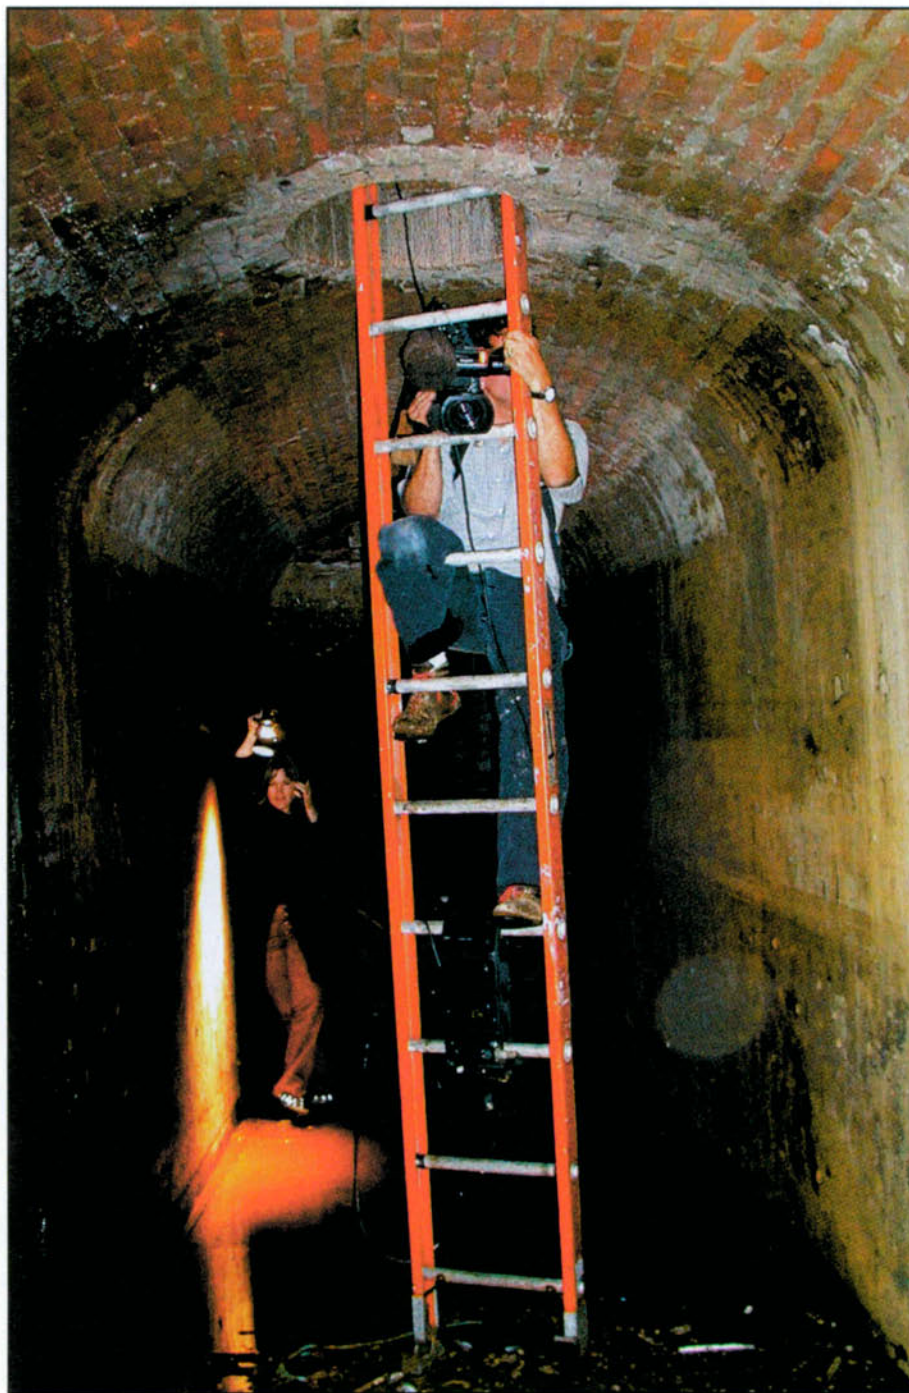
Interior of cistern  
behind Building 64.  
Photo Credit: Martin  
Mayer .

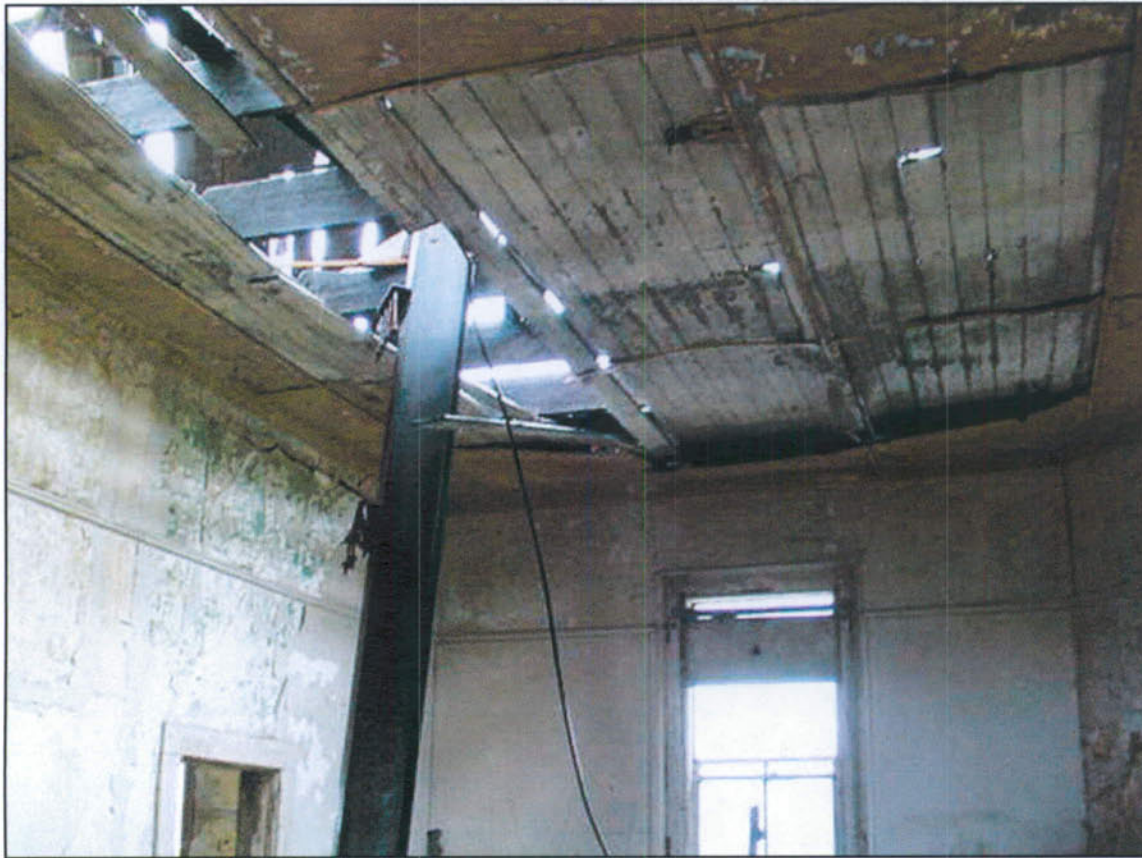
The condition of the walls on the upper levels ranges from poor to very poor. Paint is peeling extensively on the majority of the walls. Many walls have holes in them due to vandalism during the Indian Occupation. Some interior walls have been removed. The Third Floor walls have been damaged extensively by water penetration during several periods when the building's roof was in disrepair.

View of extensive ceiling damage at south end of third floor, 2003. Photo Credit: Jane Lehman.

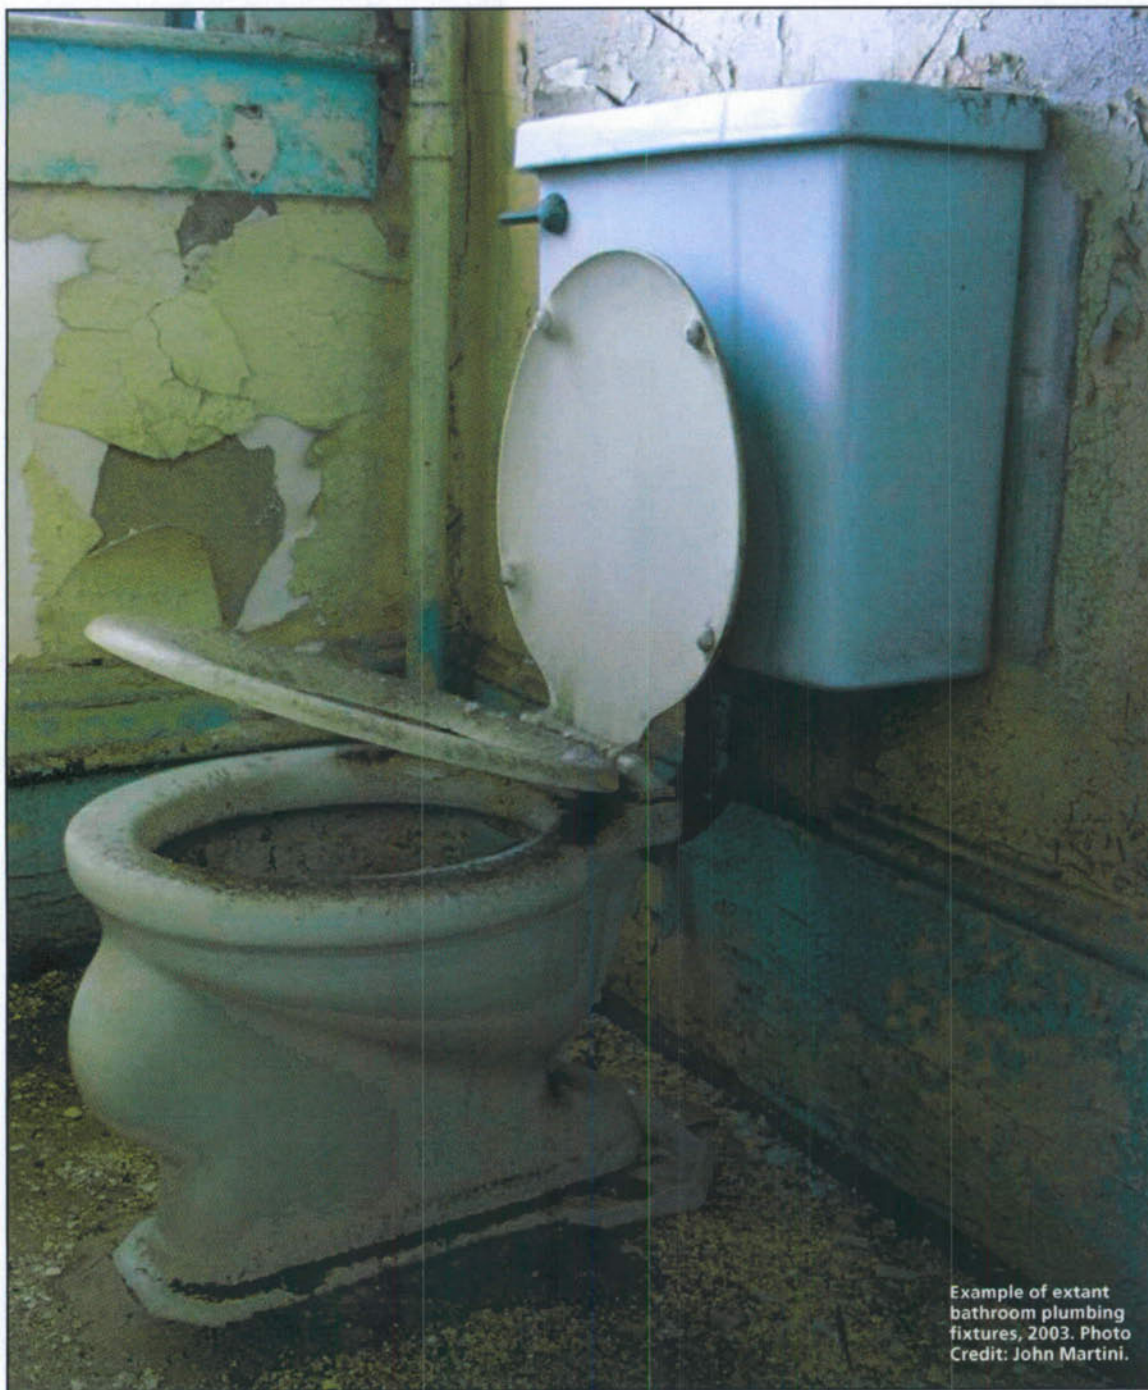
Example of extant  
bathroom plumbing  
fixtures, 2003. Photo  
Credit: John Martini.

floor-mounted bowls with wall-mounted tanks. The majority of the tanks are broken off the walls and the bowls are clogged with debris. In almost all cases, the wall-mounted sinks are broken off the walls.

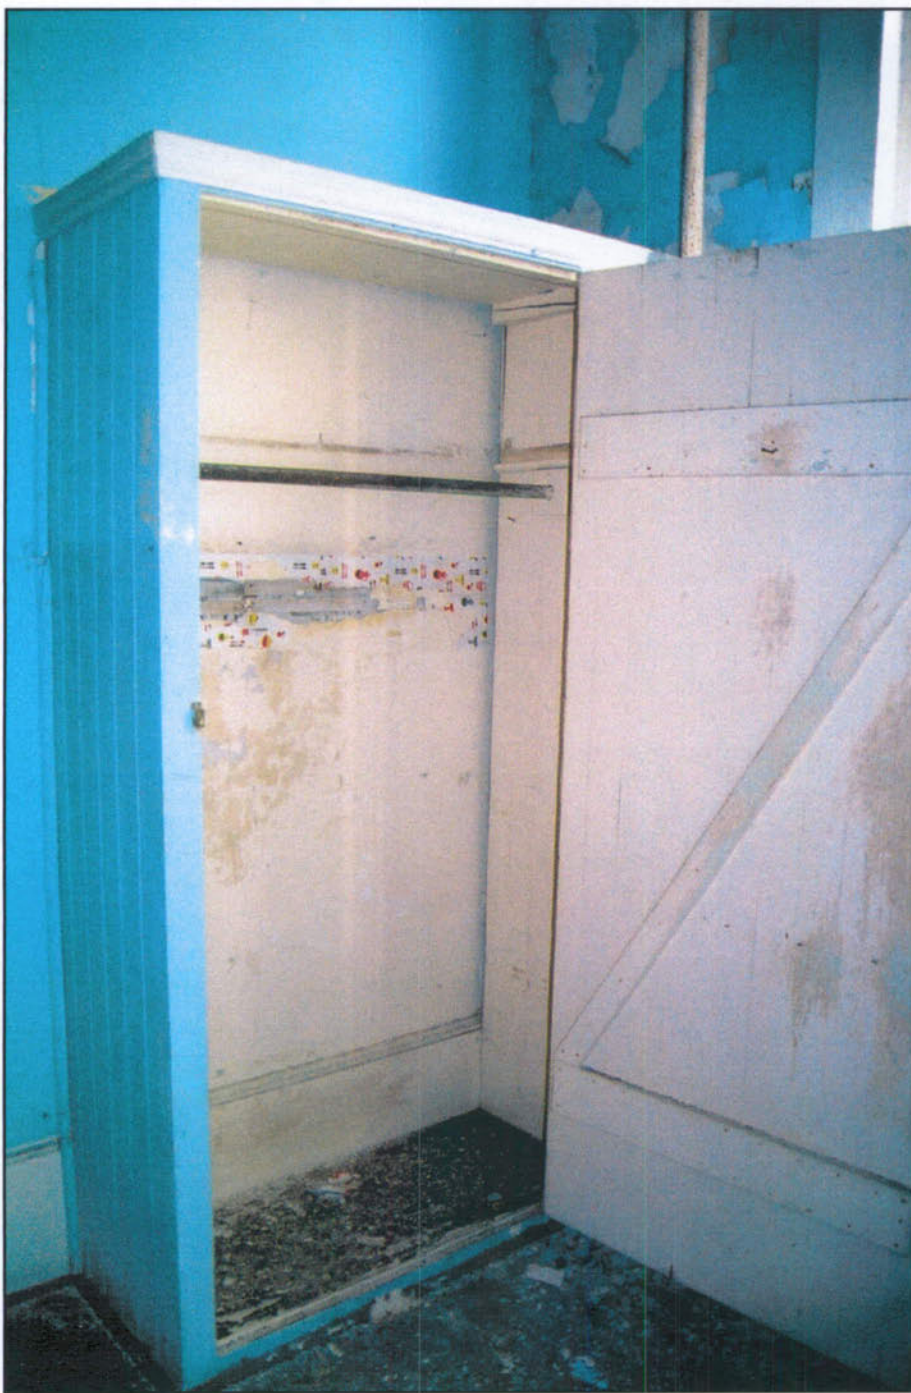
Left to right: Army-era locker converted to closet, 2003. Photo Credit: John Martini.

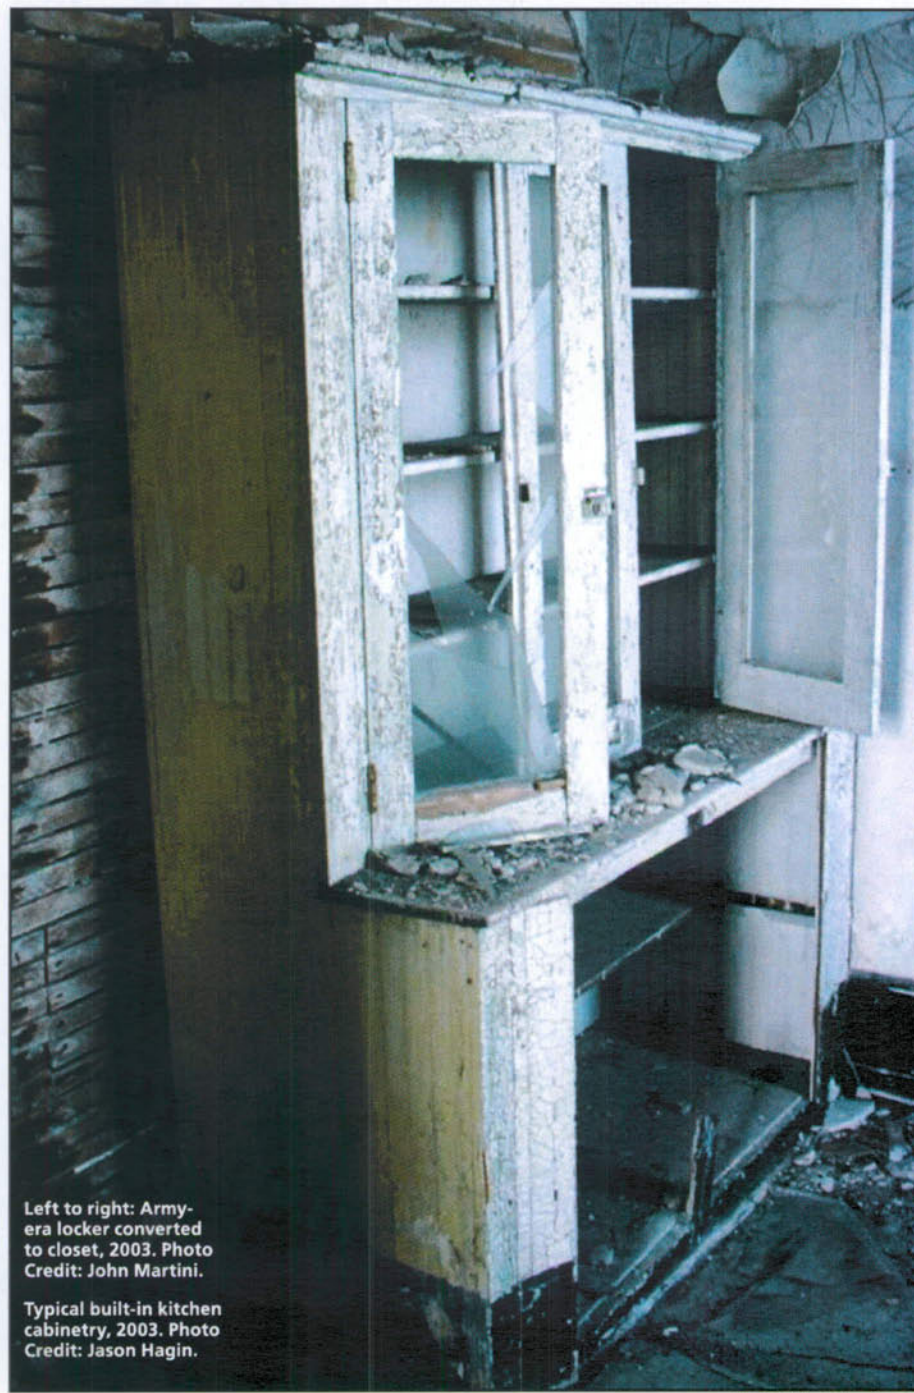
Typical built-in kitchen cabinetry, 2003. Photo Credit: Jason Hagin.
