# Presidio Gate, Broadway Gate and Vicinity

Cultural Landscape Report  
Presidio of San Francisco

Golden Gate National Recreation Area, California  
October 1996

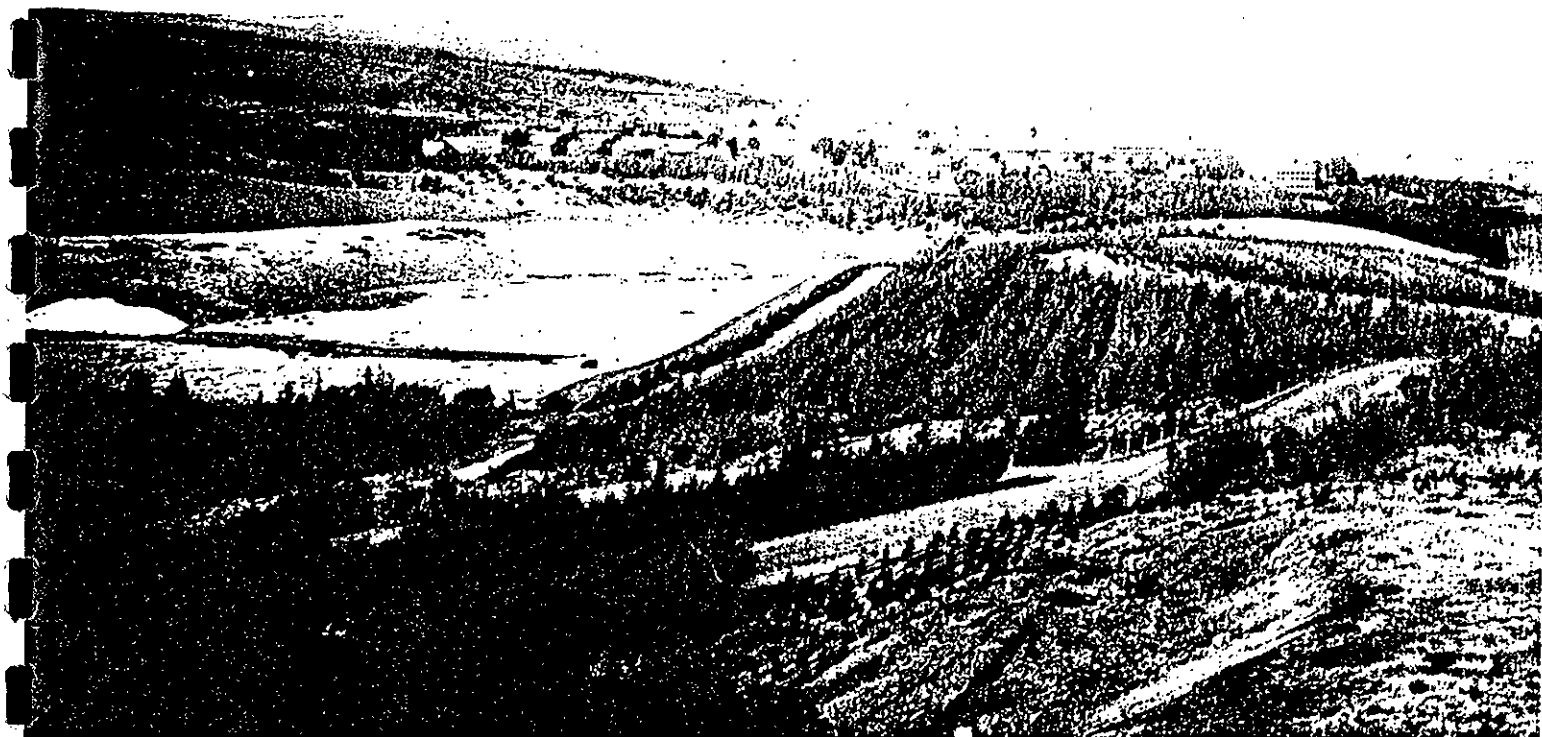
Figure 2 - 1893 Photograph of the Presidio from southeast corner

The southeastern corner of the Presidio is one of the high points in the Presidio. Views through the Presidio to the main post and bay would have been clear during the early 1900's. This knoll was kept clear of vegetation, evident in the 1893 photograph from this location, figure 2. This knoll remained clear of tree cover, shown in the 1933 aerial photograph, figure 4. The 1955 aerial photograph, figure 6, shows vegetation removed below Broadway Street, all of the Eucalyptus trees in this area were topped at 10' to 15' height (evident in existing trees), to restore view to bay? The tree canopy of the Presidio forest precludes any views from this point today.

were planted in a very short time frame creating an even aged stand of trees with very little reproduction. The trees were planted in single species stands. The Eucalyptus forest adjacent to Lovers Lane is laid out on a grid parallel with lovers lane (evident in the 1893 photograph, figure 2). Major Jones noted that Monterey Cypress accompanied Eucalyptus stands to add a "dark mass" of greenery from the ground to where the Eucalyptus towered above, giving the appearance of depth. (Jones 1883) The border planting of cypress is evident along Lovers Lane and Presidio Boulevard at the entrance gate. An allée of Monterey Cypress and Monterey Pine lined Presidio Boulevard from the entrance gate to Broadway Street on the east and West Pacific Avenue on the west.

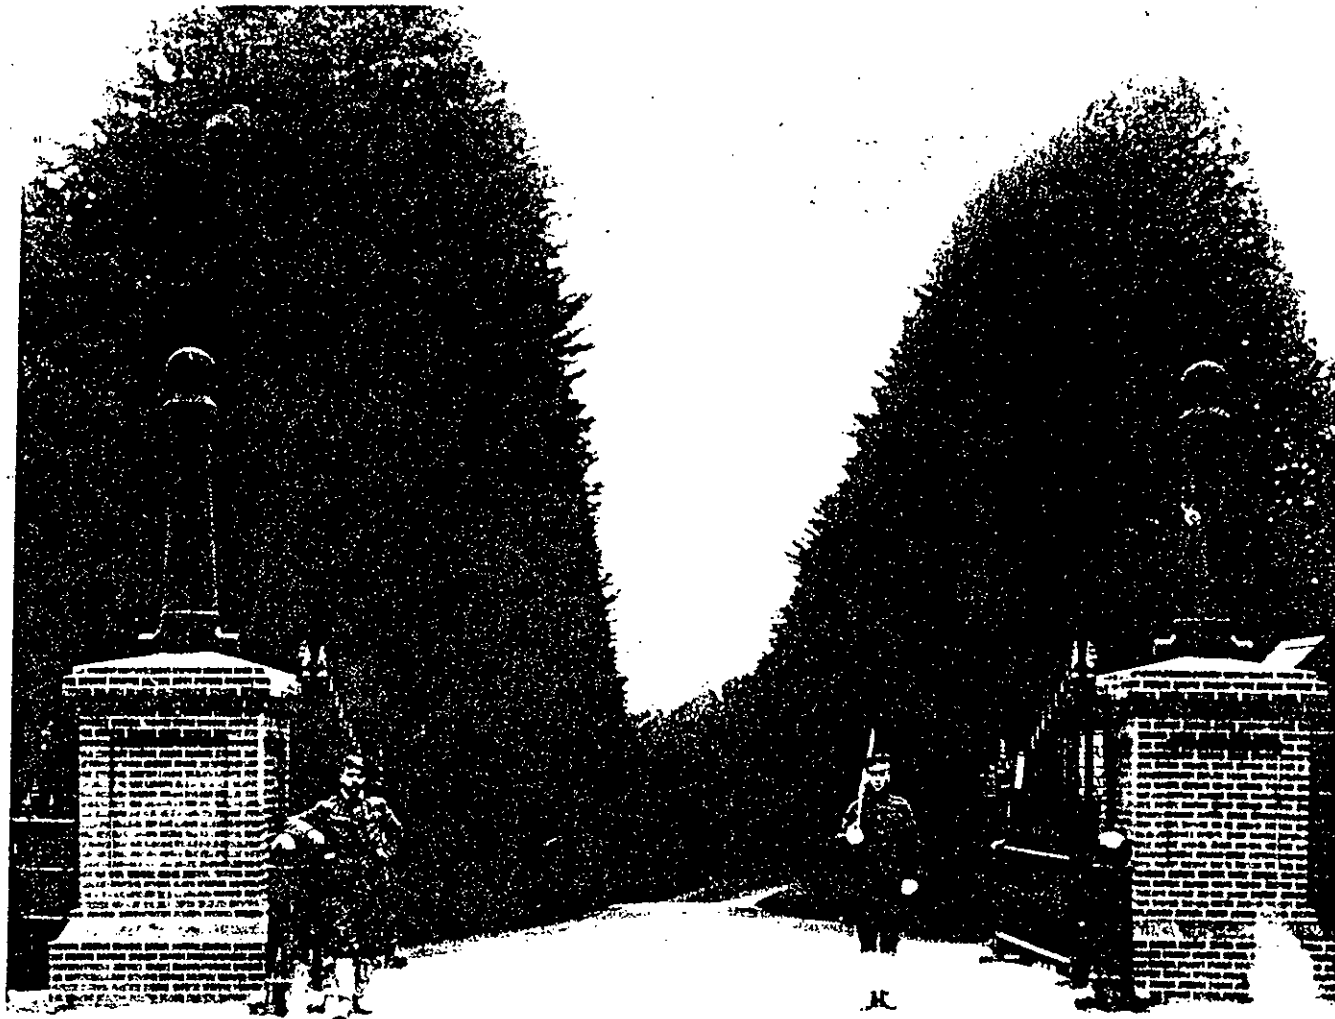
Figure 3 - 1906 Photograph of Presidio Gate

- \* pedestals now constructed in common bond brick work with very clean-looking mortar (when was the light tan parging removed?)
- \* narrow, white wood-frame sentry box with gable roof is located in the rear, behind the eastern pedestal;
- \* trees appear to be @ 20' to 25' tall (they appear to be @ 10' taller than the gatekeeper's house)

The iron fence and pedestrian gate should be repaired following the original design and materials, using the existing fence and historic photographs to reproduce missing details.

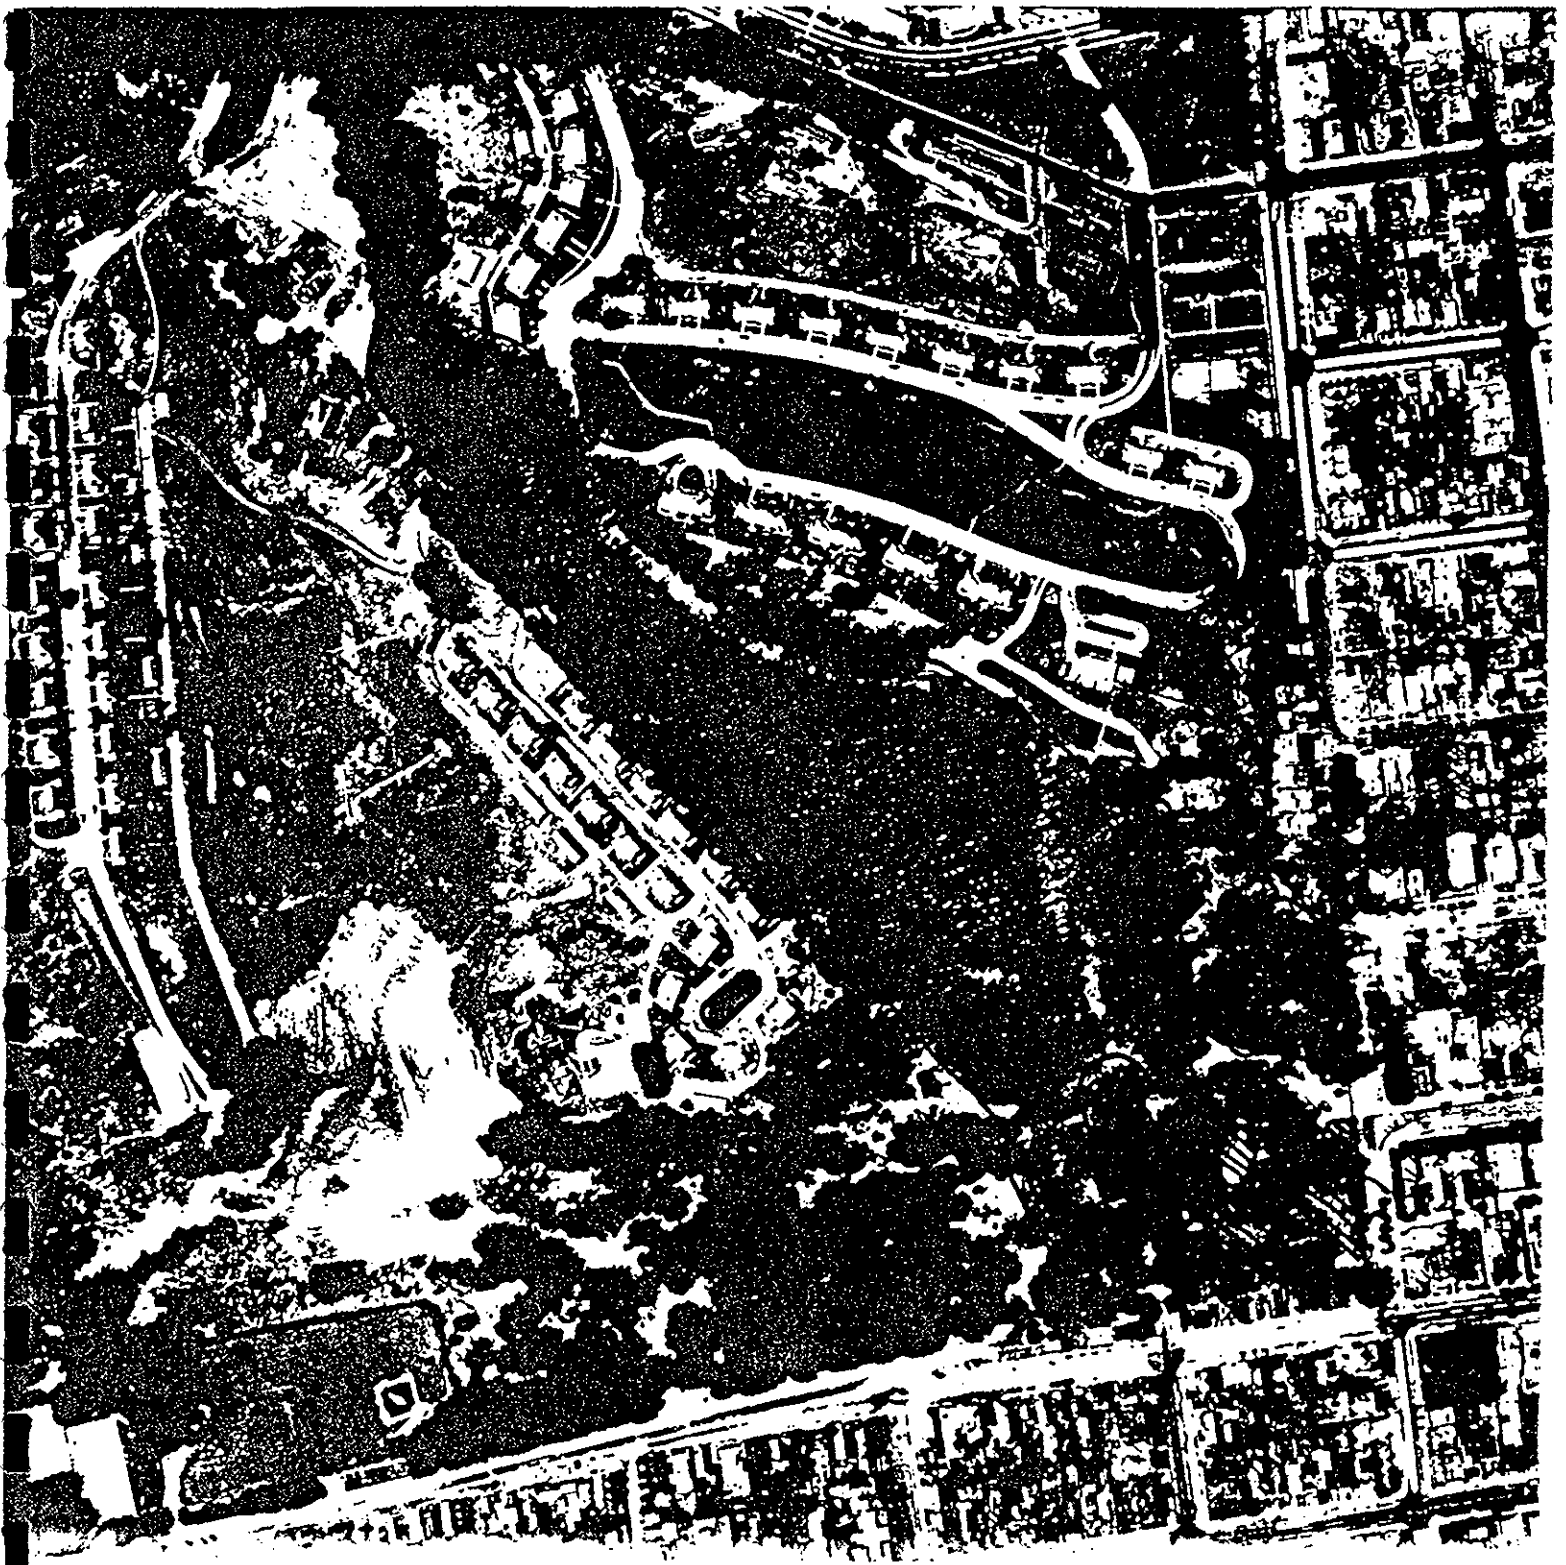
Figure 5 - 1948 Aerial photograph

There is a pedestrian access point via stone/concrete stairs at the end of Vallejo Street and a remnant log retaining wall and trail between Vallejo St. and the end of Shafter Road. This access is cut off by a chain link fence on top of the boundary wall, however, there is some use by people crawling under the fence and heading uphill from this point causing moderate erosion to the slope. The log retaining structure is in poor condition, the cross members are broken or damaged. The date of this pedestrian connection is unknown, the steps appear to be added on to the boundary wall. The trail shows up clearly in the 1948 aerial map, figure 5.

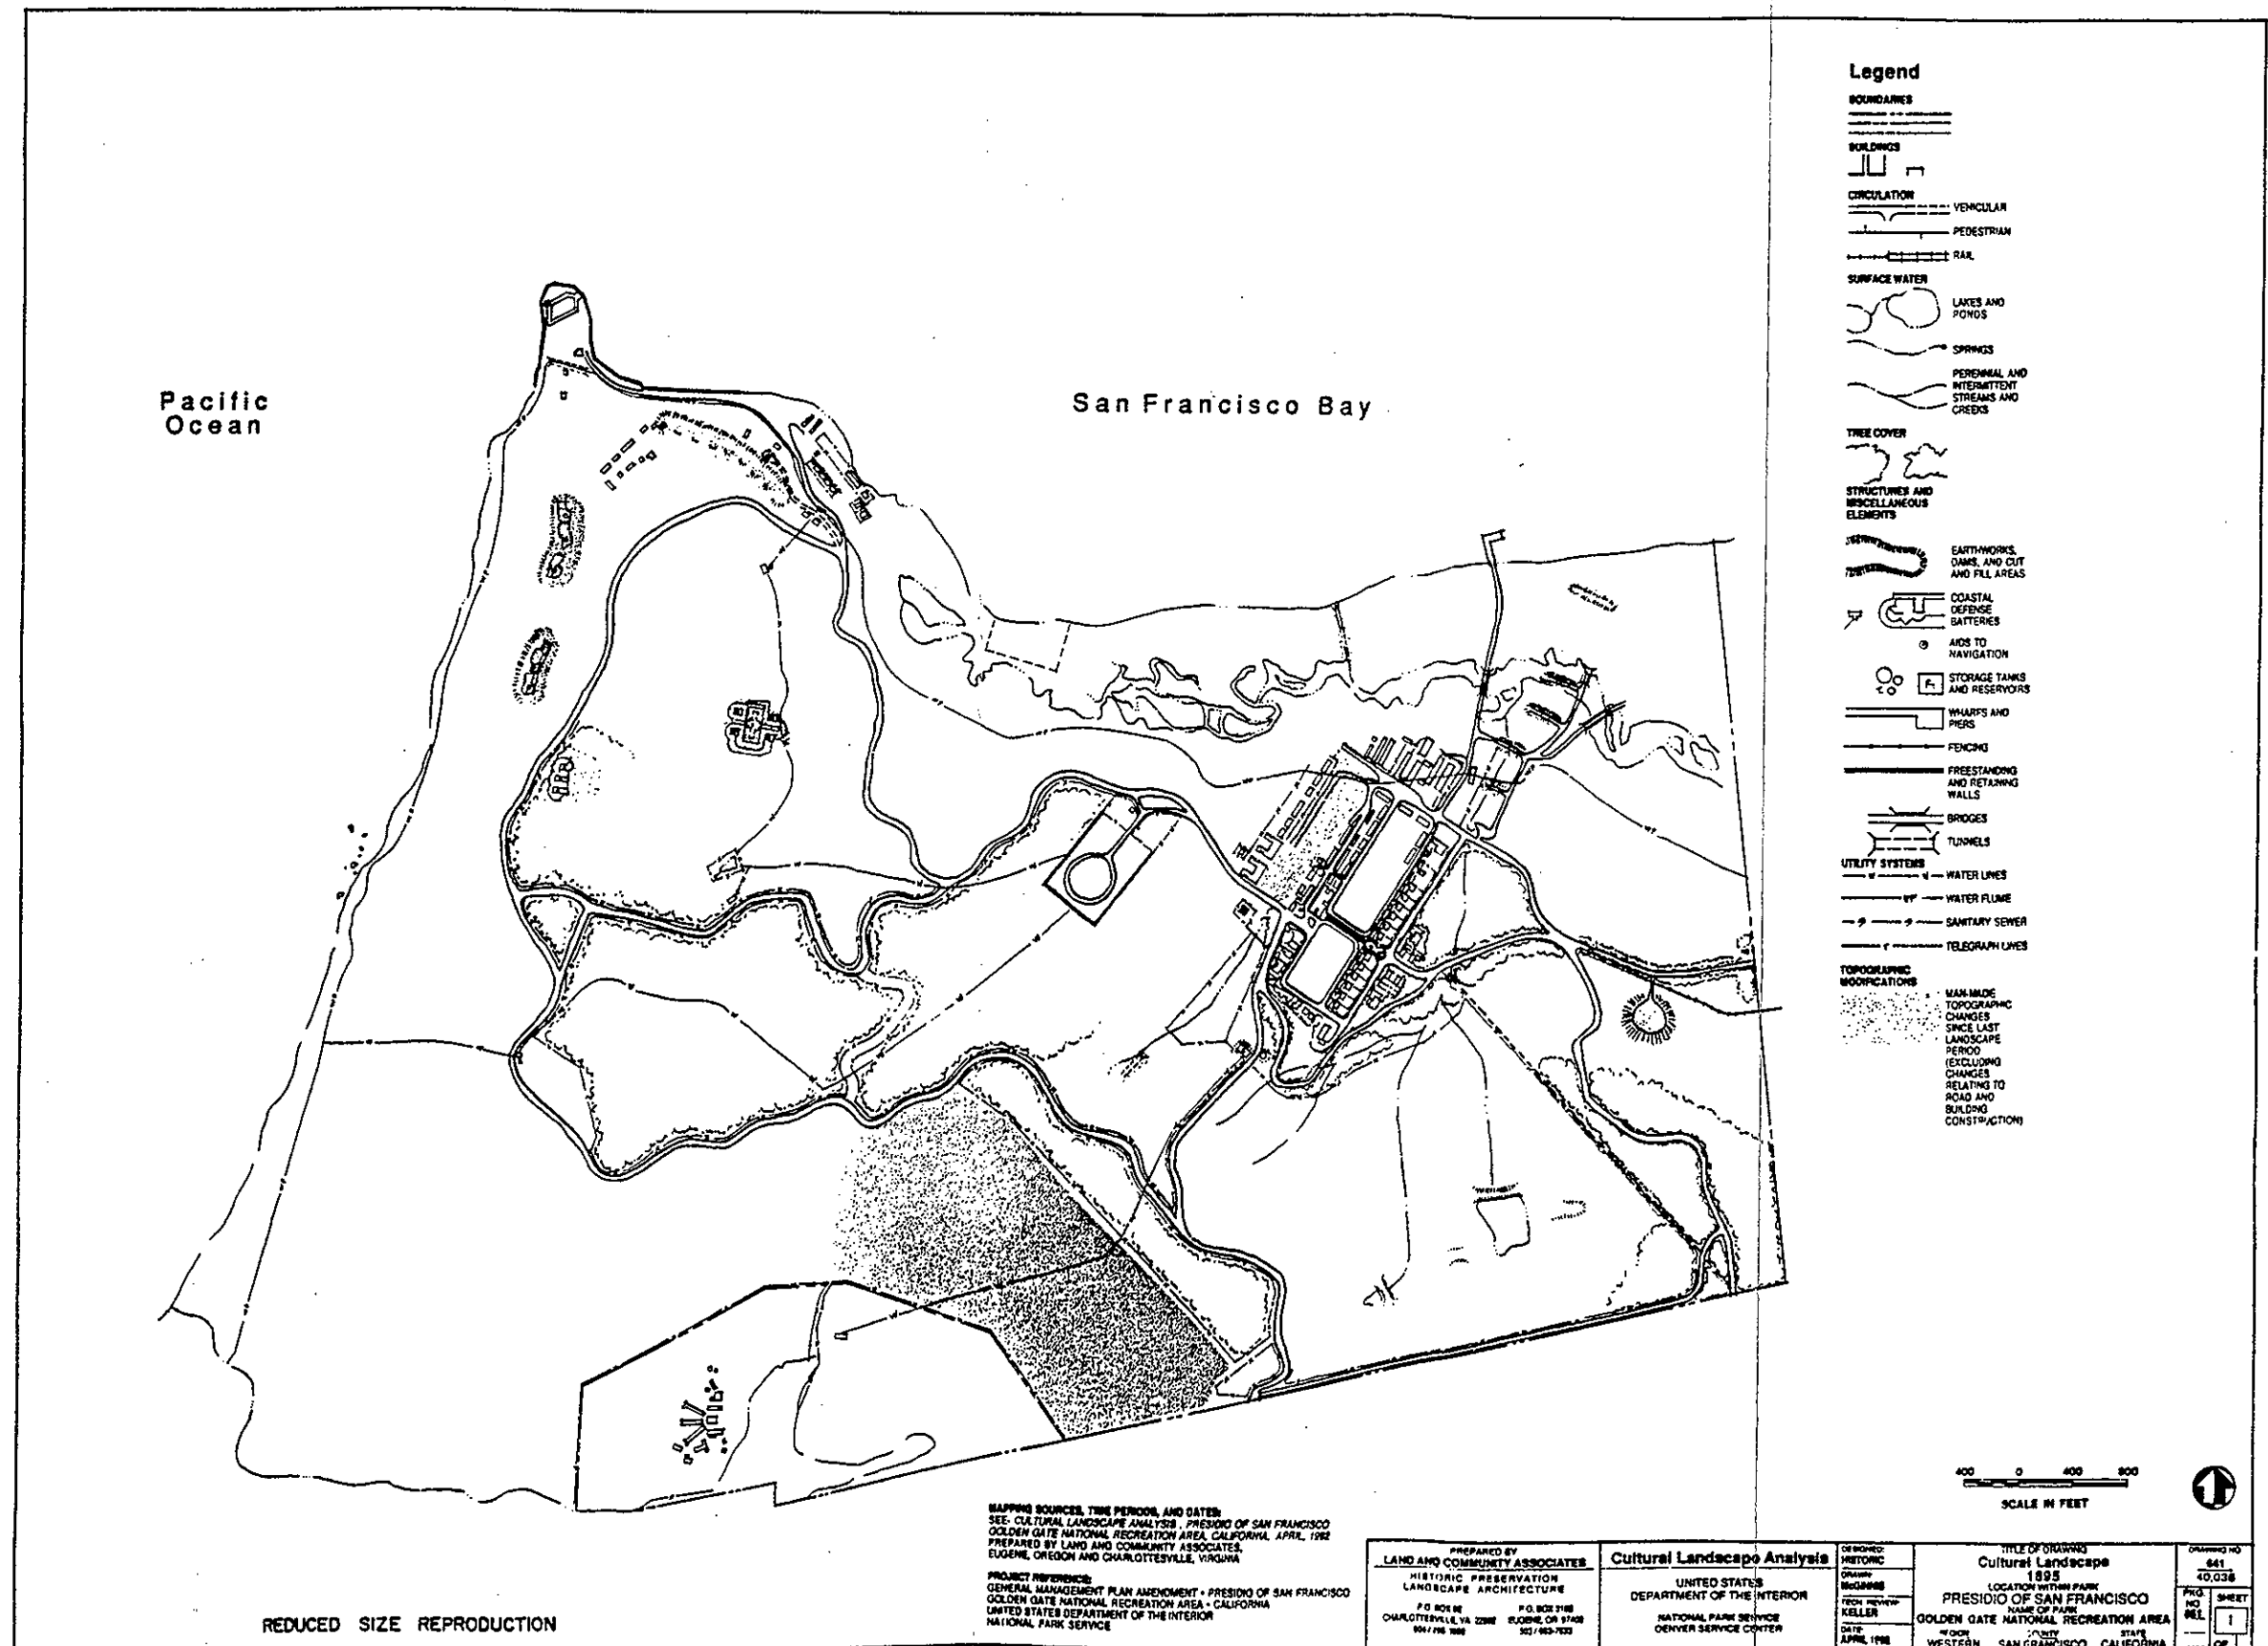
Figure 8 - 1895 map of the Presidio

West Pacific Avenue is a paved 22' wide connection between Arguello Boulevard and Presidio Boulevard. The avenue shows on maps as early as 1895, figure 8. The intersection with Presidio Blvd. has poor sight distance for vehicles turning onto Presidio Blvd. from W. Pacific Ave. Due to steep slope of intersection and stand of mature trees on the southwest corner. The side slopes along the north side of W. Pacific between Presidio Blvd. and Lovers Lane are eroded due to steepness of the slope and pedestrian crossing.

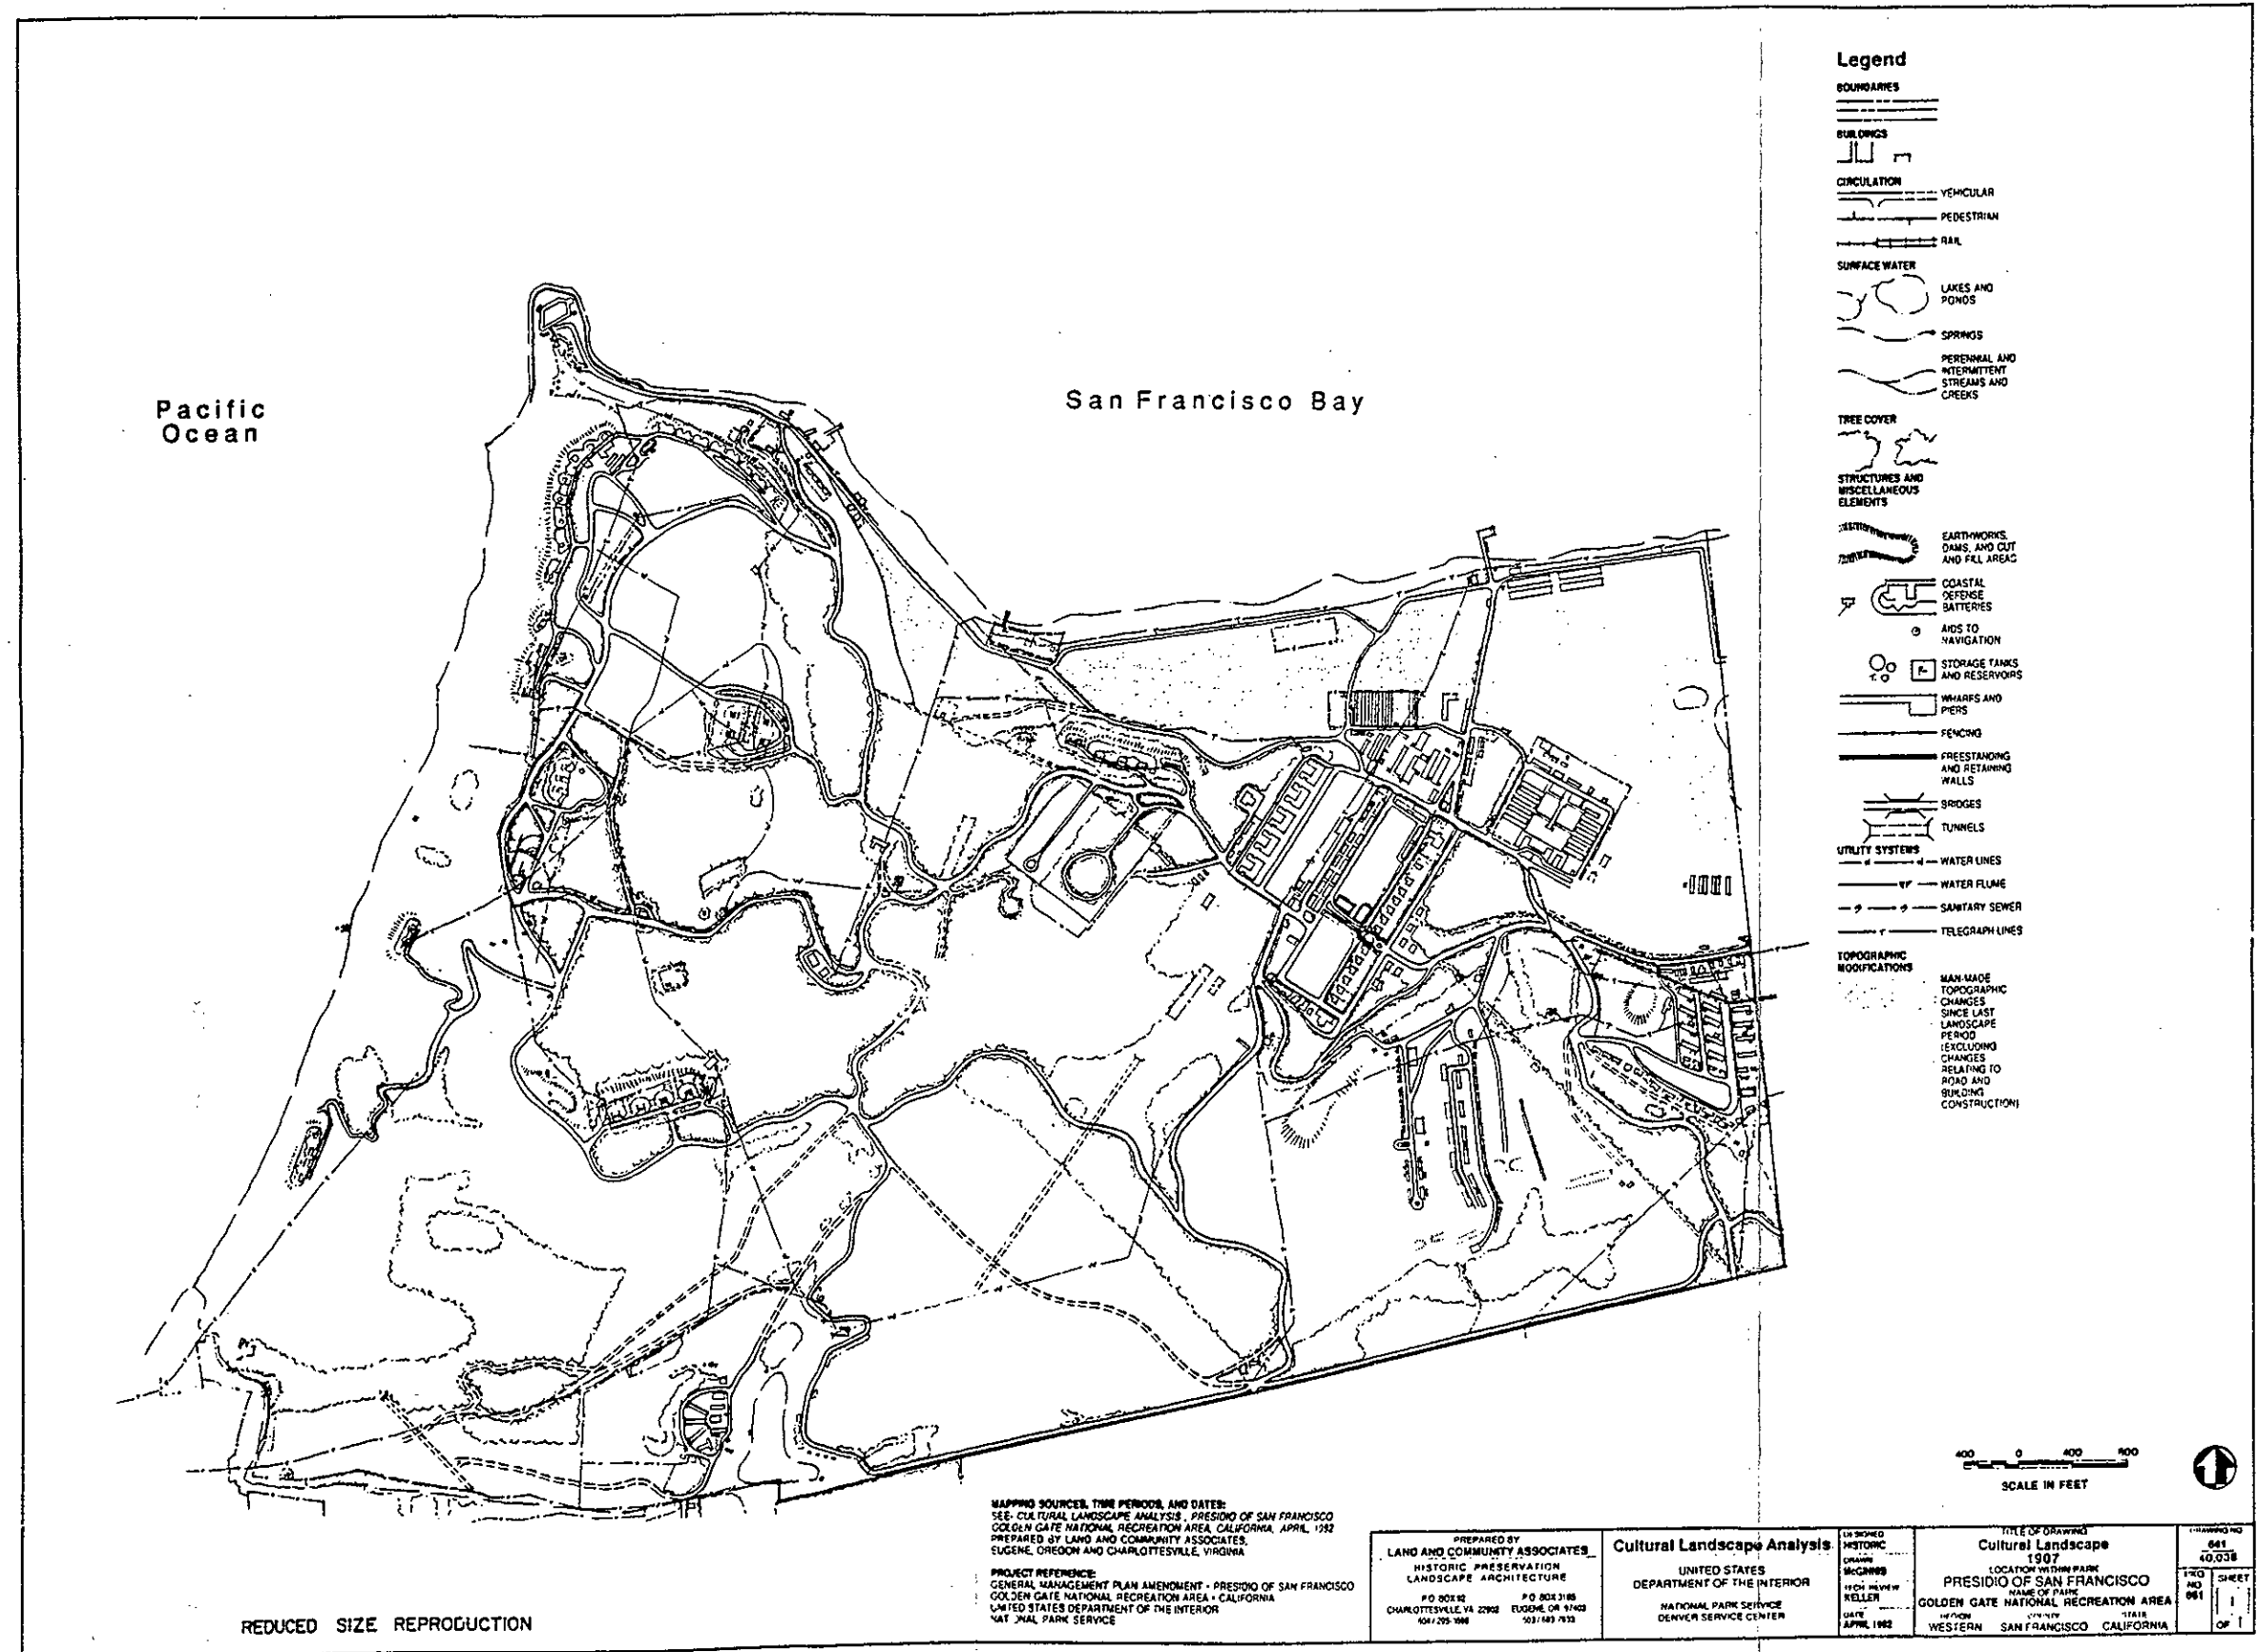
Figure 9 - 1907 map of the Presidio

Broadway Street is closed to vehicular traffic, the street is used by pedestrians and bicyclists, the street is shown on the 1907 map of the Presidio, figure 9. The street is approximately 20' wide and has a wide parking pull-off northwest of the Broadway Gate. A non-historic pipe gate blocks the entrance at Presidio Boulevard.
