## MOLOKA'I LIGHT STATION HISTORIC RESOURCES REPORT

by William Chapman

Kalaupapa National Historical Park  
 Moloka'i, Hawai'i  
 November, 2001

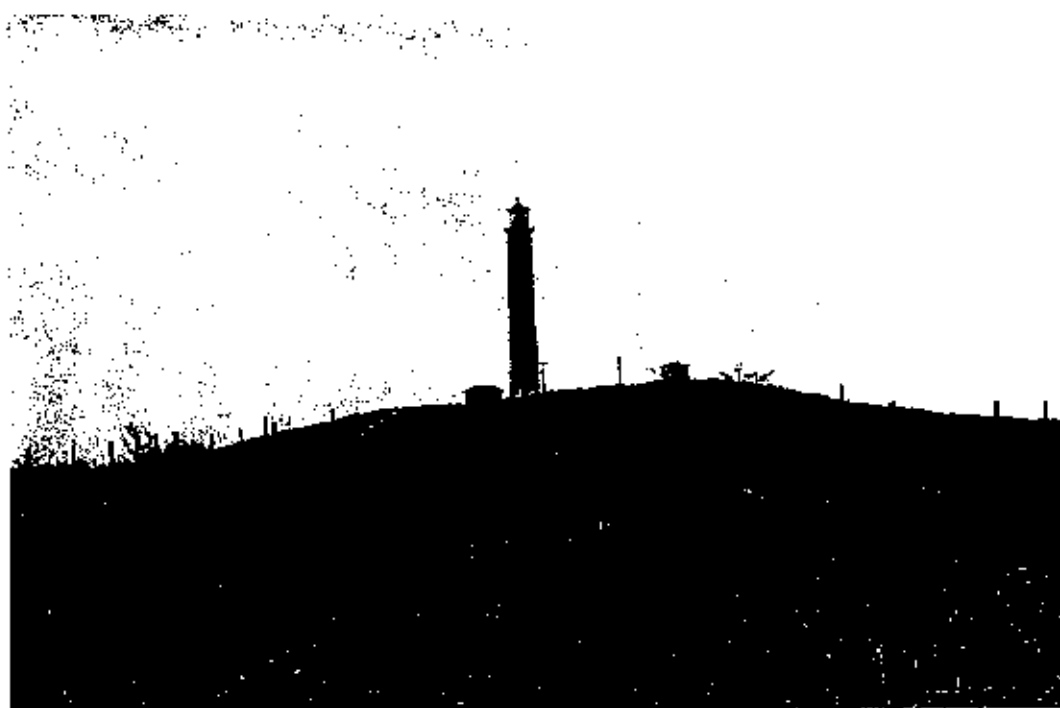
Figure 14. Kalaupapa Lighthouse, Moloka'i, Hawai'i, June 1978, Bishop Museum Archives, negative number I 114, 812 - frame 16.

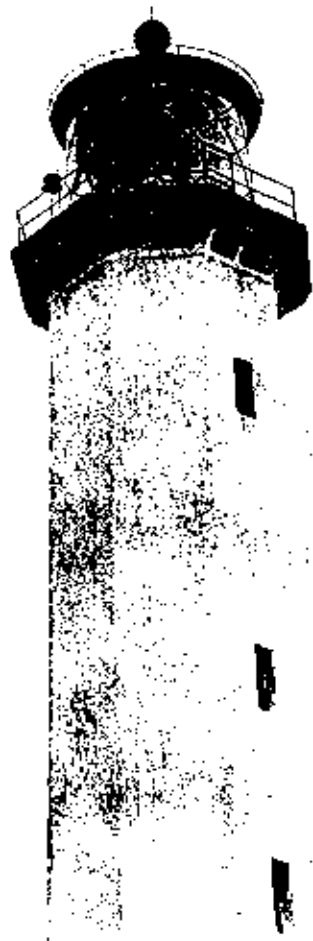
Figure 17. Detail of tower and lantern, from northwest, 1985, U.S. Coast Guard Archives, Honolulu, Hawai'i.

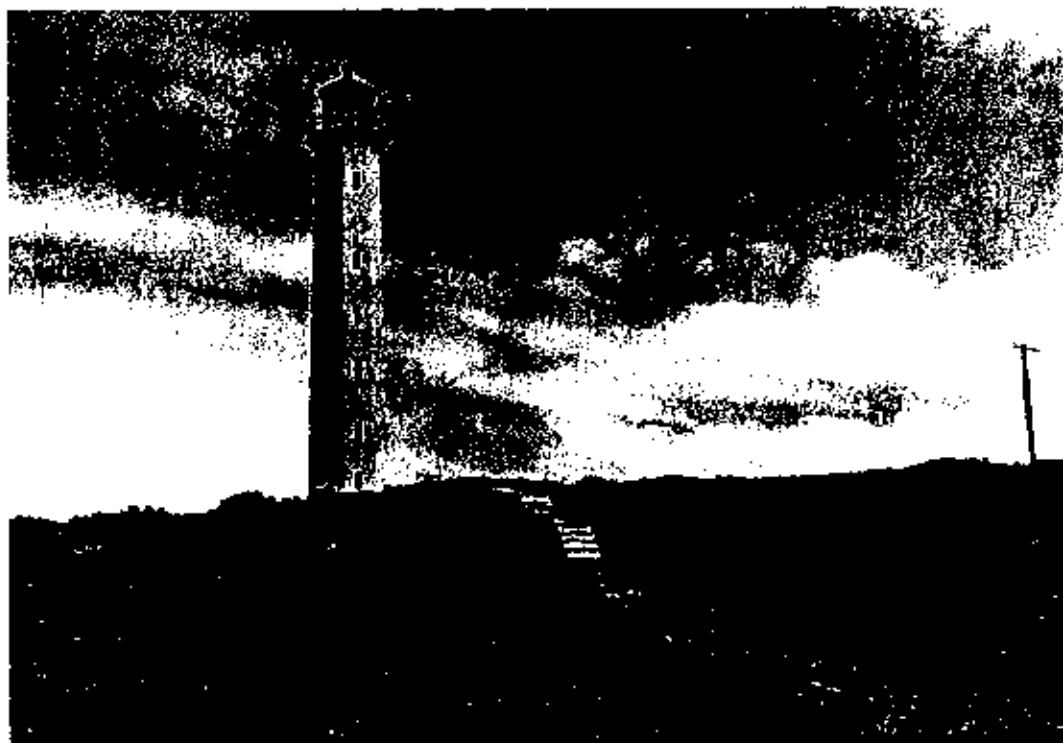
Figure 24. Lighthouse tower (Feature 1) and concrete sidewalk (Feature 2), from northeast, September, 1999. Photograph: William Chapman.

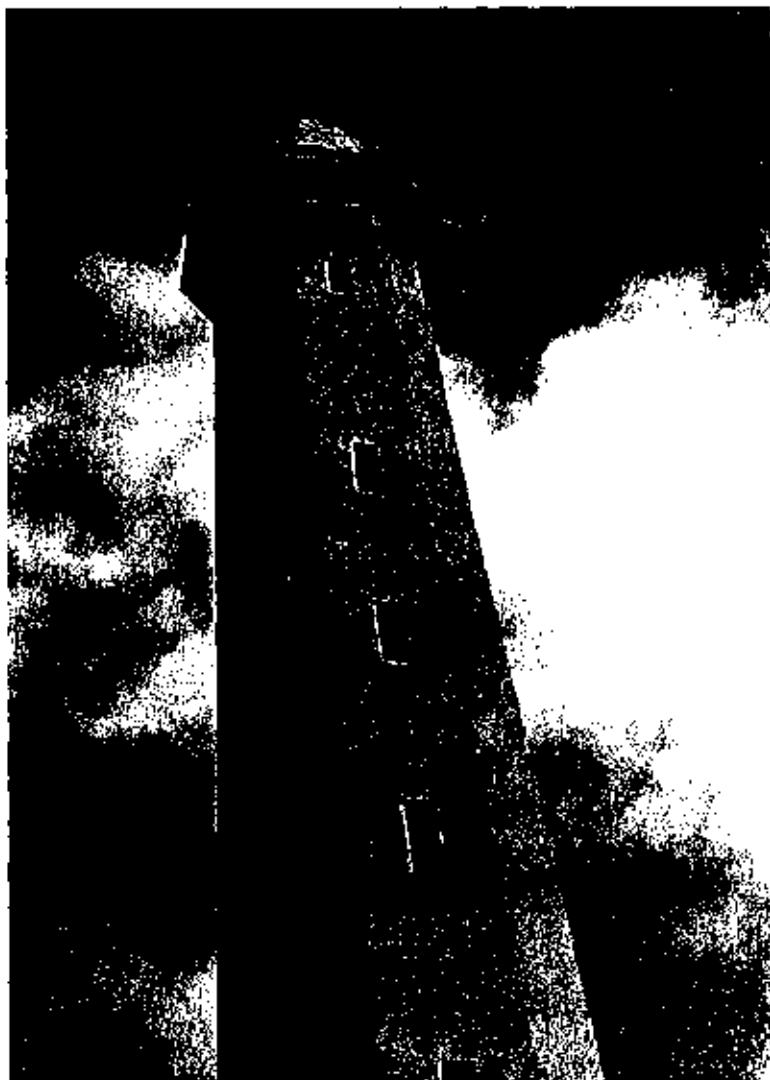
Figure 27. Lighthouse tower (Feature 1), view from west, September, 1999. Photograph: William Chapman.

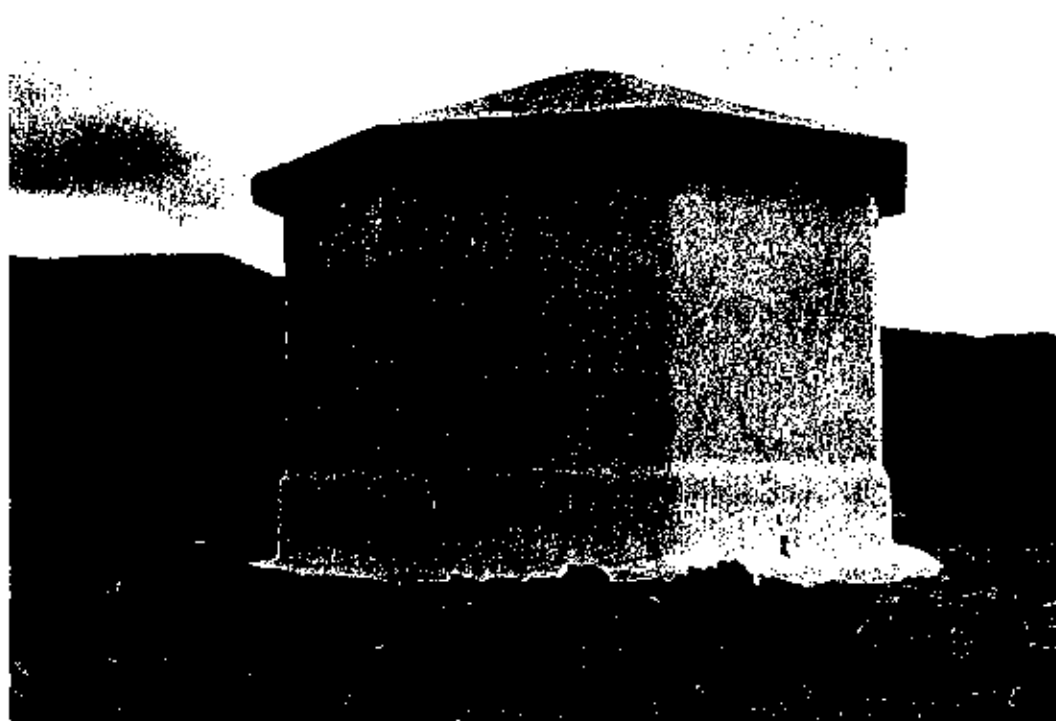
Figure 33. Octagonal, reinforced-concrete water-storage tank (Feature 3), view from north, September, 1999. Photograph: William Chapman.

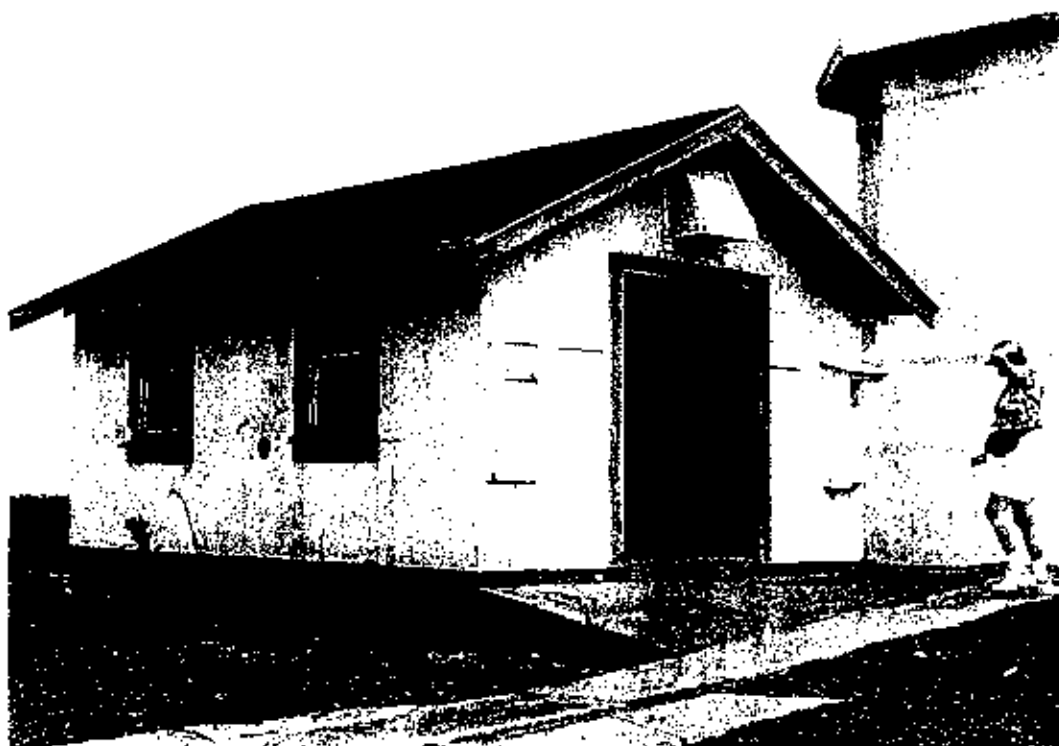
Figure 34. Wood-frame powerhouse (Feature 4), view from west, September, 1999.  
Photograph: William Chapman.

A concrete ramp extends across the front of the building. This measures 14 ft 2 in (the width of the front of the building) by 6 ft 2 in. The ramp conforms to the contours of the slope, dropping approximately 1 ft on the left (southwest) and ascending about 3 in on the right (southeast), where it adjoins the earlier (1929) sidewalk. A concrete drive straddles the walkway, just to the west of the powerhouse, allowing access to the water tank and other secondary structures near the lighthouse tower. This measures about 8 ft by 4 ft (with an additional 2 ½ ft for the pre-existing sidewalk) and crosses the walk at a diagonal about 3 ft west of the concrete ramp.

The small building is of frame construction, the frame consisting of true 2 x 4 in members, with the upright posts (studs) set about 3 ft on center. There is a horizontal member at about three ft above grade; also a 4 x 4 in sill and top plate. The structure is braced in the corners by 2 x 4 in diagonal members, which interlock with the supporting studs. The structure is attached by metal bolts to the reinforced concrete floor and foundation.

The exterior of the building is clad with 6 in (actually 5 ½ in) vertical siding. The cladding is exposed on the interior. The boards are tongue-and-groove Douglas fir, of the type common in Hawai'i during this period.

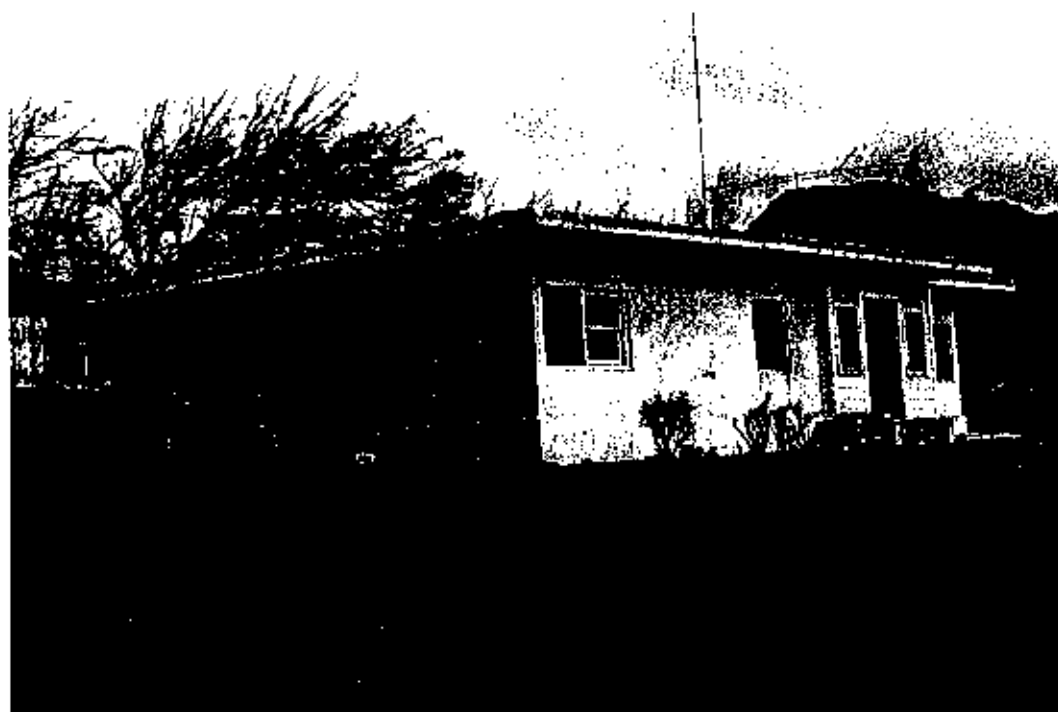
Figure 41. First Assistant Keeper's Residence, later Keeper's Residence (Feature 8), view from northwest, September, 1999. Photograph: William Chapman.

| Figure 41. First Assistant Keeper's Residence, later Keeper's Residence (Feature 8), view from northwest, September, 1999. Photograph: William Chapman. | 168 |

The First Assistant Keeper's Residence is a one-story, concrete-block, flat-roofed building located in the near middle of the historic keepers' compound. Measuring about 30 by 46 ft overall, the house sits on slightly sloping land, which rises toward the rear of the building. Extremely

utilitarian in style, the walls consist of white-painted, and unembellished concrete blocks sitting on a poured concrete foundation. The roof, which is constructed with wood rafters, is cantilevered about 3 ft from the surface of the wall. The eaves are boxed, with a fascia of about 6 in in width running around the building on all sides. The ends of the 2 x 6-in rafters are visible in the soffits. The edges of the roof have 3-in metal flashing; the roof covering is rolled roofing (asphalt), colored a bright white.

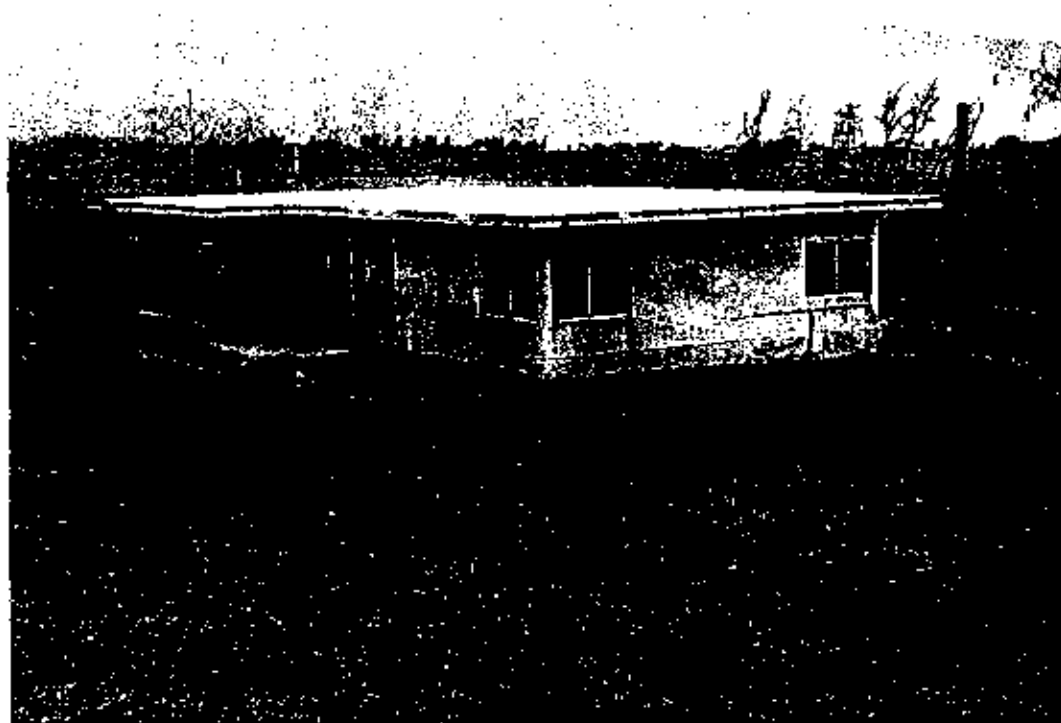
**Figure 42. First Assistant Keeper's Residence, later Keeper's Residence (Feature 8), view from northeast, September, 1999. Photograph: William Chapman.**

| Figure 42. First Assistant Keeper's Residence, later Keeper's Residence (Feature 8), view from northeast, September, 1999. Photograph: William Chapman. | 169 |

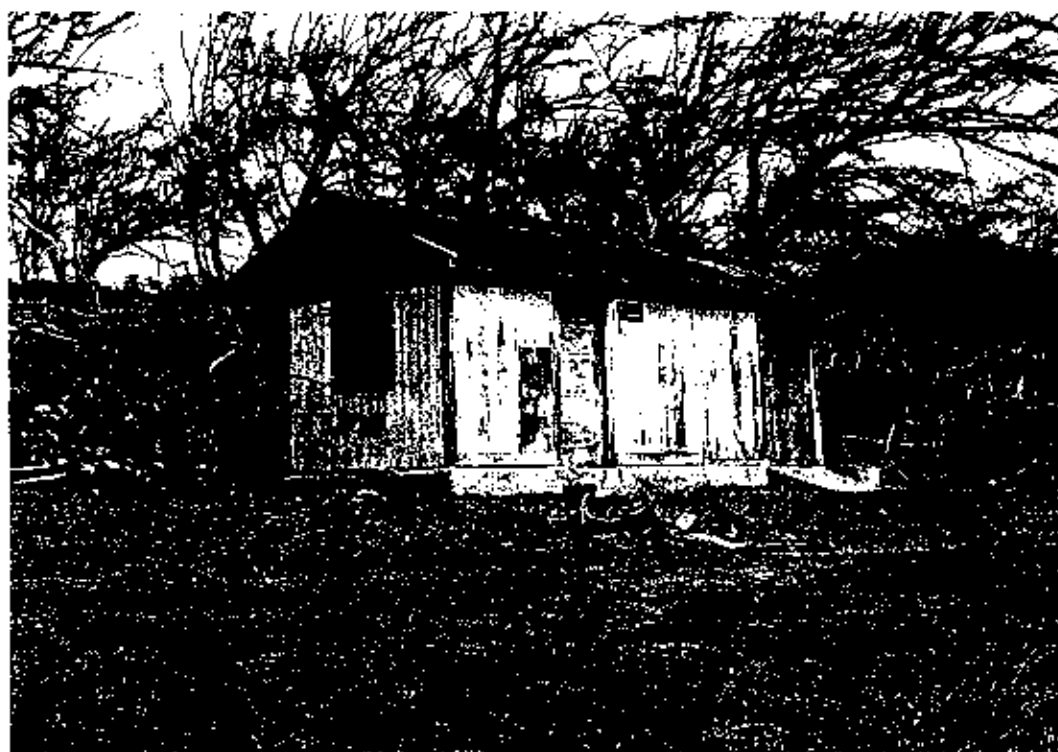
Figure 45. Wash house/Storage shed (Feature 9), view from northwest, September, 1999. Photograph: William Chapman.

| Figure 45. Wash house/Storage shed (Feature 9), view from northwest, September, 1999. Photograph: William Chapman. | 176 |

The present building is a one-story frame structure, measuring 20 by 9 ½ ft. Constructed of 5-in wide tongue-and-groove vertical boards, with some interior framing members, on the north and of a mixture of 7-in wide vertical and 6-in wide horizontal siding on the later south addition, the structure sits on a poured, reinforced concrete slab, which projects about 2 in from the face of the building. Built on a slight slope, the concrete base extends about 12 in above grade on the west side,

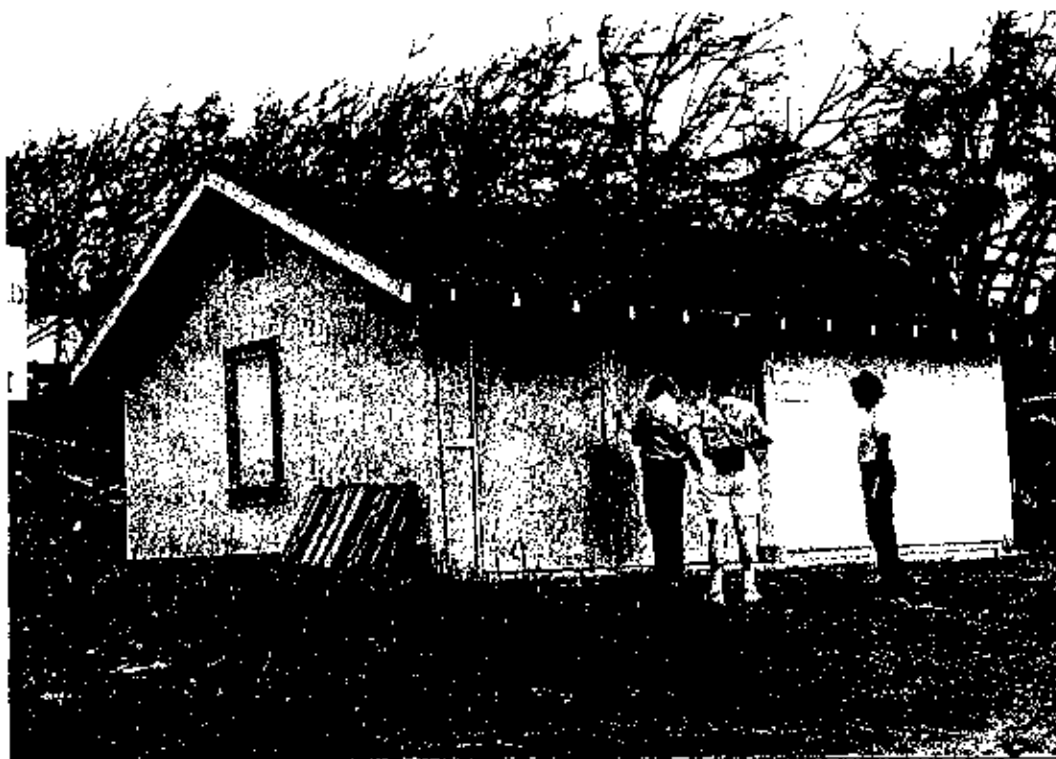
Figure 46. Wood-frame garage (Feature 10), from northwest, September, 1999.  
Photograph: William Chapman.

| Figure 46. Wood-frame garage (Feature 10), from northwest, September, 1999. Photograph: William Chapman. | 178 |

The simple, rectangular structure measures 17 ft 3 in by 25 ft 2 in. It is oriented roughly north and south, following the longitudinal ridge of the gabled-roof. Placed on a concrete foundation and slab, which extends 14 in above grade on the west and 6 in above grade on the east, the building has a simple 2 x 4-in frame construction and is sheathed in 5-in wide tongue-and-groove vertical boards.

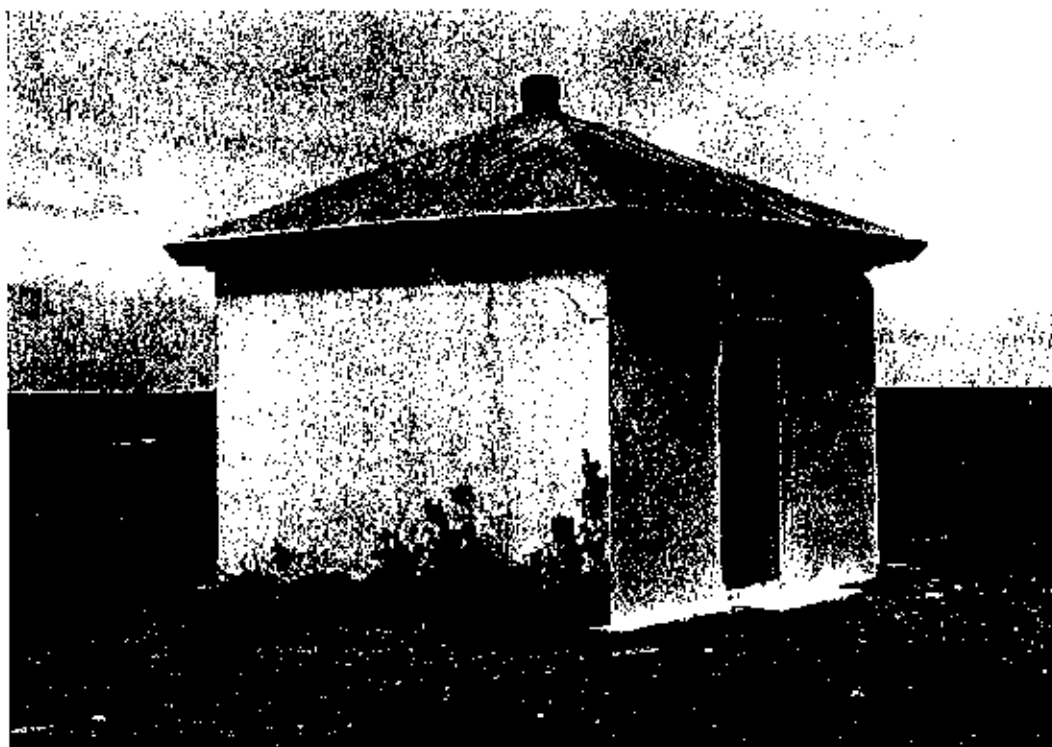
Figure 48. Oil-storage building (Feature 11), view from south, September, 1999.  
Photograph: William Chapman.

| Figure 48. Oil-storage building (Feature 11), view from south, September, 1999. Photograph: William Chapman. | 182 |

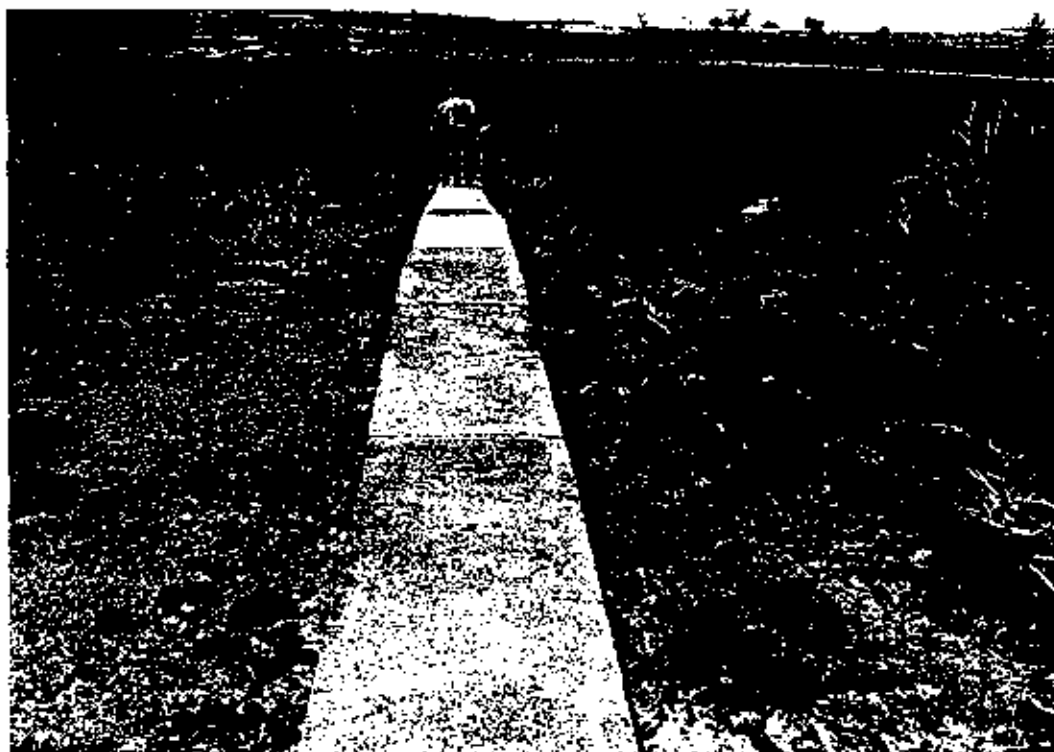
**Figure 50. Concrete sidewalk (Feature 12) from southeast, September, 1999.  
Photograph: William Chapman.**

| Figure 50. Concrete sidewalk (Feature 12) from southeast, September, 1999. Photograph: William Chapman. | 186 |

The concrete walkway served as a means of communication between the keepers' compound and the lighthouse tower. Before its construction keepers relied on unpaved paths to carry out their duties. The walk is 450 ft long, beginning at the edge of the keepers' compound and ending at the steps to the lighthouse tower. It travels in a east-southeasterly direction for a distance of 250 ft, then turns eastward for 150 ft, then southeastward for the remaining 50 ft. Divided into 10 ft sections and 32 in wide, the walk is broken by six sets of steps. The first of these is a single step, the next 2 steps, the next 5 steps, the next 4 steps, the next 2 steps, and the last, near the top, 1 step again. Each of the steps is about 6-7 in high and 1 ft deep.

concrete walkway in its middle. Total dimensions are about 8 by 4 ft, not including the 32-in wide walkway.

The concrete has a 3-in smooth edge on four sides of each section. Overall the walkway is in good condition, with some minor settlement and tilting along its course.

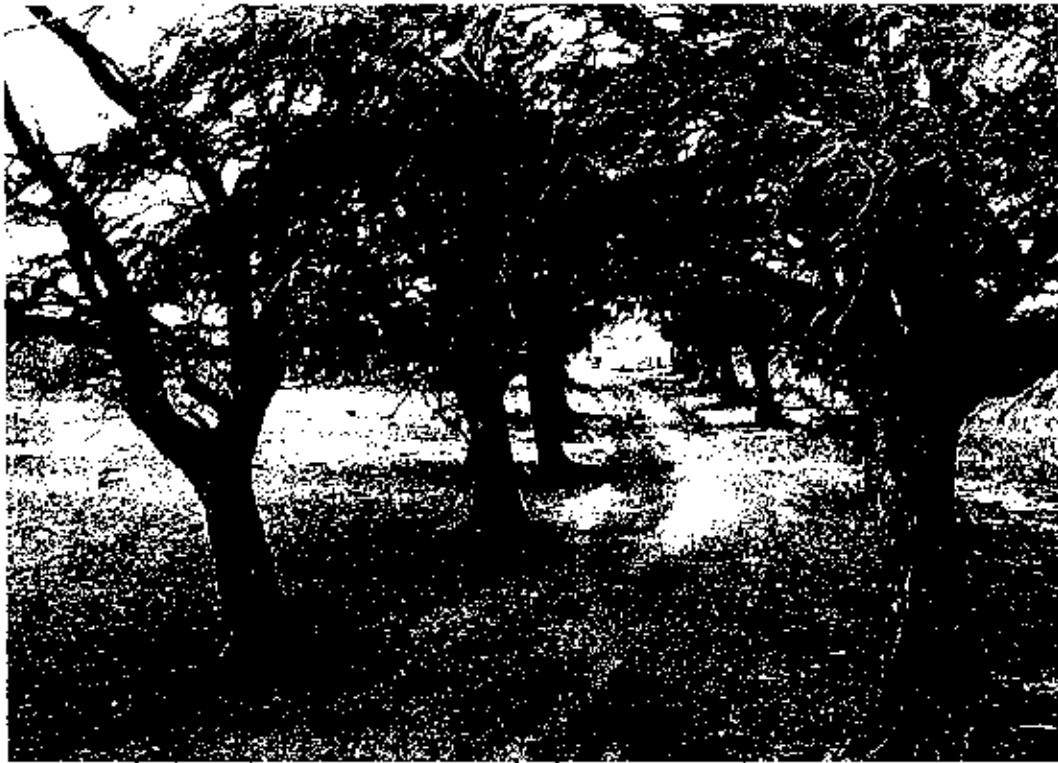
**Figure 51. Principal access road and Ironwood trees (Features 13 and 19), view looking west/northwest, September, 1999. Photograph: William Chapman.**

| Figure 51. Principal access road and Ironwood trees (Features 13 and 19), view looking west/northwest, September, 1999. Photograph: William Chapman. | 188 |

The road as nominated to the National Register extends from the northwest edge of the plot in a southeasterly direction, then curves toward the south in a wide arc ending at a point in front of and parallel to the west wall of the keepers' compound for a distance of about 700 ft. Just to the north and west of the keepers' compound the road splits, with one branch going eastward toward the lighthouse tower, then southward to the rear of the keepers' compound.

The road is gravel surfaced and graded. It appears to follow its historic route.
