**Archeological Investigations at the  
Harriet Dean House (11SG272),  
Lincoln Home National Historic Site,  
Springfield, Illinois**

National Park Service - Midwest Archeological Center

Enclosed are seven copies of a report entitled "Archeological Excavations at the Harriet Dean House (11SG272), Lincoln Home National Historic Site, Springfield, Illinois," by Vergil E. Noble. This report describes the results of archeological test excavations conducted at the Cook House prior to its restoration and adaptive reuse.

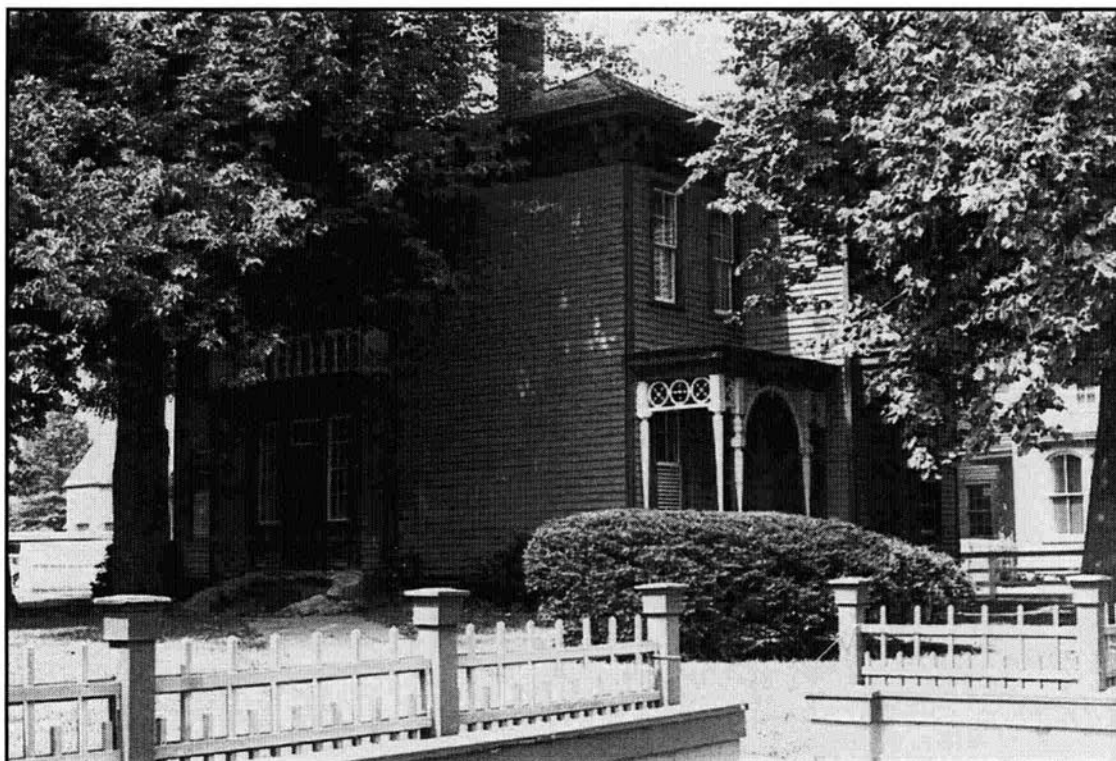
Figure 1. The Harriet Dean House as it appeared in 1991: viewed from the southeast (top) and viewed from the west (bottom).

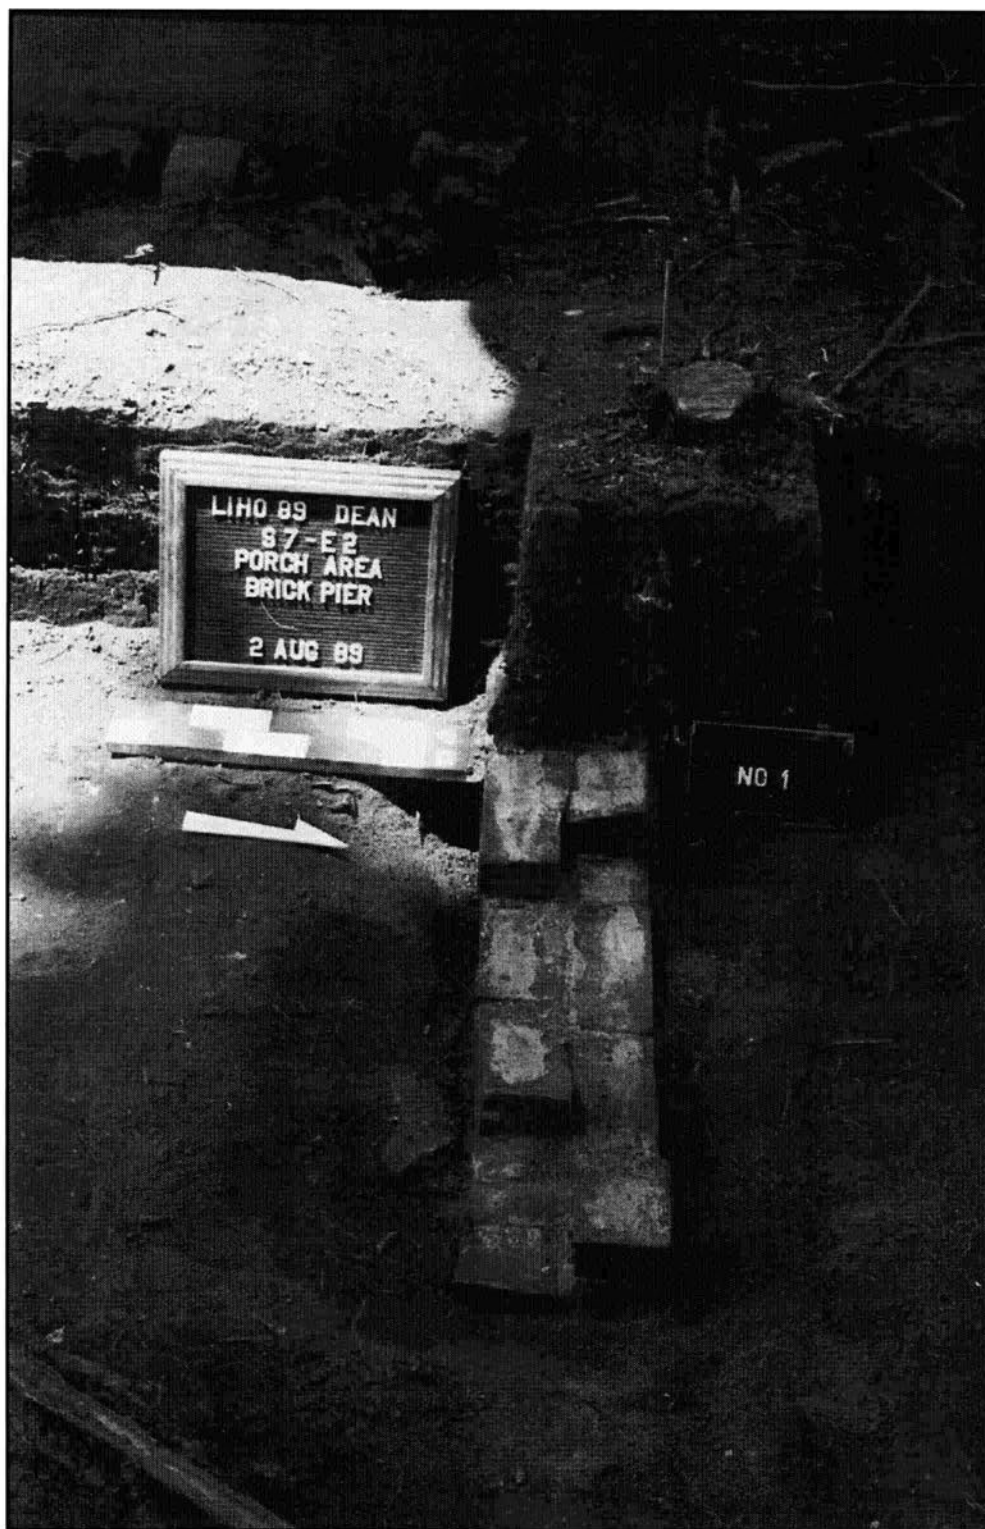
Figure 14. Front porch area and the north brick alignment, looking west toward the entry of the Harriet Dean House.

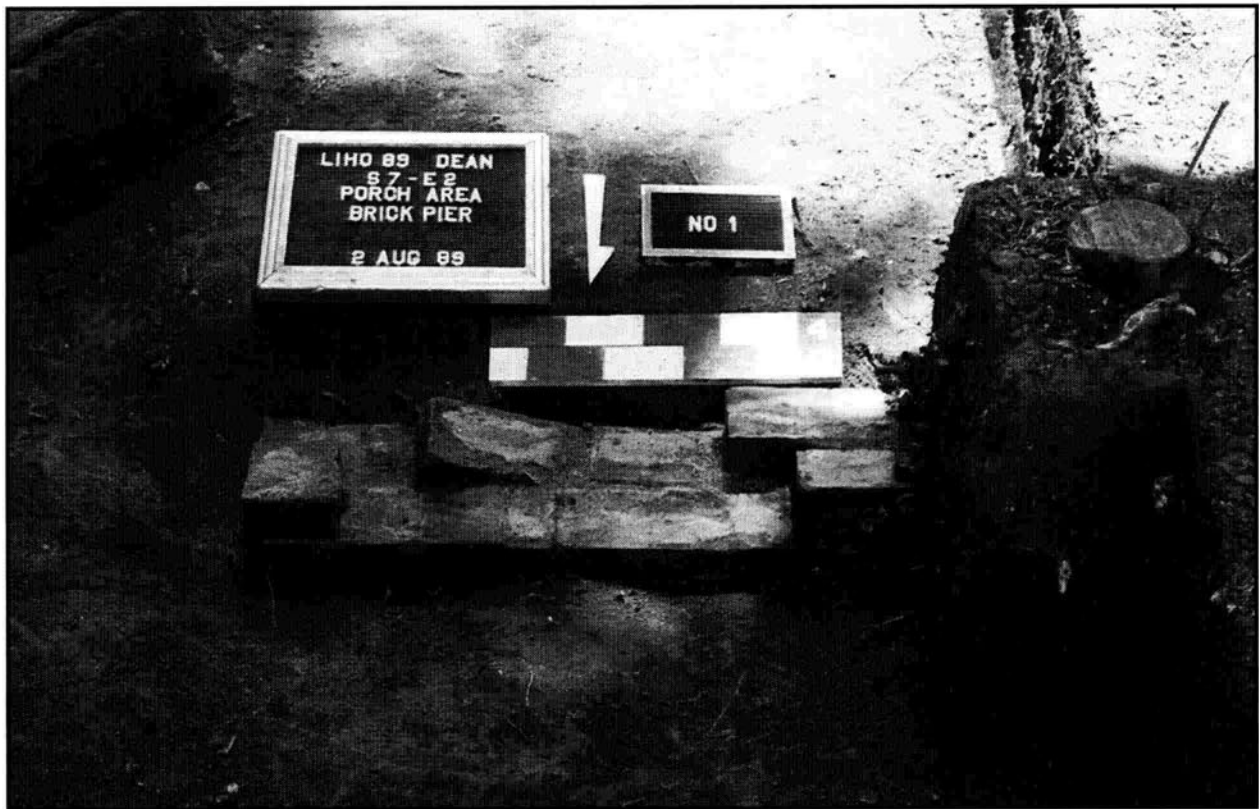
Figure 15. Front porch area and profile of the north brick alignment.

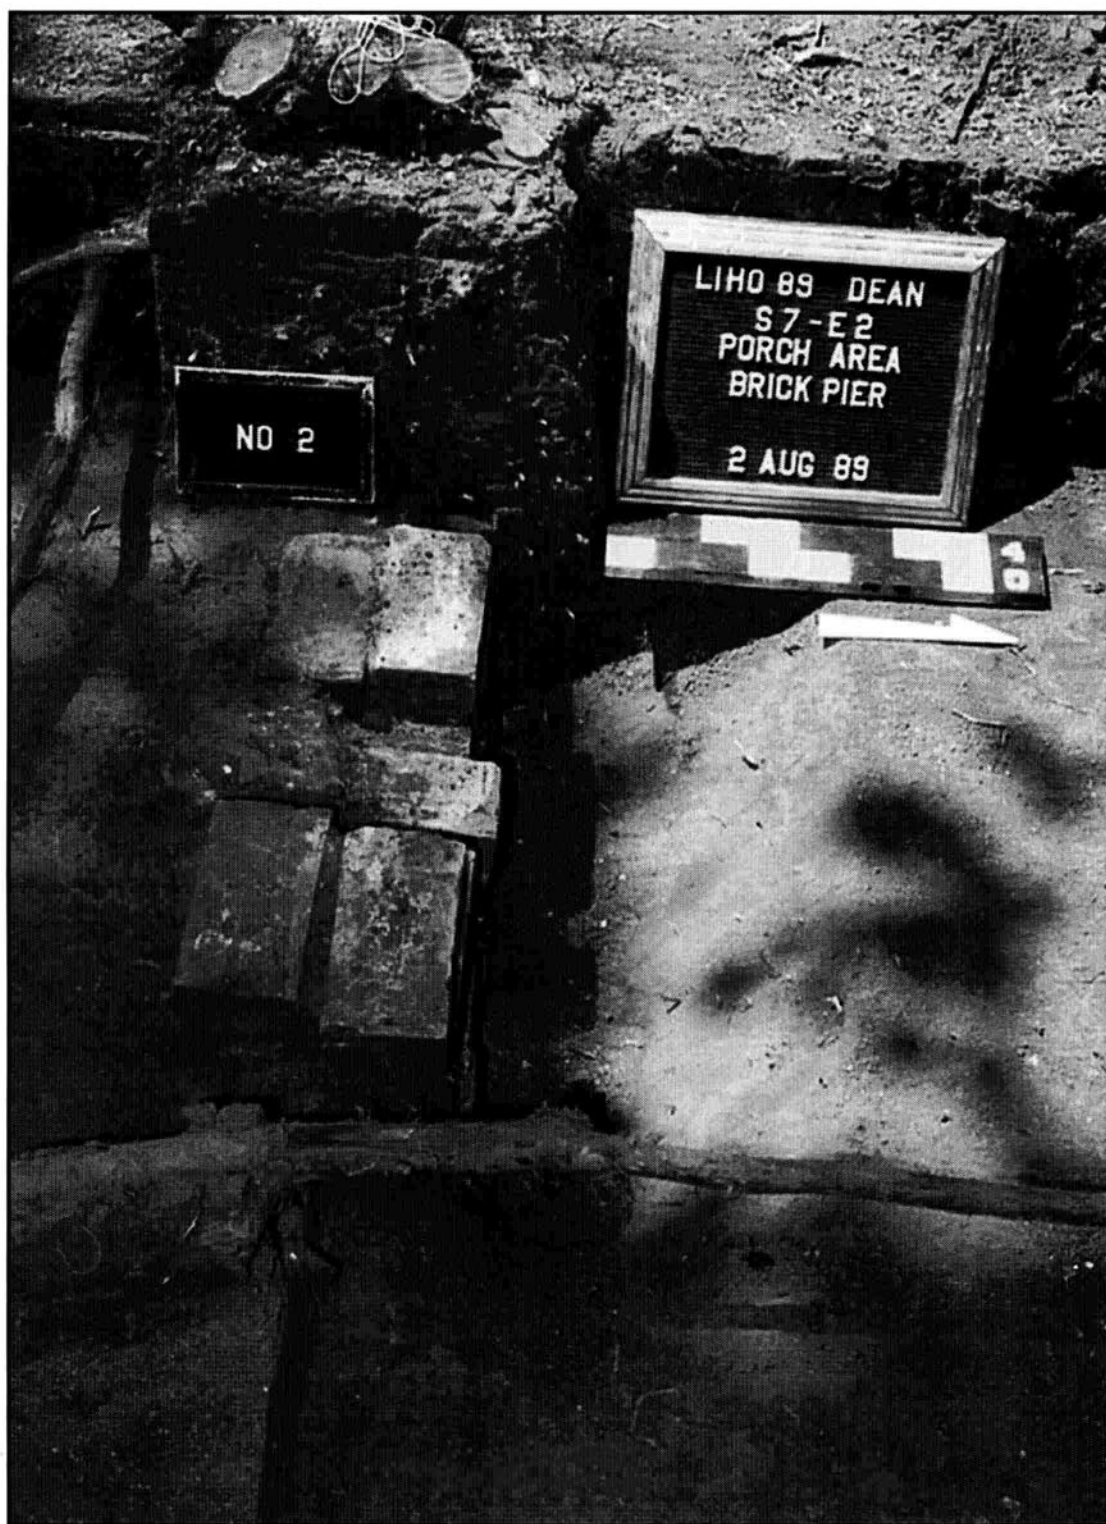
Figure 16. Front porch area and the south brick alignment, looking west toward the entry of the Harriet Dean House.

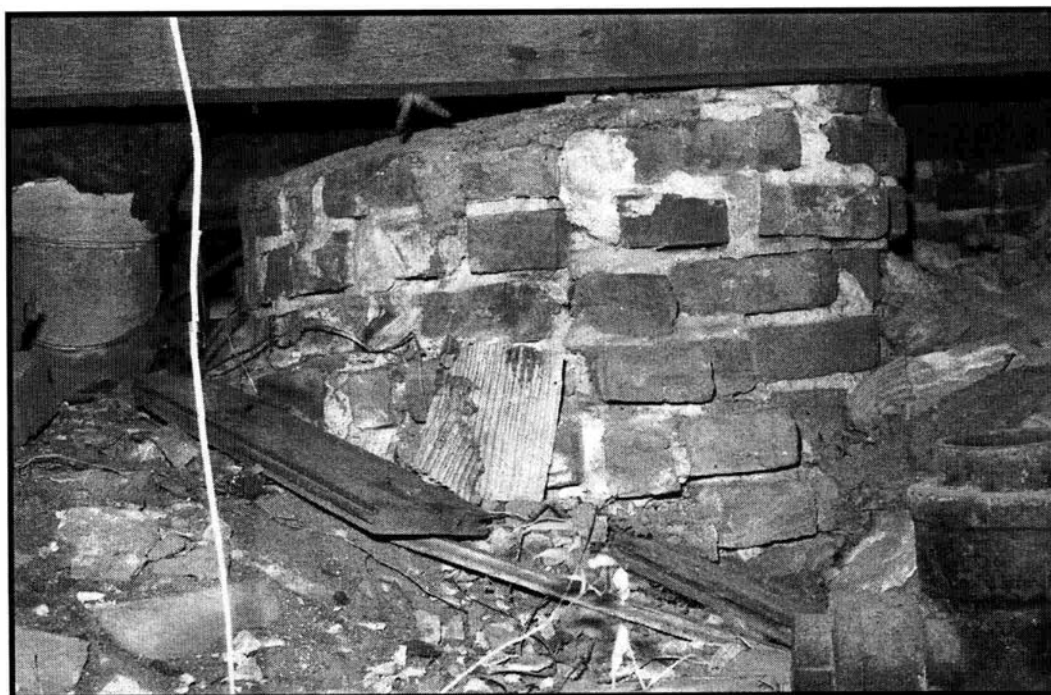
Figure 18. Cistern in Harriet Dean House crawl space.
