DISCOVERY OF A  
**NECHES RIVER FERRYBOAT**  
**BIG THICKET NATIONAL PRESERVE**  
TYLER COUNTY, TEXAS

JAMES E. BRADFORD

1992

National Park Service  
Division of Anthropology  
BRANCH OF CULTURAL RESOURCES MANAGEMENT  
PARK PAPERS BITH-02  
Santa Fe, New Mexico

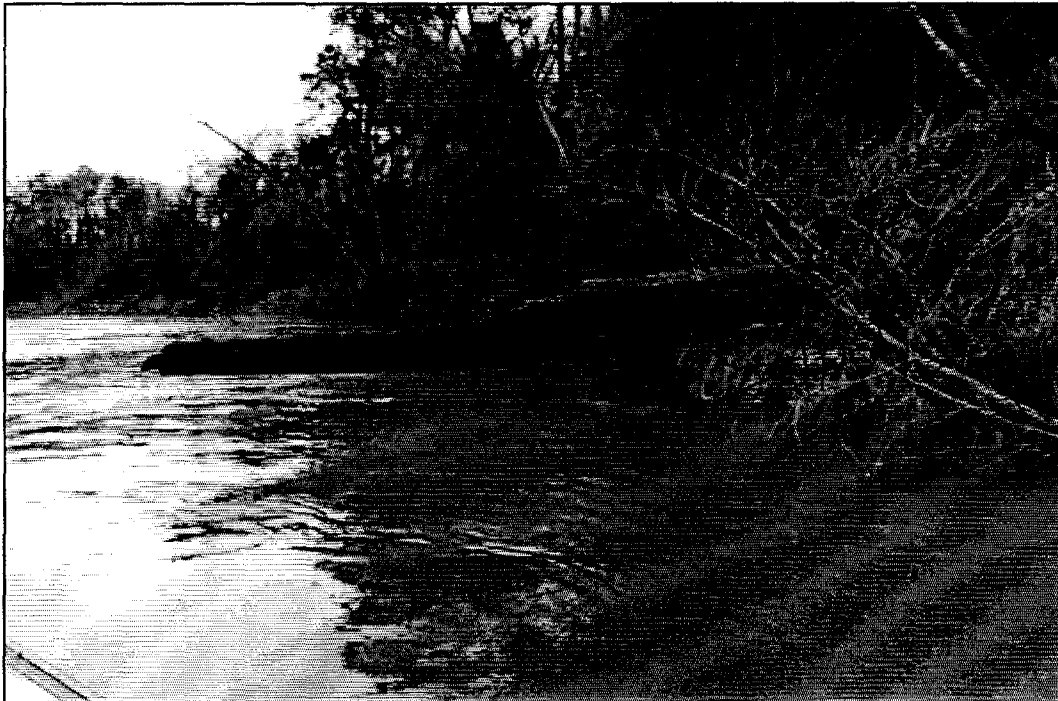
FIGURE 2: View downriver of one chine log extending out of the river bank and over the Neches River.

The craft appears to be the nearly intact remains of a wooden ferryboat. Fourteen feet of hull, an estimated one-quarter to one-third of the total length, was found projecting out over the river with the remainder buried beneath 13.5 feet of river bank sand (Figures 2-5). Inspection revealed a flat bottomed, keel-less craft of basic barge construction (Figures 6 and 7).

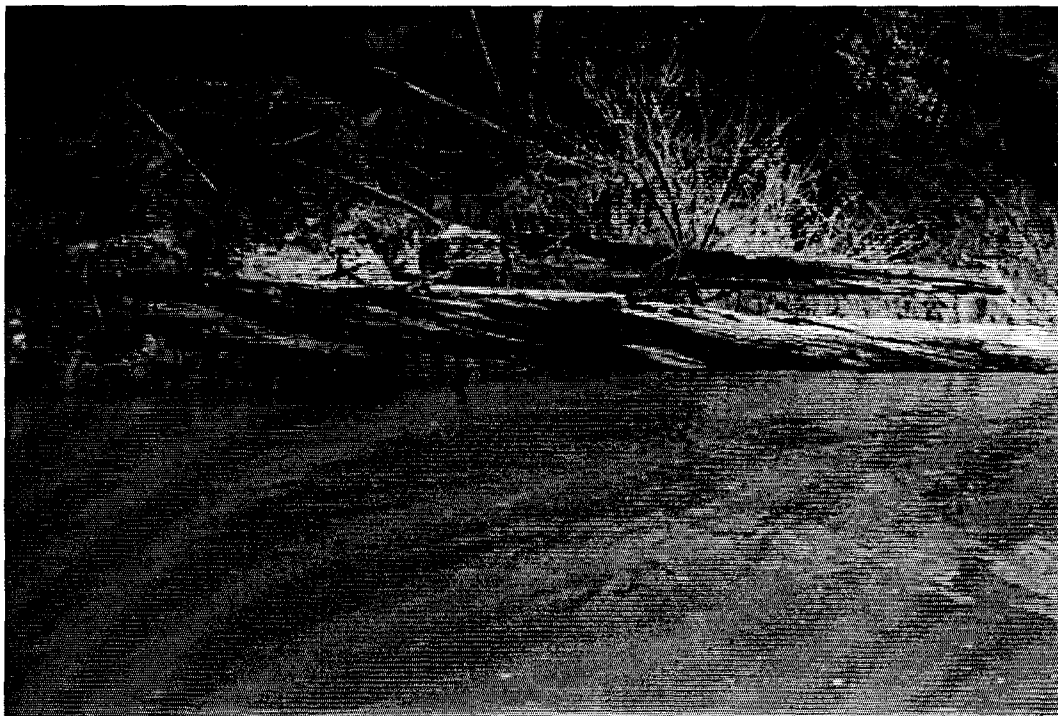
FIGURE 3: View west toward the river bank showing the chine logs protruding from the sandy river bank.

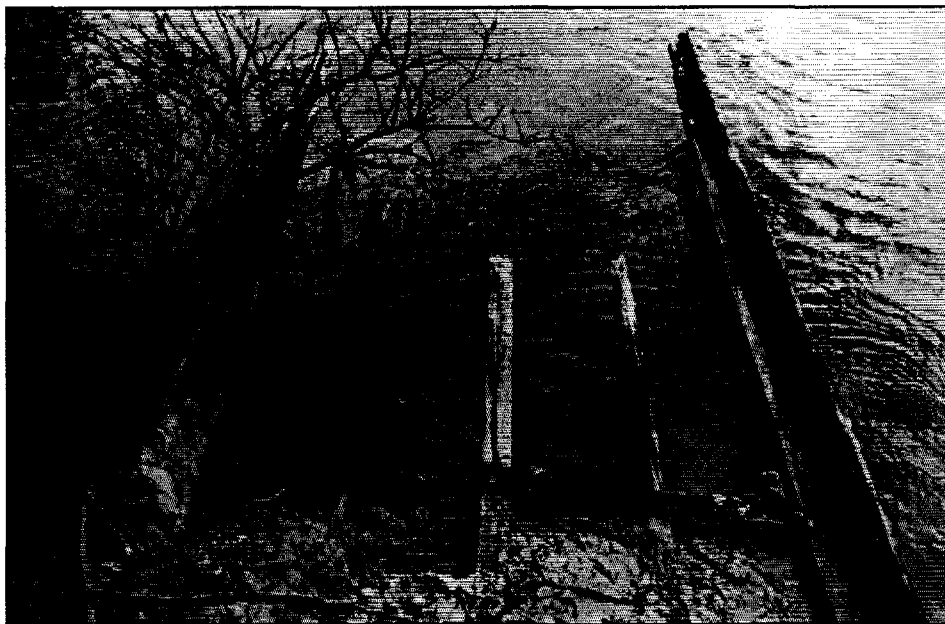
FIGURE 4: View from bank looking upriver showing the major exposed features of the ferryboat remains. The two chine logs bracket the three interior stringers.

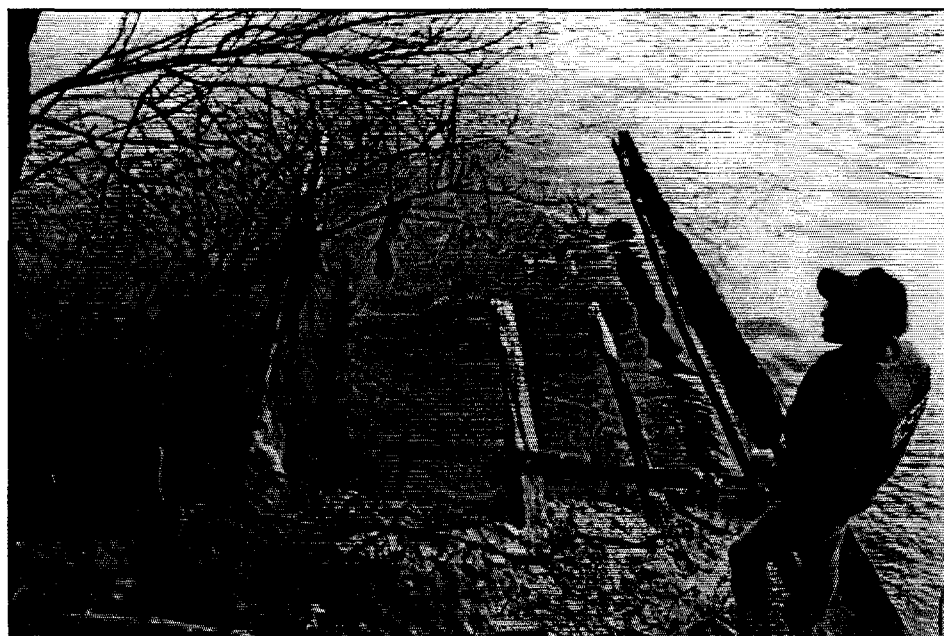
FIGURE 5: Same view as Figure 4 with Jim Trott for scale. Note the single deck plank across the stringers.

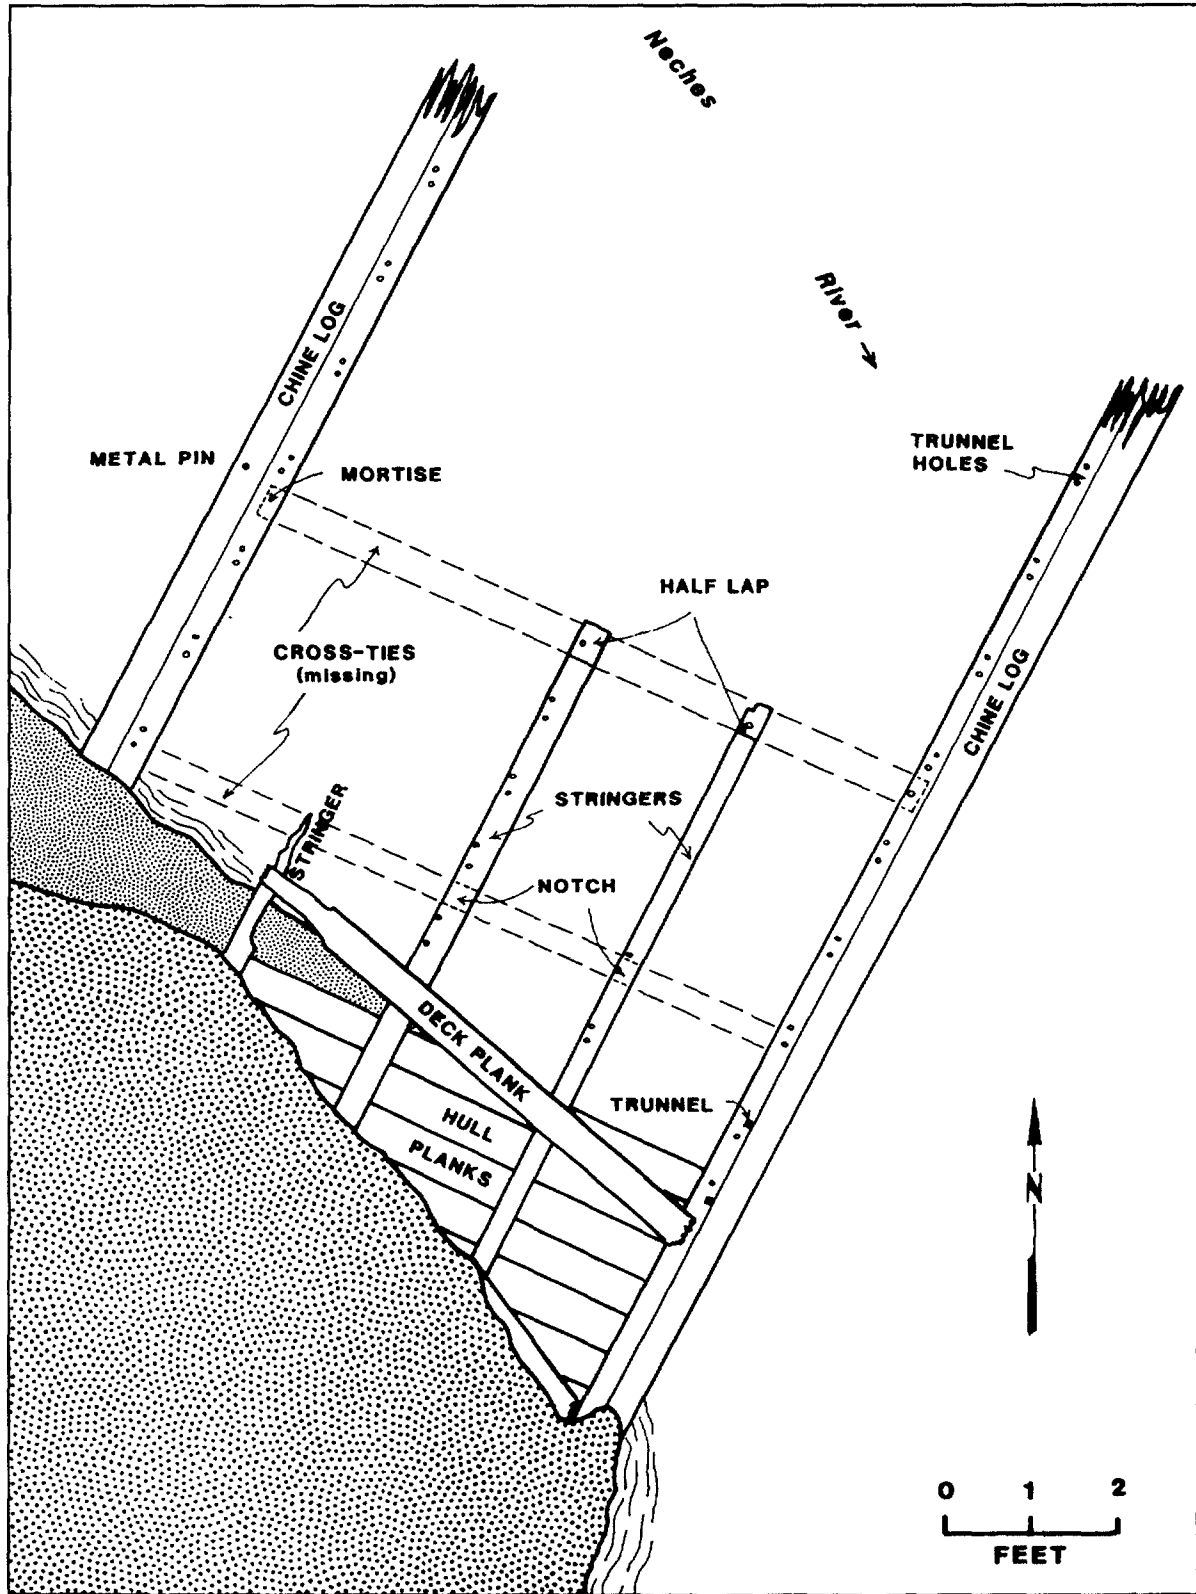
FIGURE 6: Plan Map of the Ferryboat Site.

The single piece of metal noted on the vessel is a 3/4-inch diameter pin driven in the gunwale of the north chine log (Figure 6). The function of this item is unknown, but the lack of any other metal in the construction of this vessel is noteworthy.

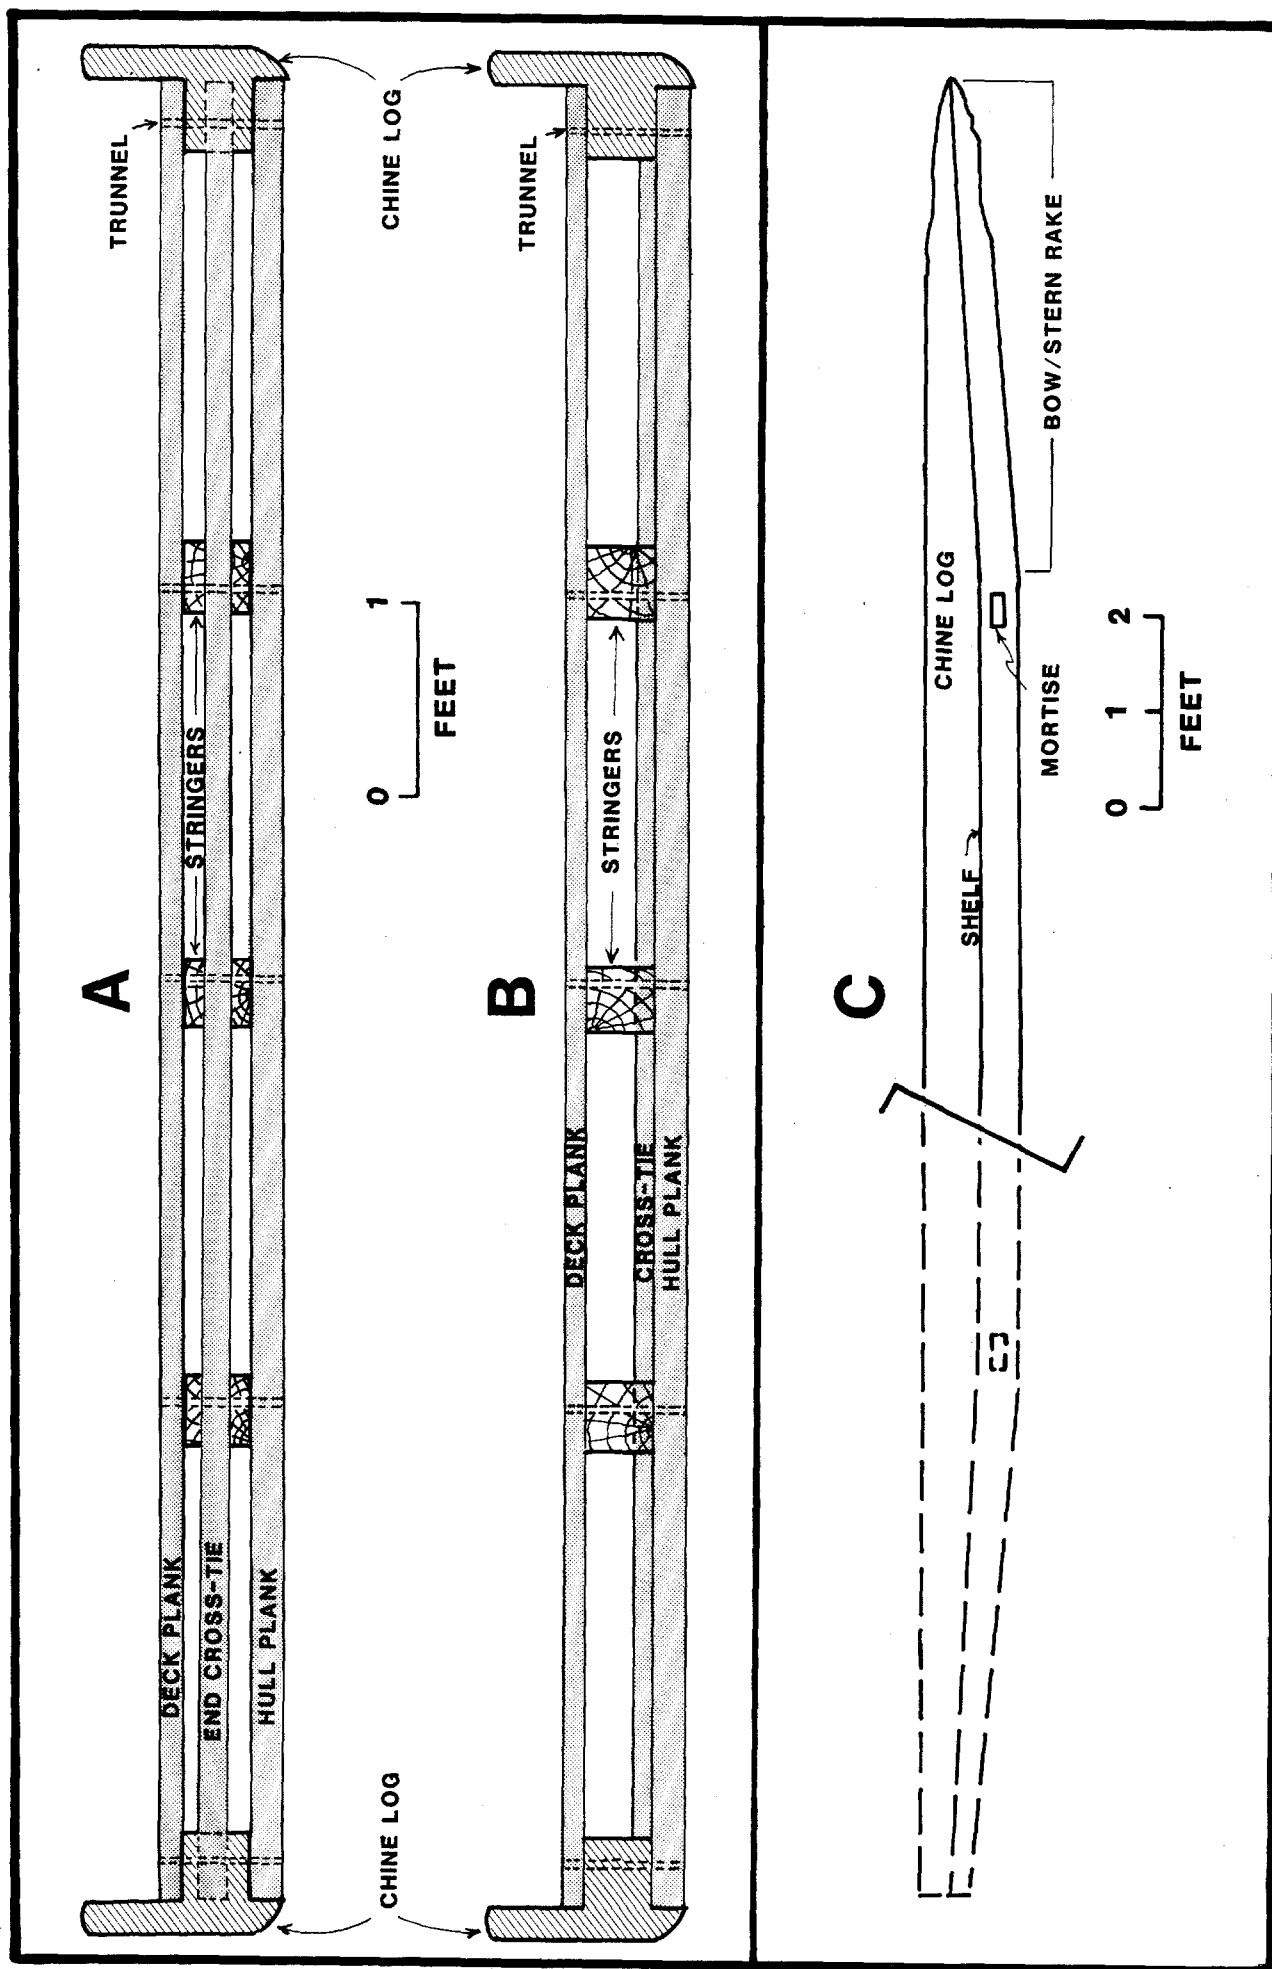
FIGURE 7: Reconstructed Cross Sections and Elevation of the Ferryboat.

The cross-ties, or frames, are composed of two types: 1) a heavier piece measuring 4.5 inches wide by 1.5 inch thick that was fitted into a mortise in the shelf just aft of the run, or bow/stern rake, of the craft (Figures 6, 7c and 10); and 2) a slightly smaller board measuring 3.5 inches by 1 inch located 3 feet aft of the heavier frame (Figures 6 and 10). The method of attachment of the smaller piece to the chine logs could not be determined; no mortises were observed in the shelf at this point. In cross section the heavier frame is situated midway between the hull planking and flooring within the bilges (Figure 7a), while the smaller cross-ties were situated so as to lay directly on top of, and parallel with, the hull planking (Figure 7b). Based on this evidence, it is suggested that a series of three or four (depending on the actual length of the craft) of the smaller cross-ties are between the two larger end frames.

The craft was strengthened longitudinally by three stringers between the chine logs: one on centerline, and one to either side. All three measure 4 by 4 inches and run at least the waterline length of the craft. Whether they continued up the stern/bow rake to a transom can only be answered by exposing the buried end. With the exception of the chine logs, all structural members in the last 5 to 6 feet are missing from the exposed end of the vessel. Where the larger cross-tie was located, a half lap was cut in the top of the stringers to support it (Figures 6, 10 and 12). With the smaller cross-ties, a single notch was cut in the underside of the stringers, thus allowing the stringers to overlay the cross-ties which, in turn, were flush with the hull planking below (Figures 6, 7, 10 and 11).

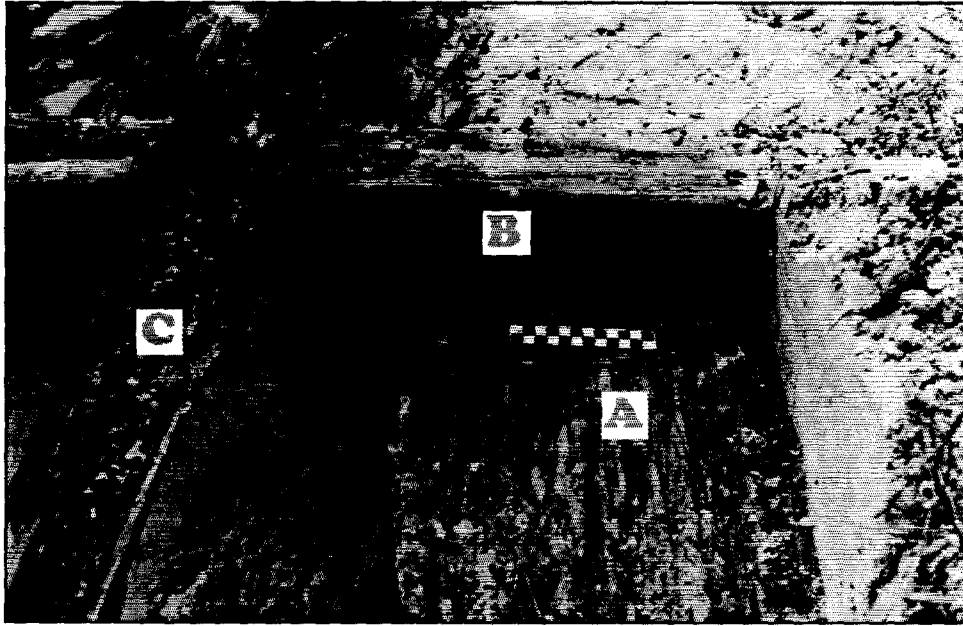
FIGURE 8: Closeup showing construction detail. Hull planking (A) exposed in river bank underlays, and is attached to, the stringer (B). Deck planking (C) overlays the stringer. Scale is 4.6 in/12cm.

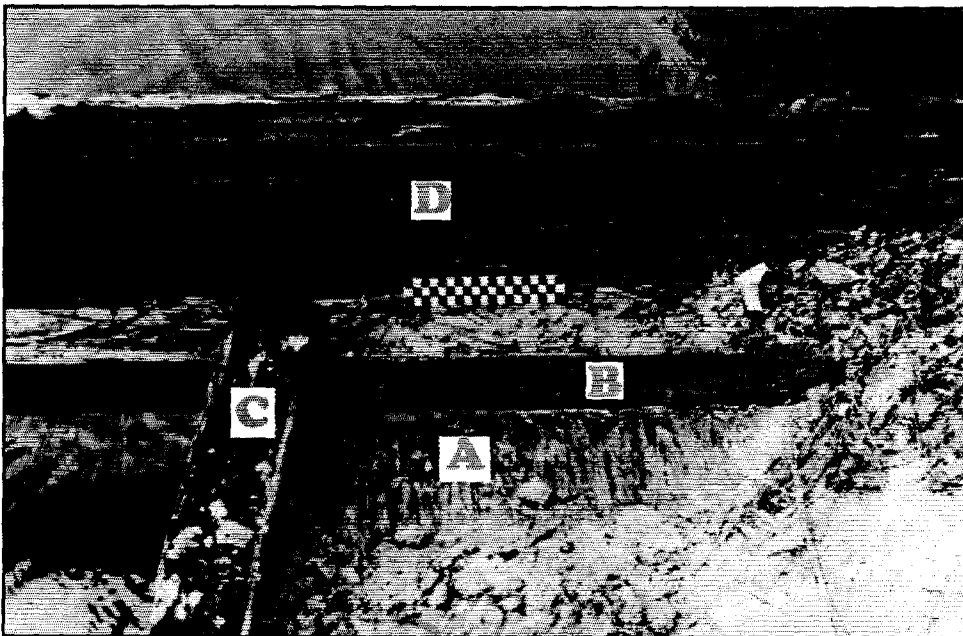
FIGURE 9: Closeup of construction detail. A - hull planking, B - chine log shelf, C - deck plank, and D - chine log. Scale is 7.5 in/19 cm.

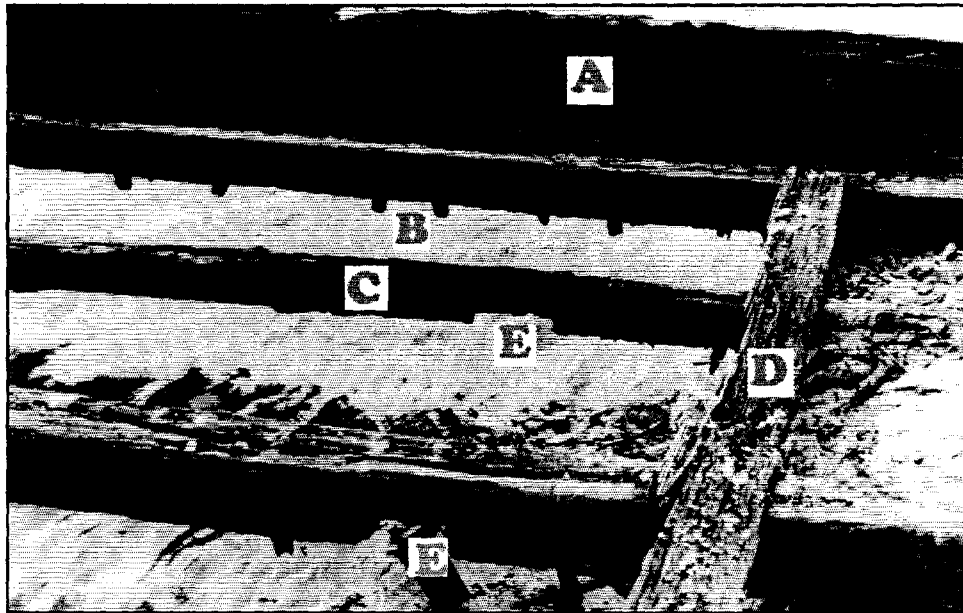
FIGURE 11: Construction detail. A - chine log, B - trunnels, C - stringer, D - deck plank, and E - notch in underside of stringer.

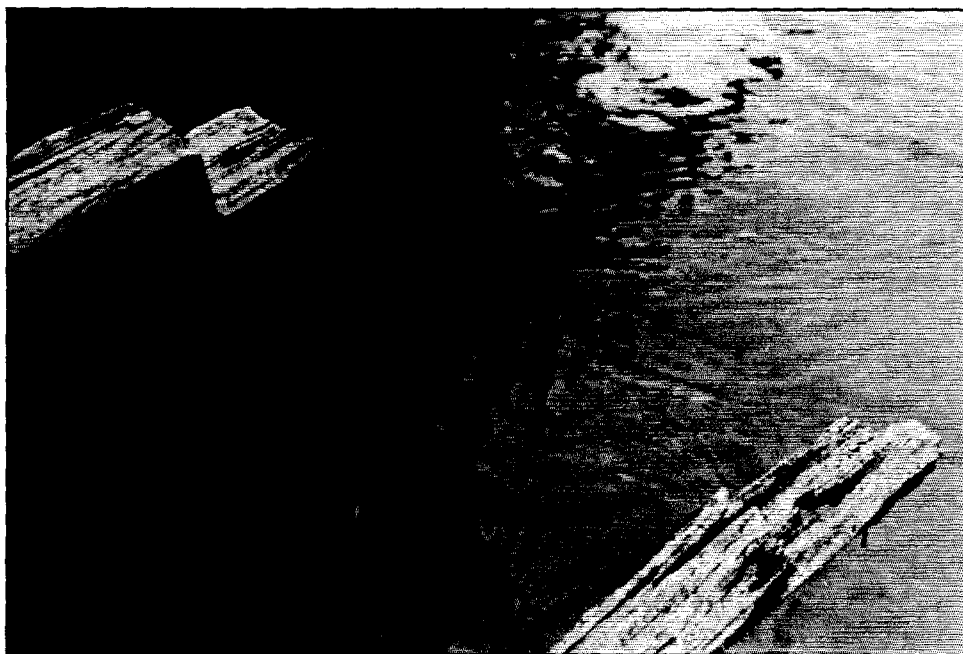
FIGURE 12: Construction detail. Half lap cut into the end of the center stringer. Note trunnel hole through stringer.
