**Cane River Creole National Historical Park**  
**Magnolia Plantation**  
**Overseer's House**  
**Historic Structure Report**

2004

2004  
Historic Structure Report  
Overseer's House  
Magnolia Plantation  
Cane River Creole National Historical Park  
Natchez, LA  
LCS#: 091558

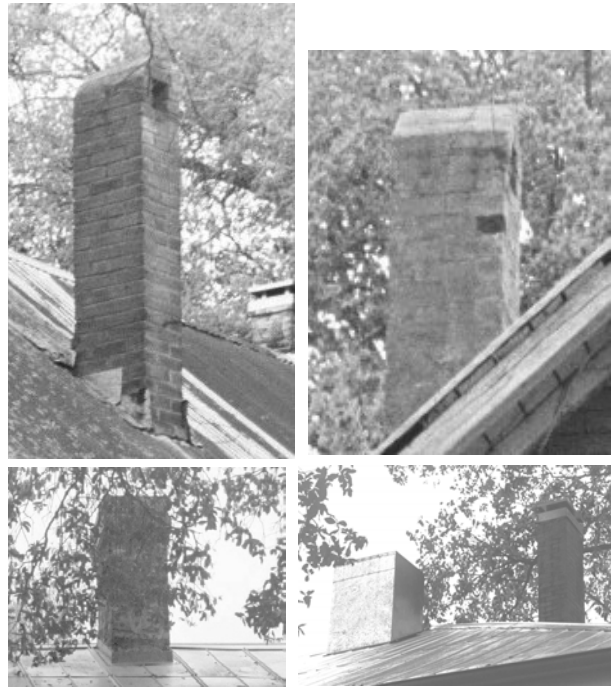
**FIGURE 9.** Chimneys for stove in Room 111, upper left; for stove in Room 110, upper right; fireplace in Room 104, lower left; and for fireplaces in Room 101, Room 102, and Room 103.

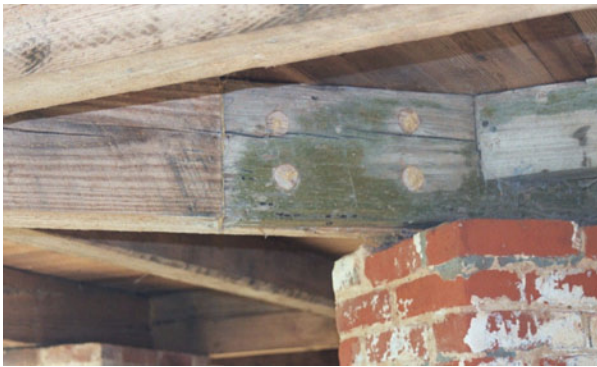
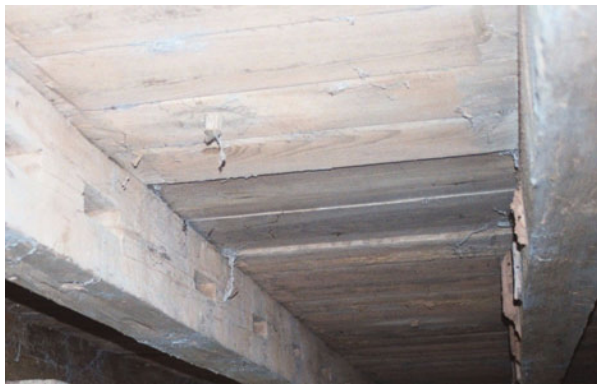
**FIGURE 15.** Above, pegged connections in historic floor framing; below, recycled joist in northwestern section of floor framing.

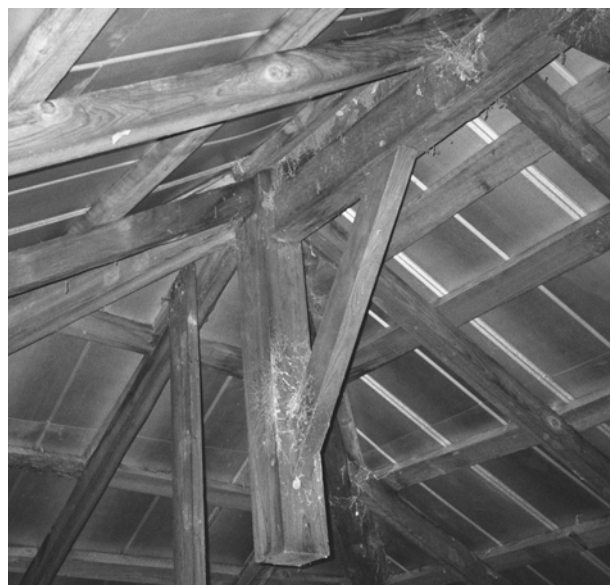
FIGURE 21. Framing at hip in roof. Note difference in end of king post.

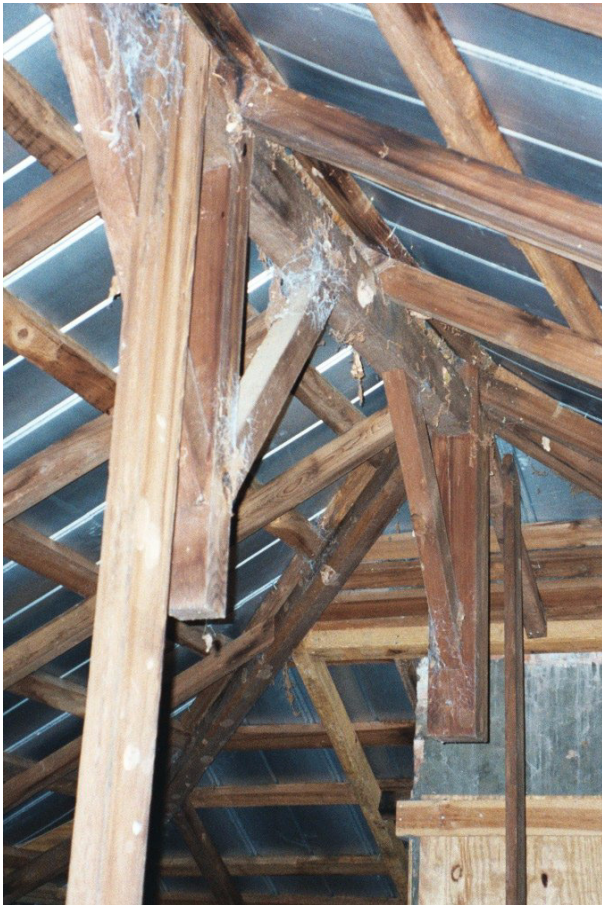
FIGURE 23. King post in center of attic supporting ridge beam.

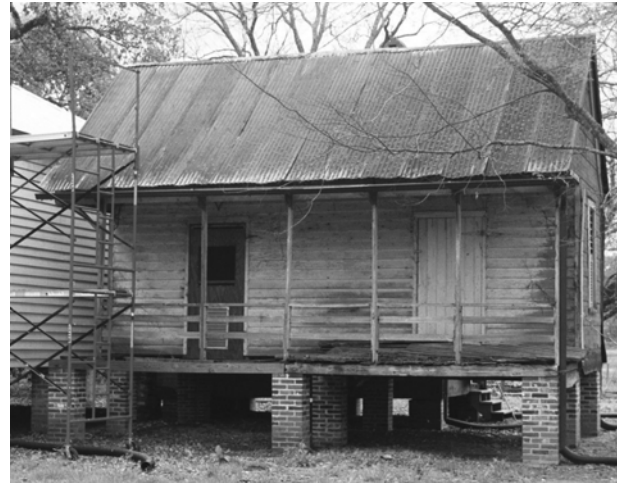
FIGURE 31. Room 111 wing, southeast elevation.

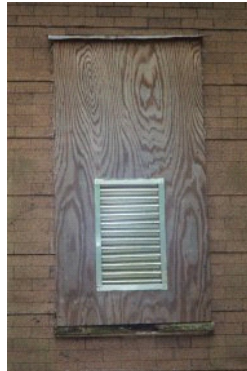
Evidence of original bars  
Window 11, Room 103

**Window 11:** This window is located on the interior wall separating Rooms 103 and 106 and holds no sashes. The underside of the head at this window opening reveals seven square mortises turned at 45 degrees to resemble diamond shapes. The *Materials Analysis* asserts that these mortises once held square bars that extended the length of the window. To the right of the opening, mounted on window trim in

Room 106, are two hinge pins. The characteristics of this hardware indicate that a casement type shutter was once likely mounted at this window opening.

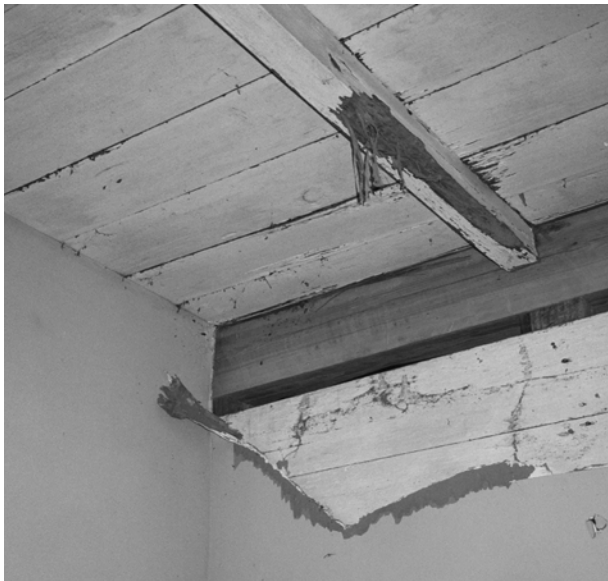
**Ceiling.** The height of the ceiling in Room 101 is 10' to 10" above the finished floor. The ceiling is comprised of the exposed underside of the attic floor framing and flooring. The attic flooring exposed in this room runs northwest to southeast and varies in width. See *Attic Flooring Table* included later in this report for detailed dimensions. The

FIGURE 45. Room 101 ceiling and southwest wall.

boards span joists approximately 36" on center. The ceiling is painted white.

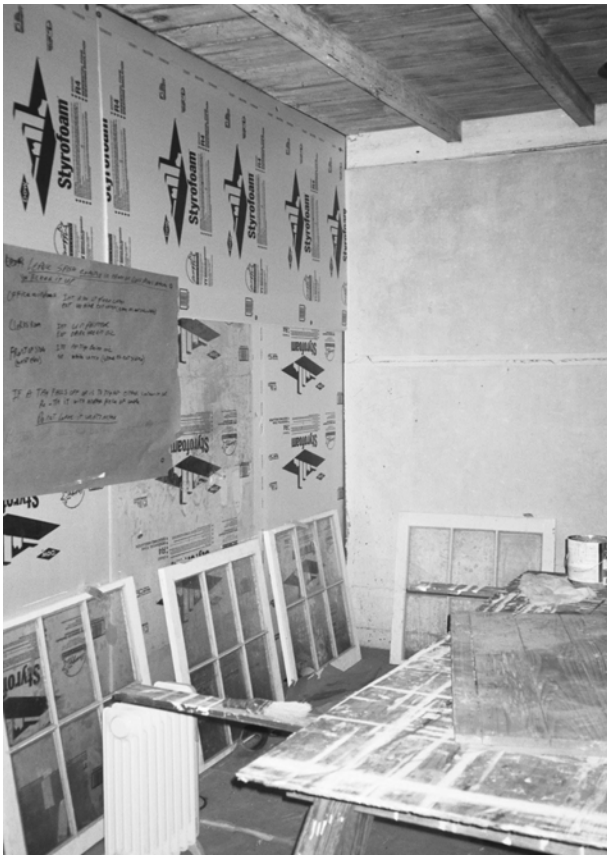
FIGURE 48. Room 102, looking north.

5 $\frac{3}{4}$ " by 4 $\frac{1}{4}$ " thick and finished with  $\frac{3}{4}$ " quarter-round molding. The National Park Service has installed expanded polystyrene board over the northwest wall as a temporary insulation measure. Room 102 is temporarily being used as a glazing room for the repair of window sashes from the Magnolia Store. Beneath the polystyrene board is new, heavy timber framing installed by the National Park Service contractor. According to National Park Service officials, the historic *bousillage* from this wall is currently stored in bins located in the Carriage Shed.

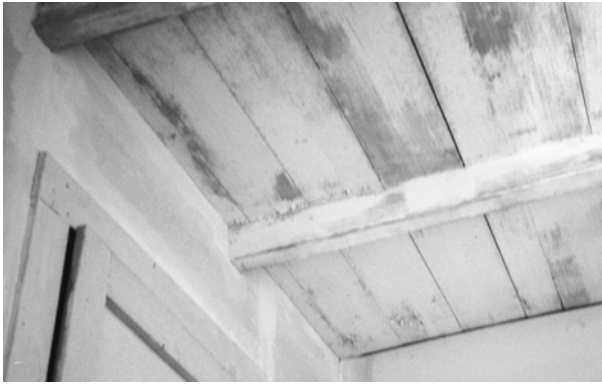
FIGURE 61. Room 108, ceiling.

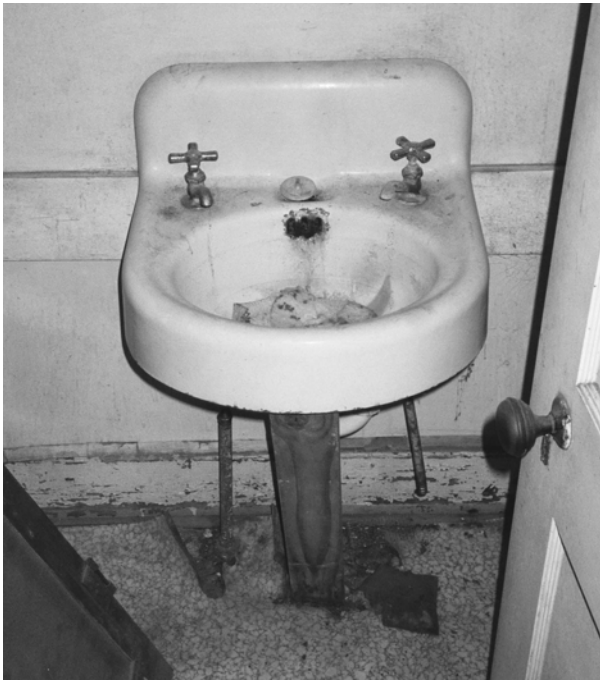
FIGURE 62. Room 109, sink.

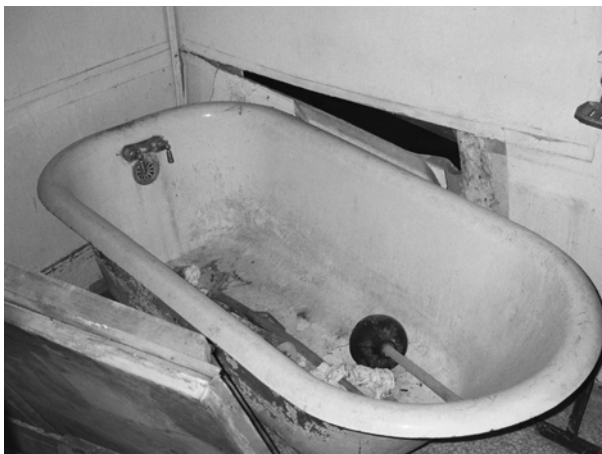
FIGURE 63. Room 109, bath tub.

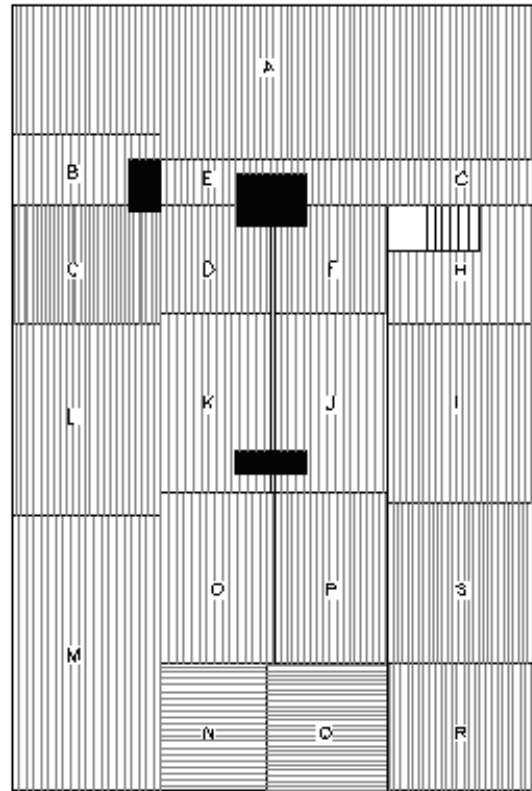
FIGURE 68. Details of attic flooring.
